Confidential Inspection Report

LOCATED AT:
1459 Crimson Clover Ct
Brentwood, TN 37027

INSPECTED ON:
Monday, November 4, 2019

Inspector, Veo A. Moore TN00198
Ultrasound Home Inspections

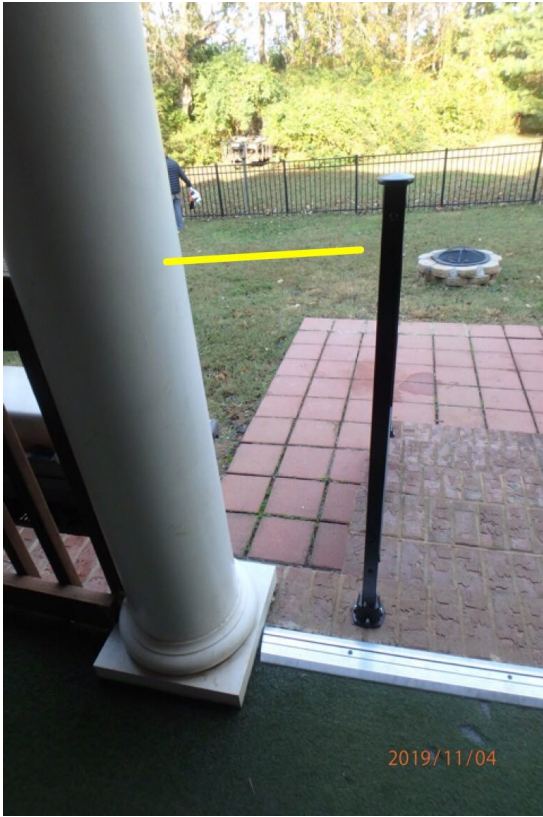
SAFT s-19: The spacing between the guardrail and post at the rear patio area exceeds 4 inches in width which does not meet today's minimum safety standards. Although it may predate this requirement, upgrading should be considered. Safety issue.

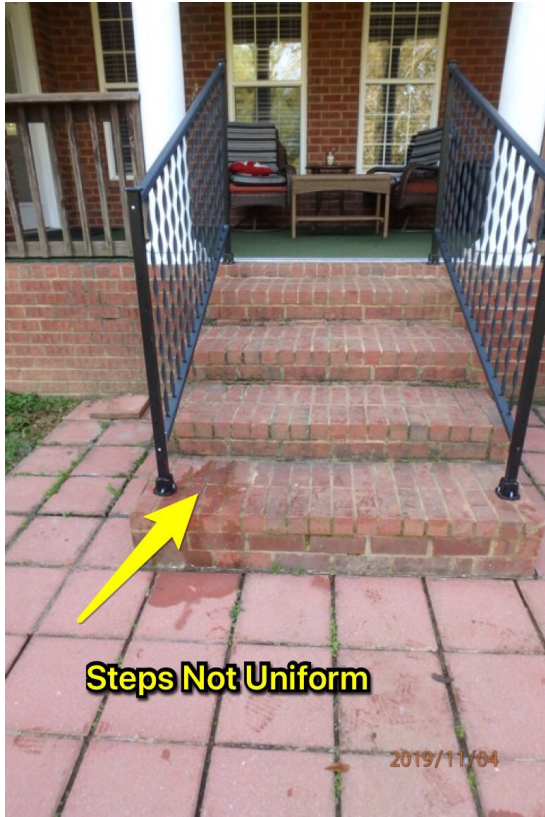
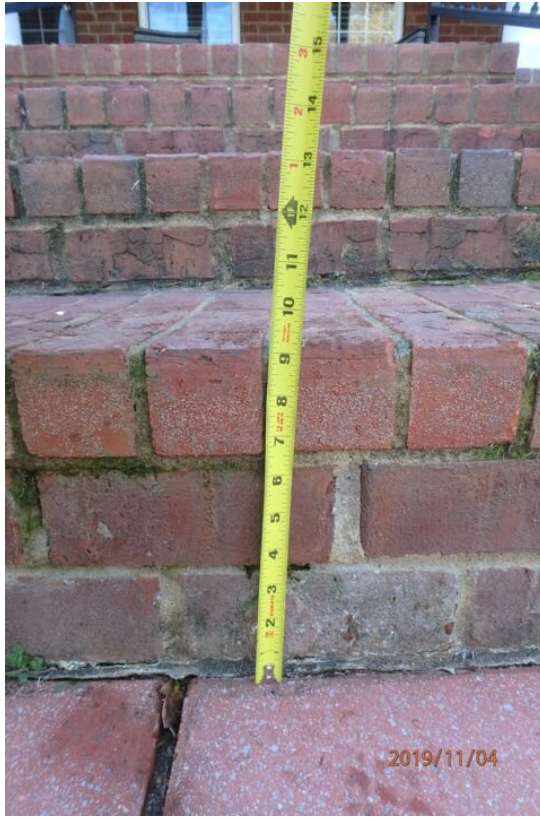
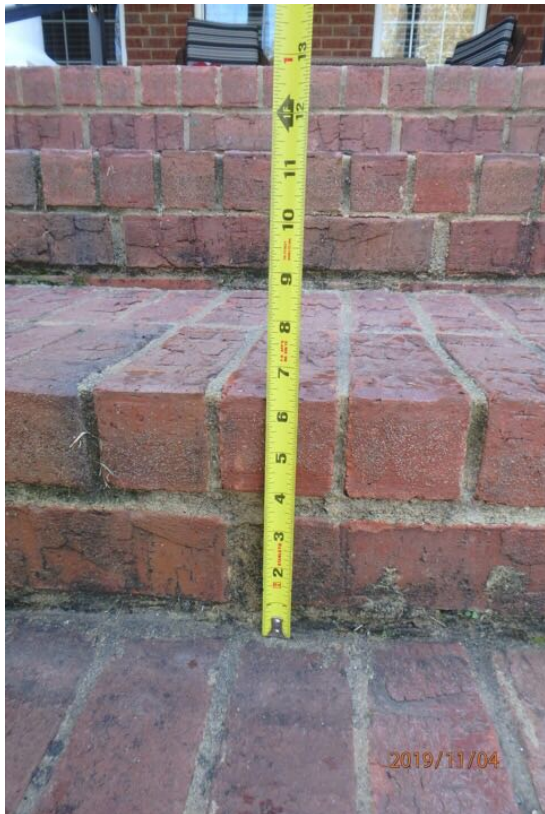
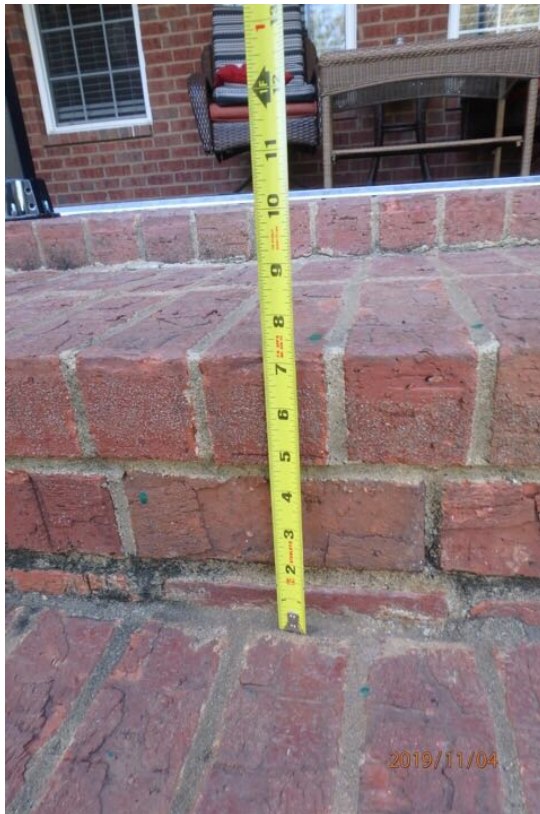
REPR s-39: The steps at the rear patio stoop are not uniform in height. Variation in step height cannot exceed 3/8" according to current safety standards. UltraSound recommends correcting this condition. Caution is advised when using these steps as this condition can be a tripping hazard.

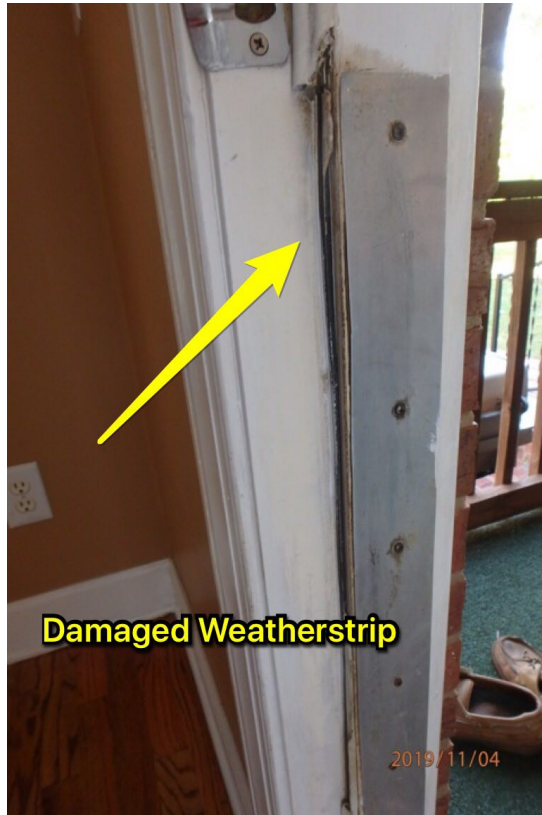
1. Rear patio door

REPR s-41: Damage was noted to the weather strip at the door(s) listed below. Repair/replacement is needed to seal the door from the outside elements and maximum heating and cooling efficiency.

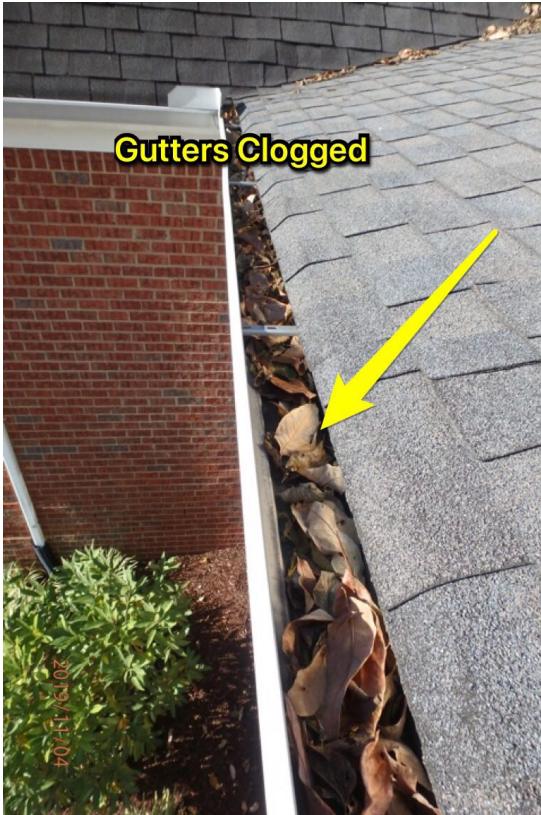
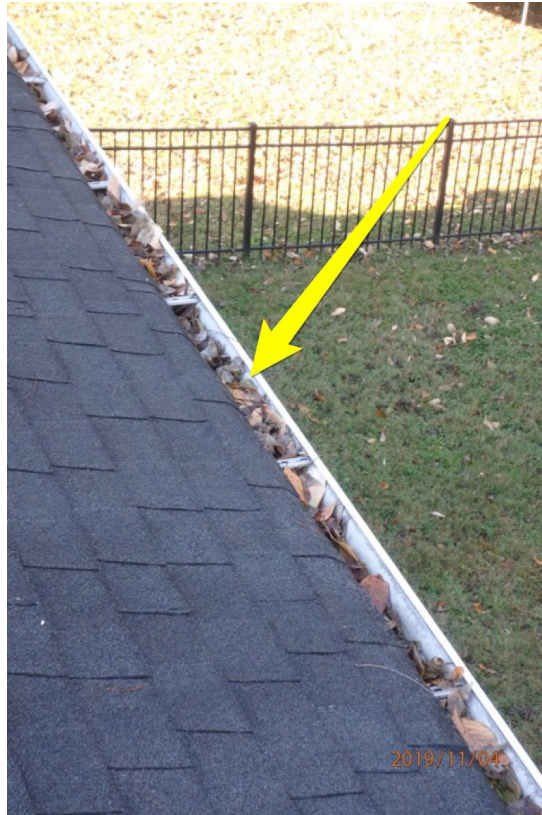
REPR s-50: Clogged gutters were noted on most of the gutter system, preventing water from properly channeling away from the structure, which can negatively impact the fascia, soffit, crawlspace, and foundation. Gutters should be examined and cleaned regularly to promote the free flow of water.

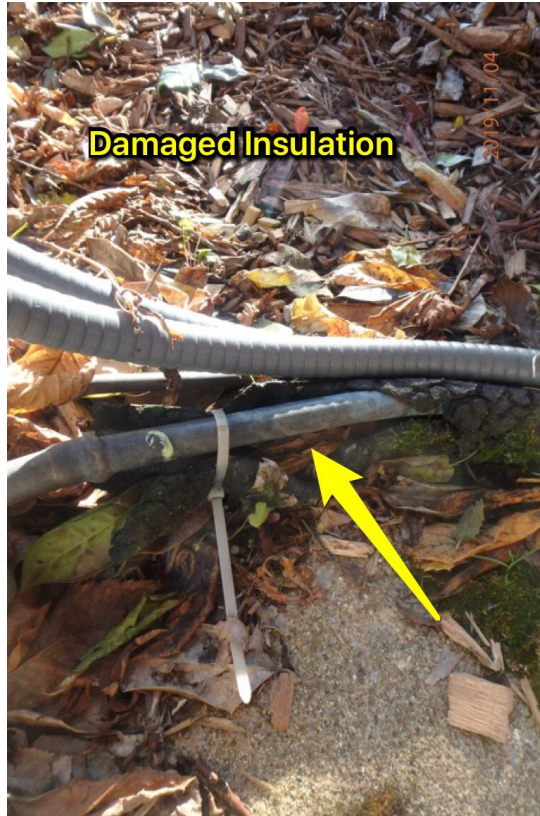
REPR s-88: Missing/decayed insulation was noted on the upper level A/C refrigerant line. All exposed sections of the refrigerant line should be fully insulated for maximum heating and cooling efficiency.

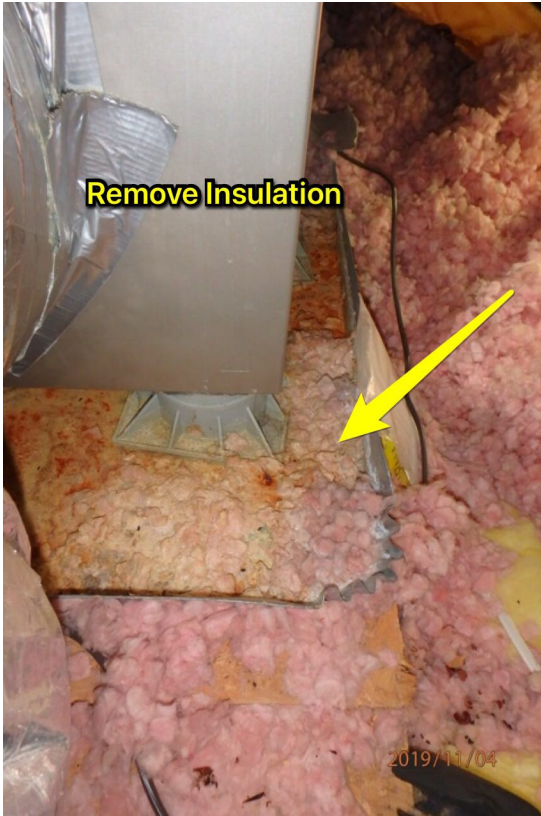
REPR s-124: Insulation was noted in the drip pan under the upper level HVAC unit which will allow the pan to become clogged, preventing proper function of the pan and float. Repair.

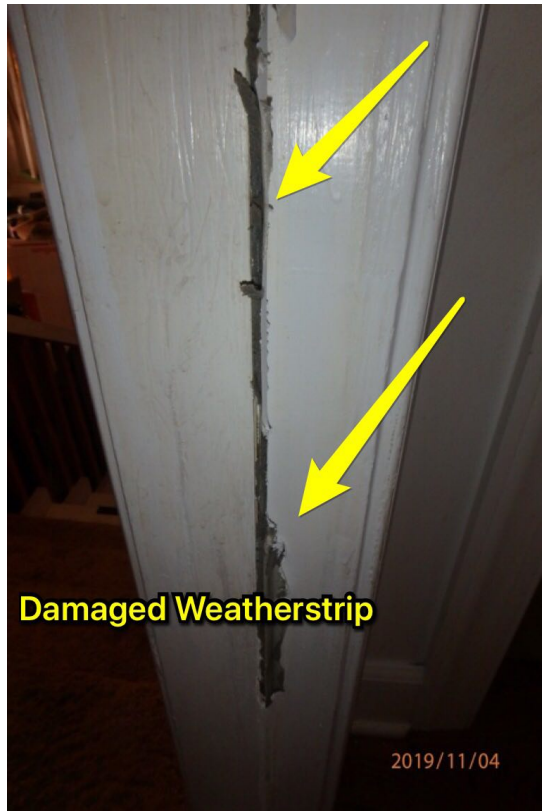
s-173: The weather strip on the garage entry door is damaged and needs replaced for maximum heating and cooling efficiency.

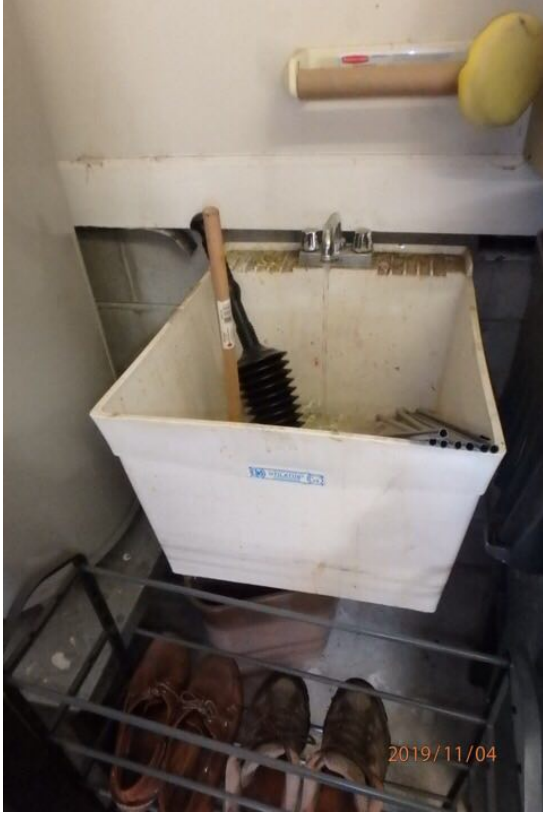
REPR s-184: The hot water shut off valve(s) located under the garage sink was found in the off position at the arrival of the inspection. For flood concerns and to meet the Tennessee Standards of Practice, the inspector is not allowed to open or operated any water valves that have been turned off. For this reason the condition of the hot water supply line and hot water side of the faucet wer undetermined and further investigation is needed.

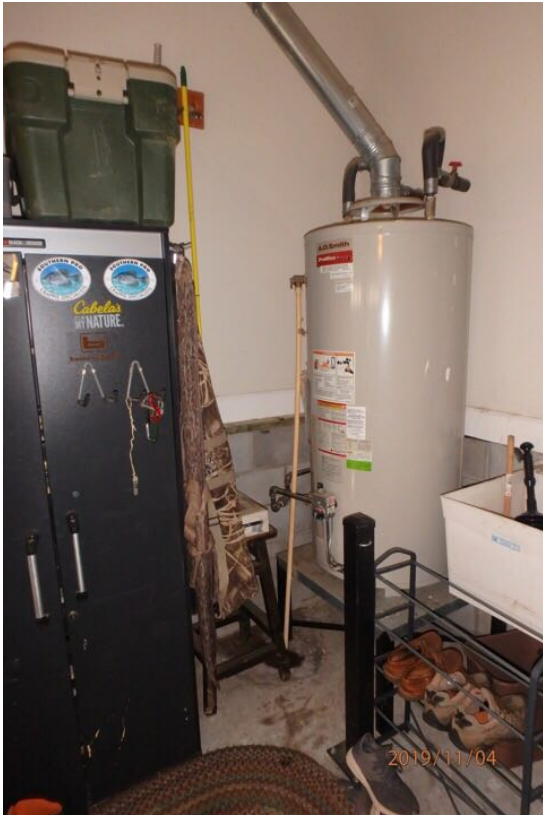
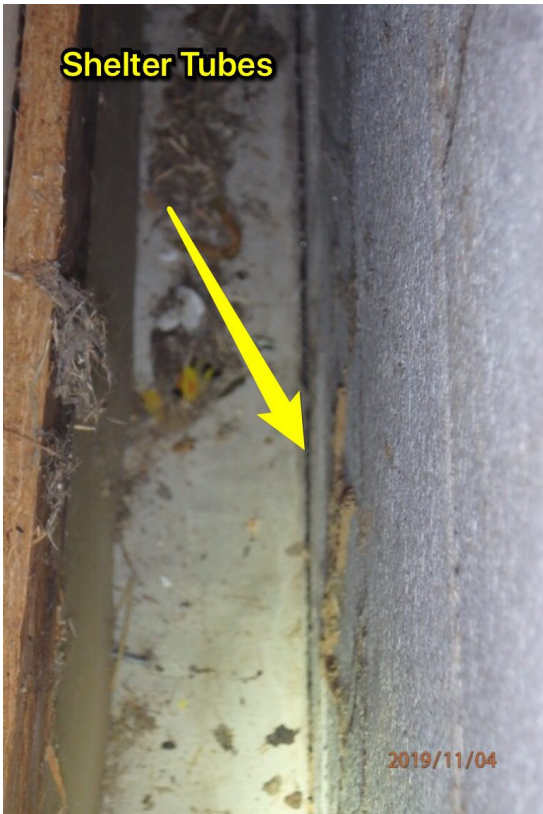
REPR s-185: Wood destroying insect shelter tubes were found along the foundation wall in the garage space. No apparent damage was found during the inspection however further attention is needed by a qualified insect contractor to determine if treatment is necessary.

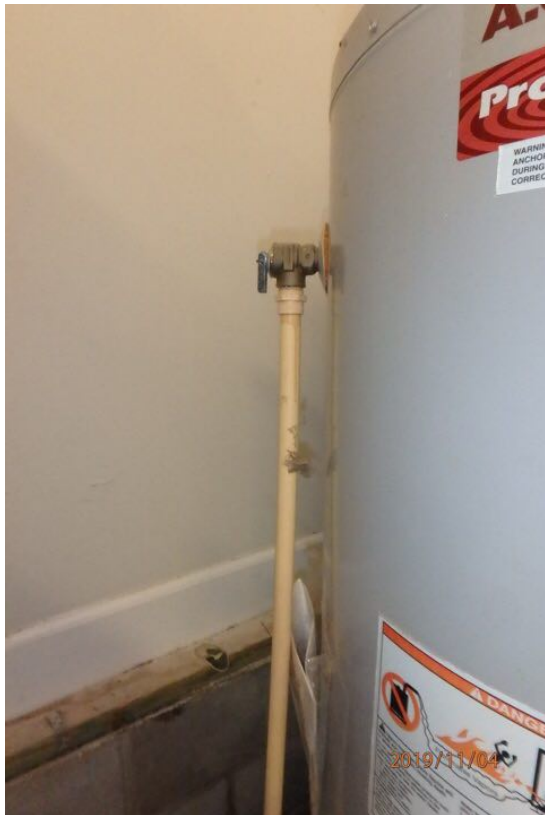
REPR s-225: A leaking TPR (temperature pressure relief) valve was noted at the water heater. Excessive water pressure, excessive water temperature, and a defective valve are common causes of this condition. UltraSound recommends further investigation and repair by a qualified professional.

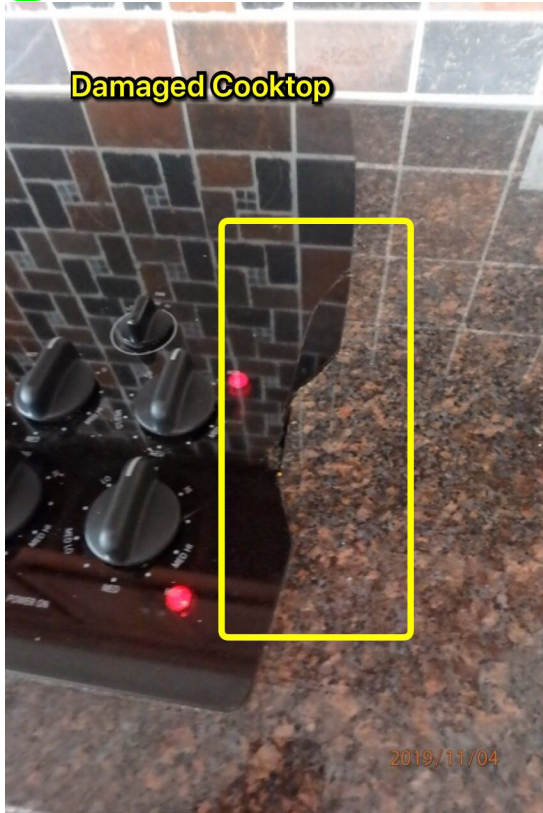
REPR **s-262:** The glass surface of the cooktop is damaged and may possible need to be replaced.

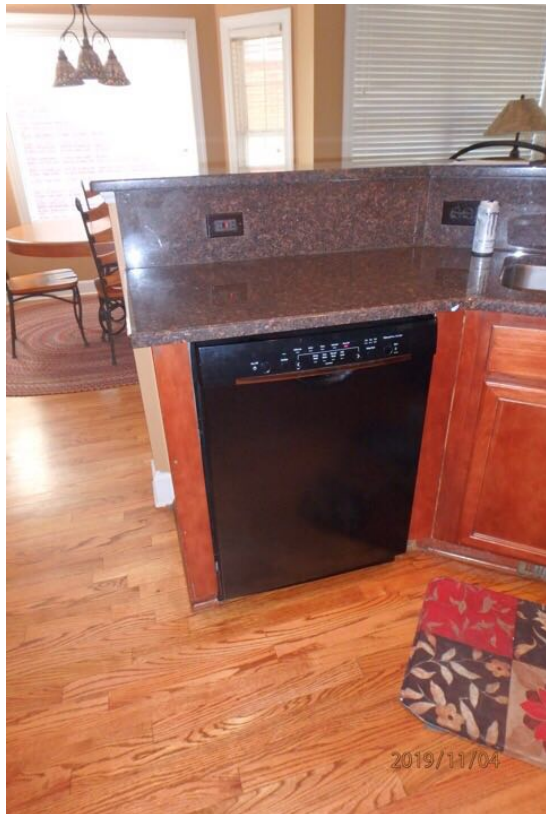
REPR s-265: The dishwasher is not properly attached to the under side of the countertop or the sides of the base cabinet. This leaves the unit in an unstable condition that should be corrected. Safety issue.

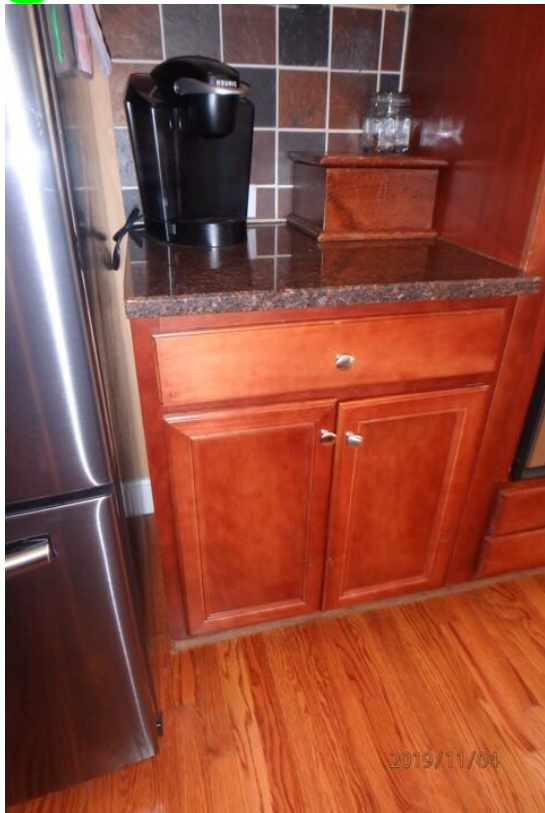
REPR s-273: Damage was found to one of the cabinet drawers.

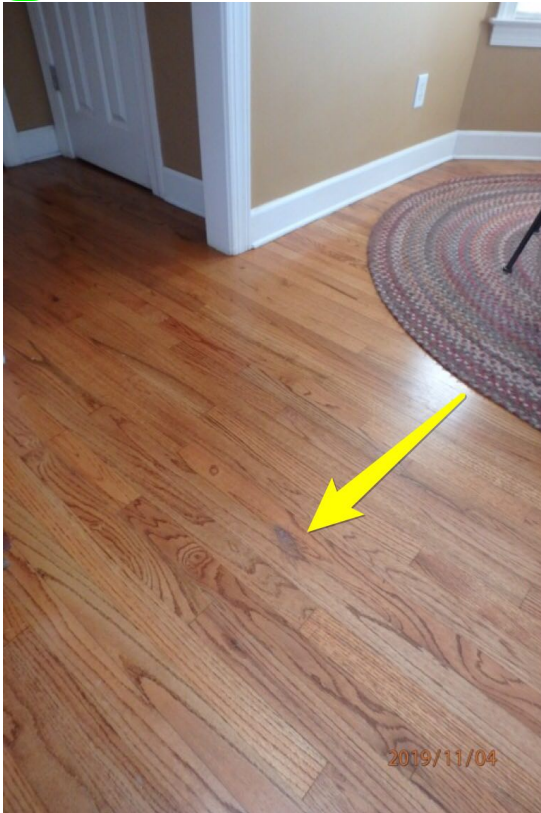
REPR **s-284:** Damage was found in the wood floor covering in the kitchen.

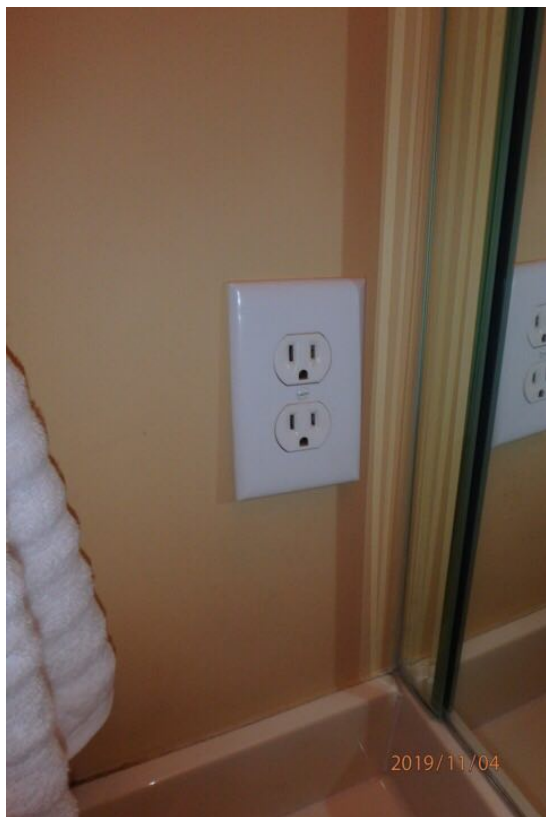
1. Downstairs hall bathroom

REPR s-298: A loose electrical outlet was noted in the bathroom listed below. This can make un-plugging appliances difficult.

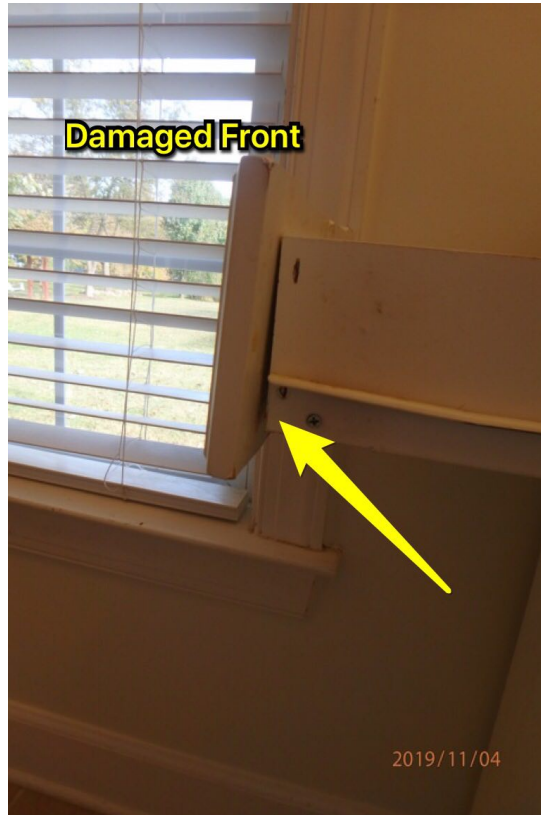
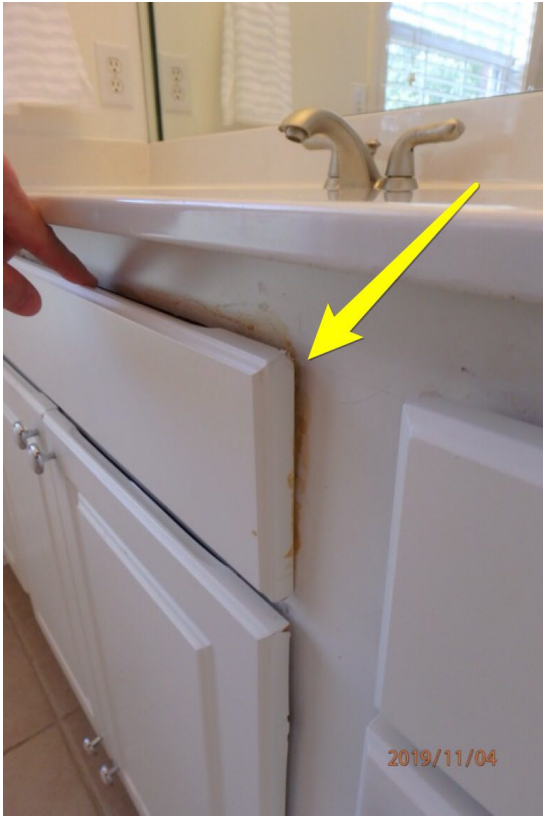
1. Master bathroom (Right side)

REPR s-299: Damage was noted to the bathroom vanity drawer in the bathroom(s) listed below. Repair/replacement is needed.

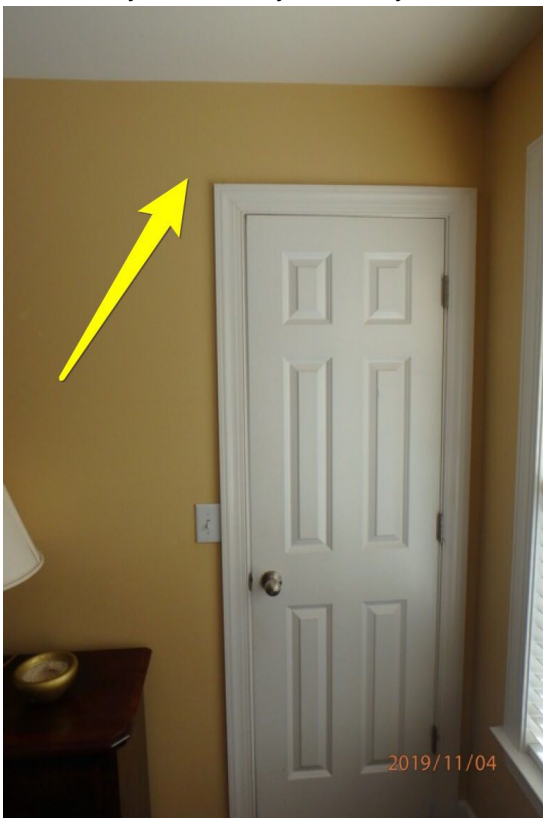
1. Upstairs front bedroom closet doorway
2. Laundry room entry doorway

REPR s-316: A wall crack(s) was noted above the door(s) at the location(s) listed below. This may be the result of excessive movement in the foundation or the framing components. The installed door is drain along the upper jamb as well. Further investigation is needed by a qualified professional and or structural engineer to determine if repairs are necessary.

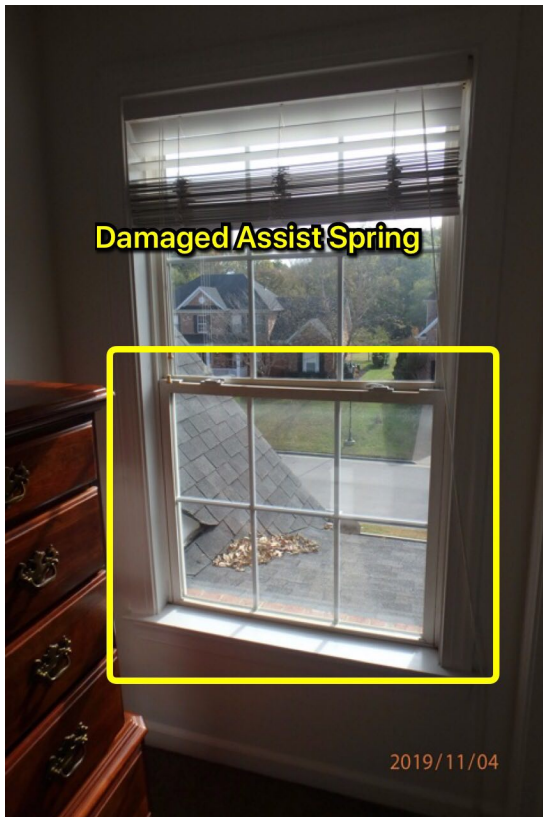
1. Upstairs front bedroom closet

s-320: A damaged assist spring was noted in the window(s) mentioned below. Repair is needed for the window(s) to function as designed.

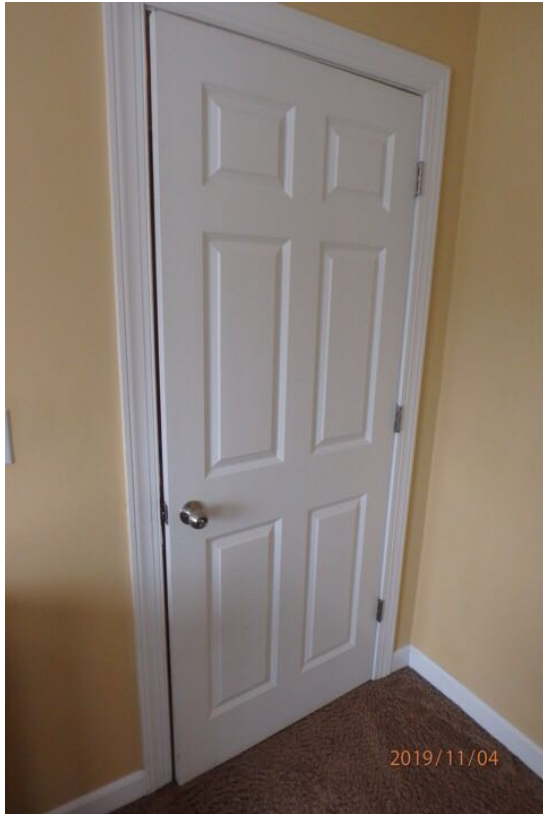
REPR **s-321:** The upstairs front bedroom entry door appears to have been forced open causing damage to the door jamb in the latch area. Repairs and/or replacement is needed for the door to latch properly.

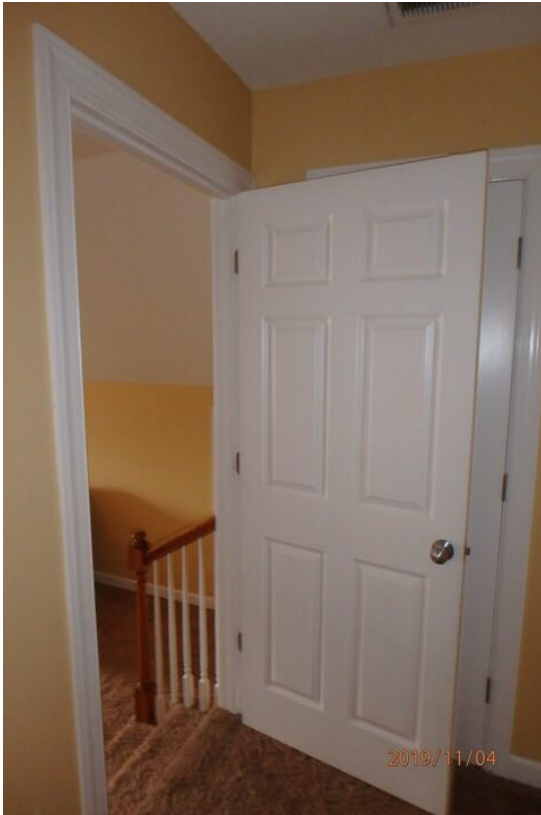
1. Upstairs bonus room

s-322: The screws that secure door hinge(s) in place are loose/stripped which prevents the door from being properly installed causing it to interfere with the jamb. Repairs are needed for it to function as designed.

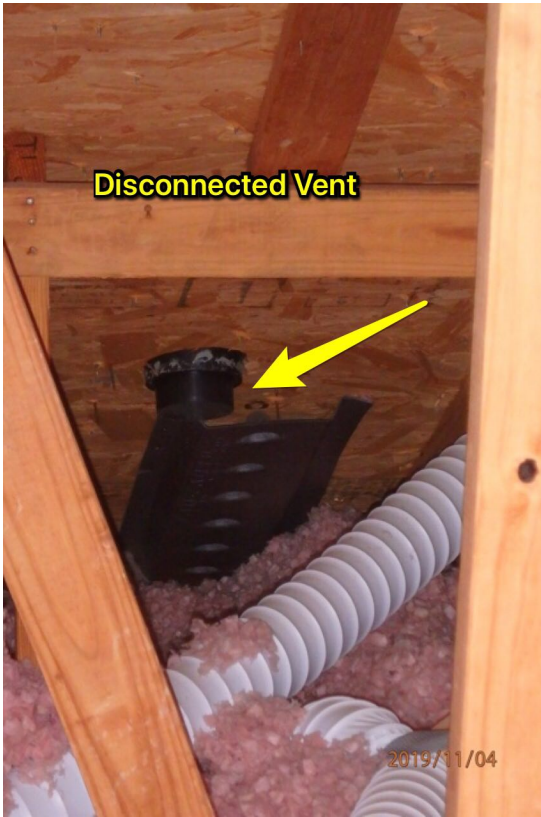
1. Left side

REPR s-353: A disconnected bathroom exhaust duct was noted in the attic at the location(s) listed below. The vent should be reattached to prevent moisture from exhausting into the attic.

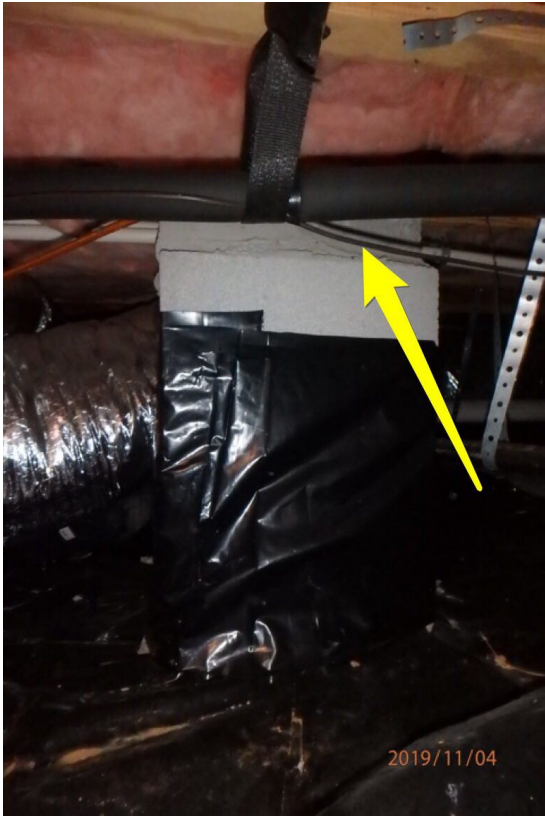
REPR s-379: Missing shims were noted at two of the installed piers in the crawlspace. The shims are needed to ensure the intended joist are properly supported. UltraSound recommends repair by a qualified professional.

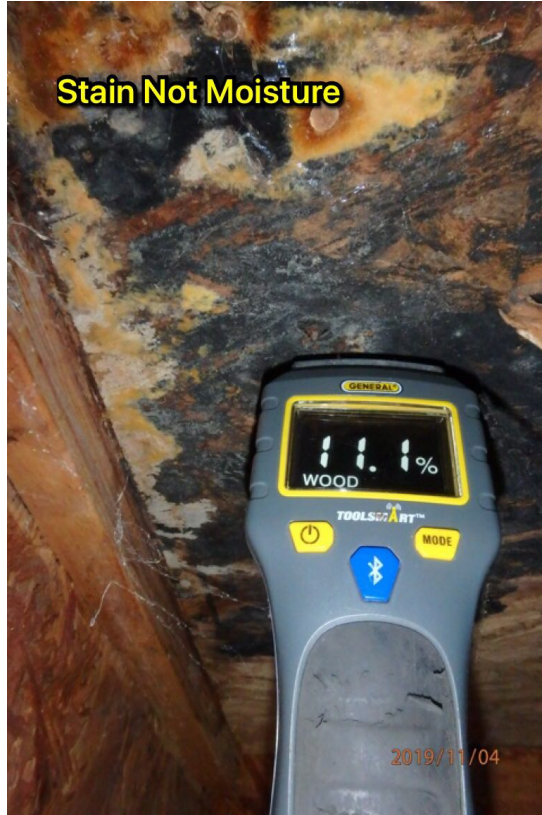
REPR s-395: Water stains were noted in the subfloor under the master bathroom toilet. No elevated moisture levels were measured in the area of the stains however leaks may not occur until the toilet is being used under normal conditions . Further investigation is needed by a qualified professional to determine if repairs are needed.

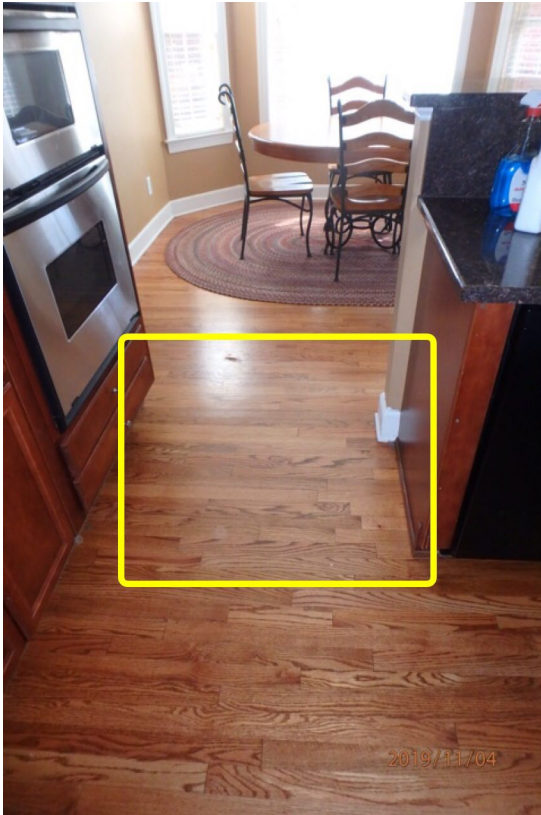
REC s-283: Slight Water damage was found in the kitchen floor to the left of the dishwasher. No elevated moisture levels were measured in the floor at the time of the inspection and the extent of any hidden damage was undetermined. Further investigation is needed by a qualified professional.

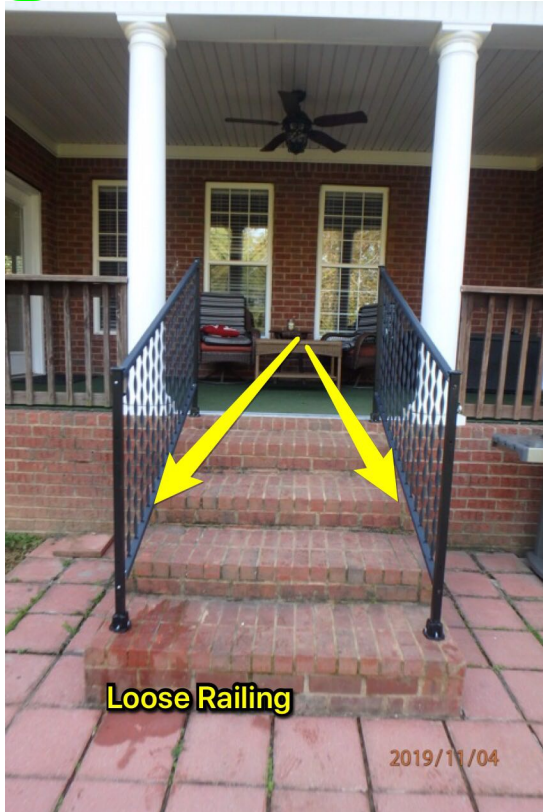
REPR 18: The patio stoop handrails appear loose and need properly re-secured.

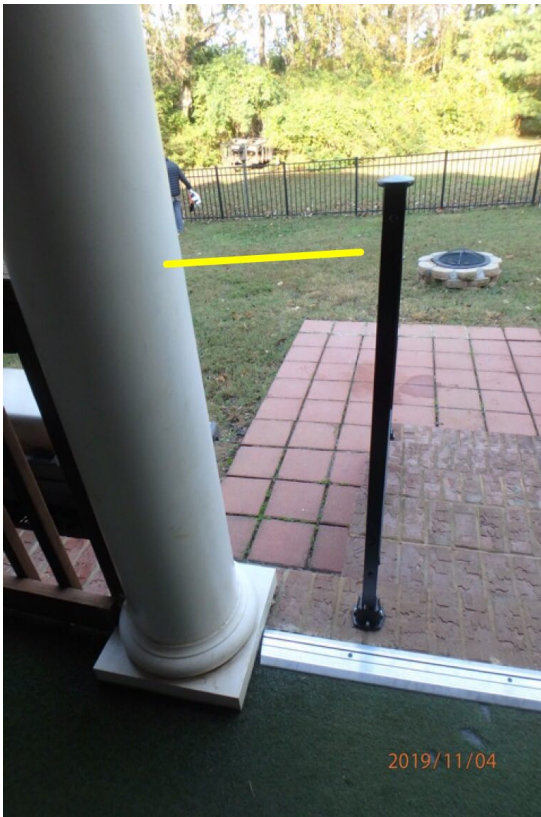
19: The spacing between the guardrail and post at the rear patio area exceeds 4 inches in width which does not meet today's minimum safety standards. Although it may predate this requirement, upgrading should be considered. Safety issue.

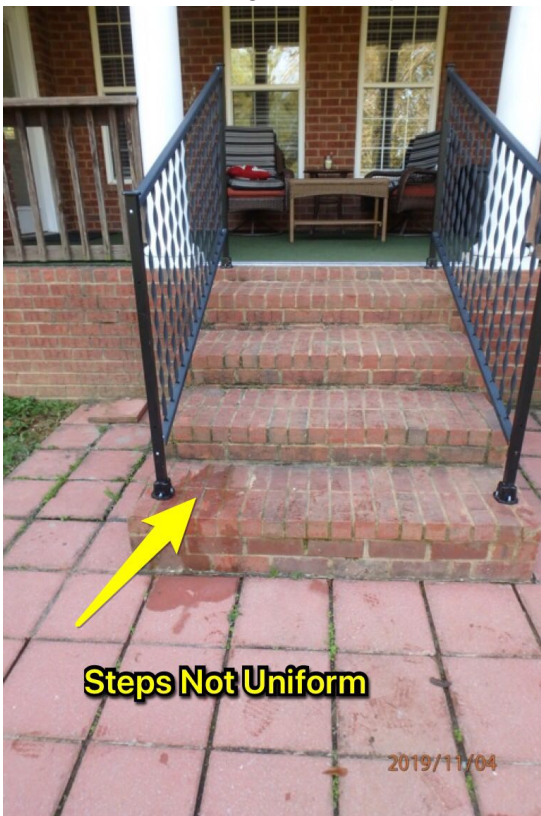
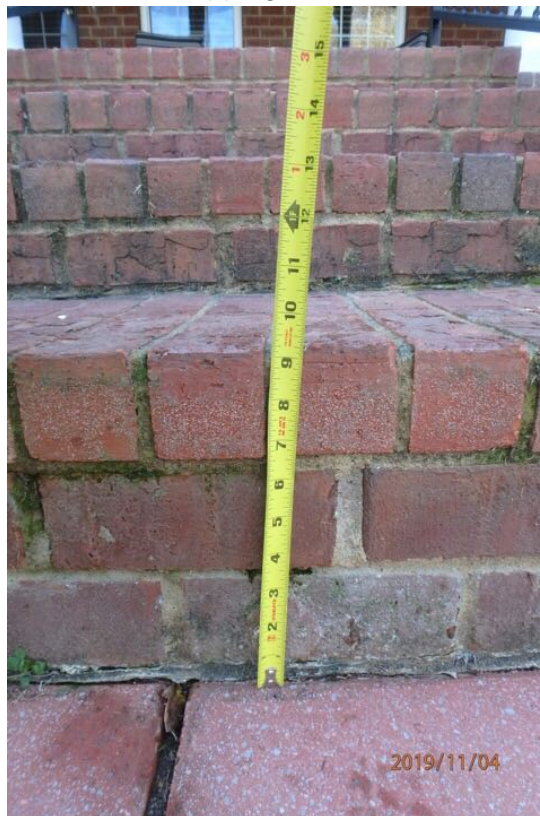
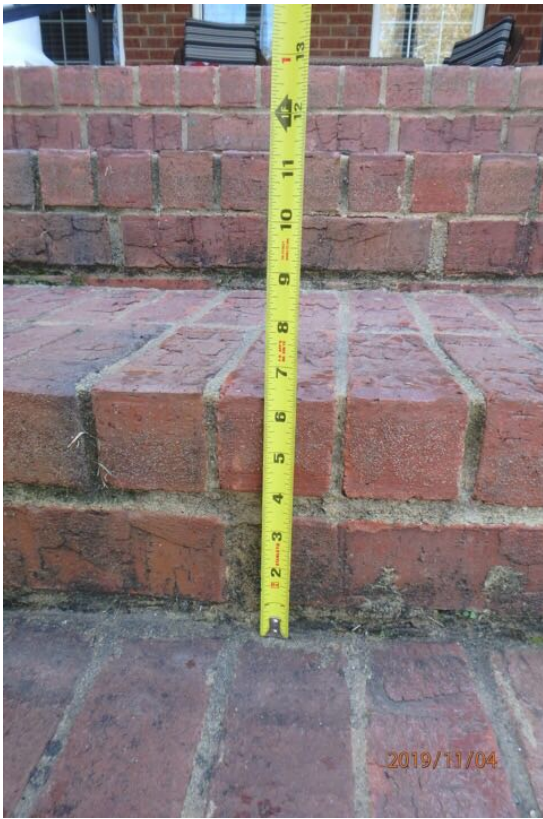
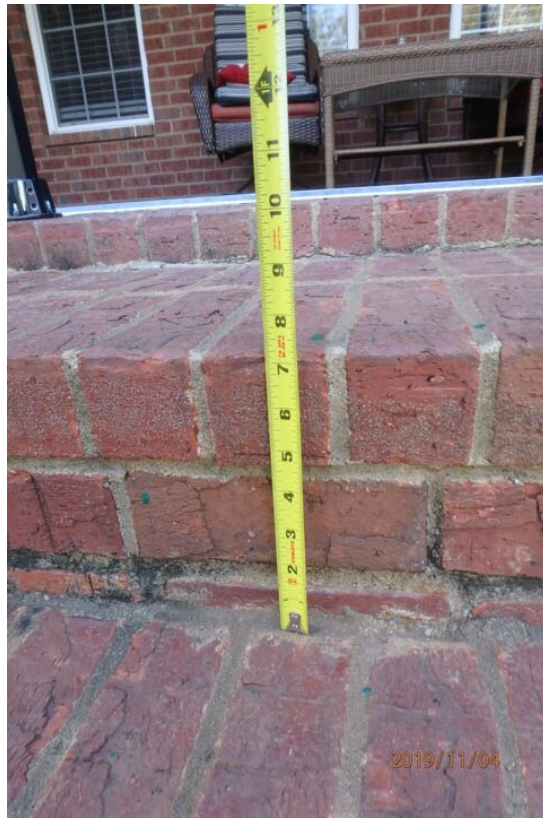
REPR 39: The steps at the rear patio stoop are not uniform in height. Variation in step height cannot exceed 3/8" according to current safety standards. UltraSound recommends correcting this condition. Caution is advised when using these steps as this condition can be a tripping hazard.

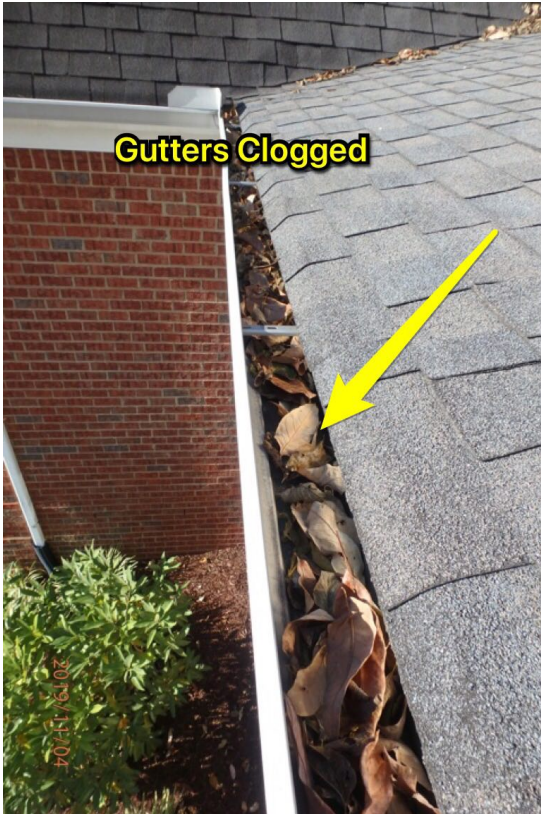
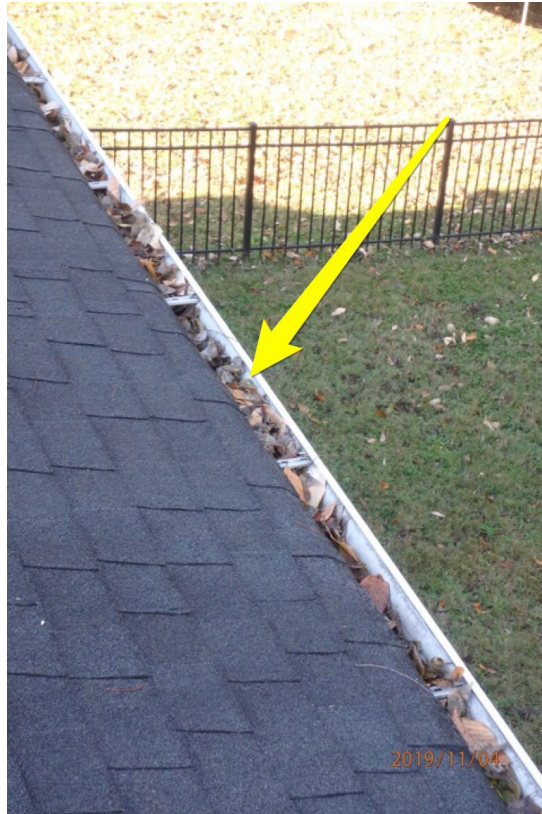
50: Clogged gutters were noted on most of the gutter system, preventing water from properly channeling away from the structure, which can negatively impact the fascia, soffit, crawlspace, and foundation. Gutters should be examined and cleaned regularly to promote the free flow of water.

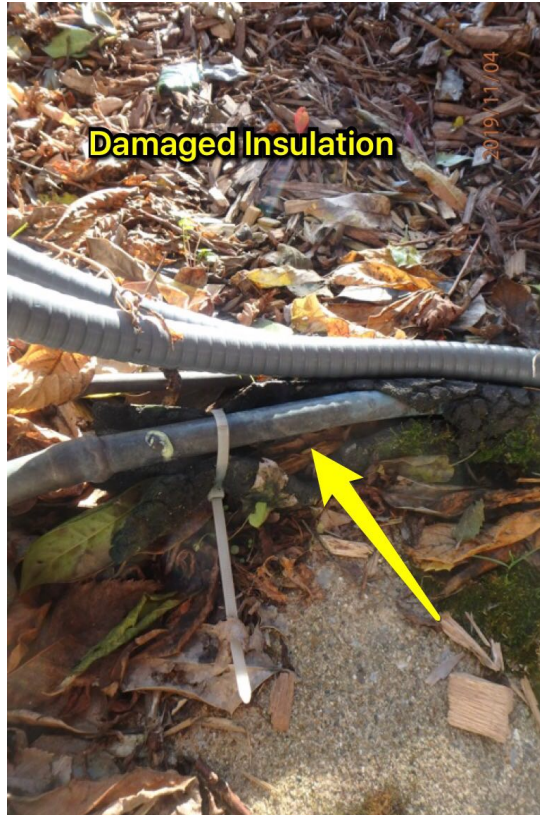
REPR 88: Missing/decayed insulation was noted on the upper level A/C refrigerant line. All exposed sections of the refrigerant line should be fully insulated for maximum heating and cooling efficiency.

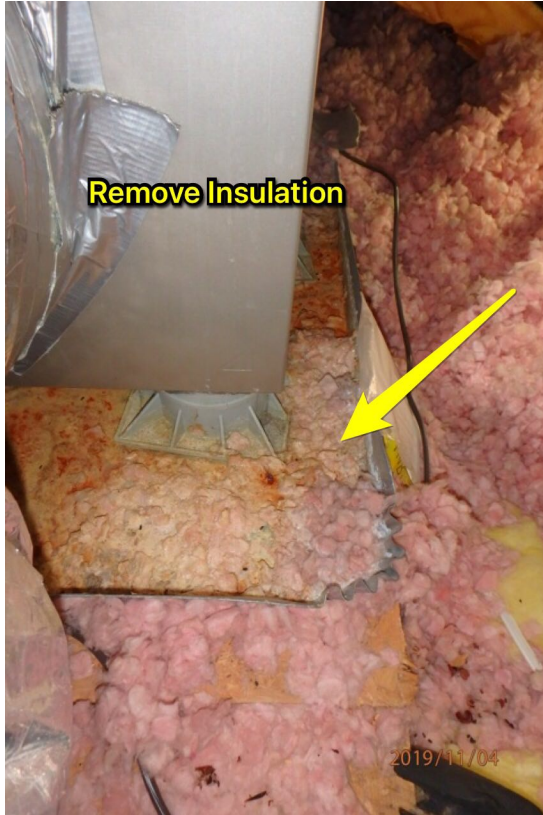
REPR 124: Insulation was noted in the drip pan under the upper level HVAC unit which will allow the pan to become clogged, preventing proper function of the pan and float. Repair.

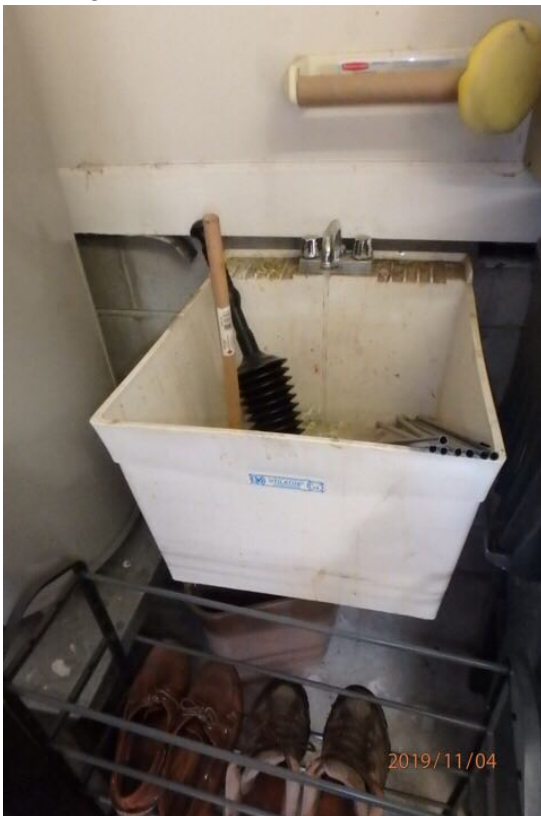
REPR 184: The hot water shut off valve(s) located under the garage sink was found in the off position at the arrival of the inspection. For flood concerns and to meet the Tennessee Standards of Practice, the inspector is not allowed to open or operated any water valves that have been turned off. For this reason the condition of the hot water supply line and hot water side of the faucet wer undetermined and further investigation is needed.

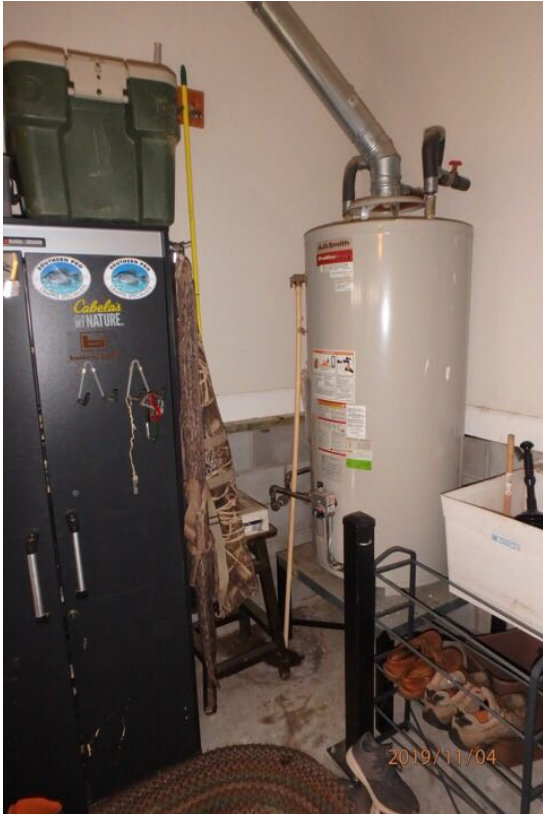
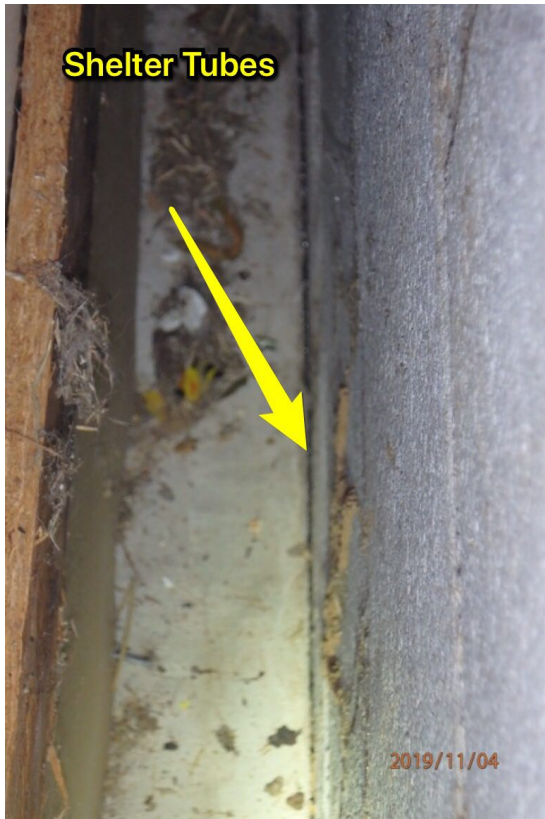
REPR 185: Wood destroying insect shelter tubes were found along the foundation wall in the garage space. No apparent damage was found during the inspection however further attention is needed by a qualified insect contractor to determine if treatment is necessary.

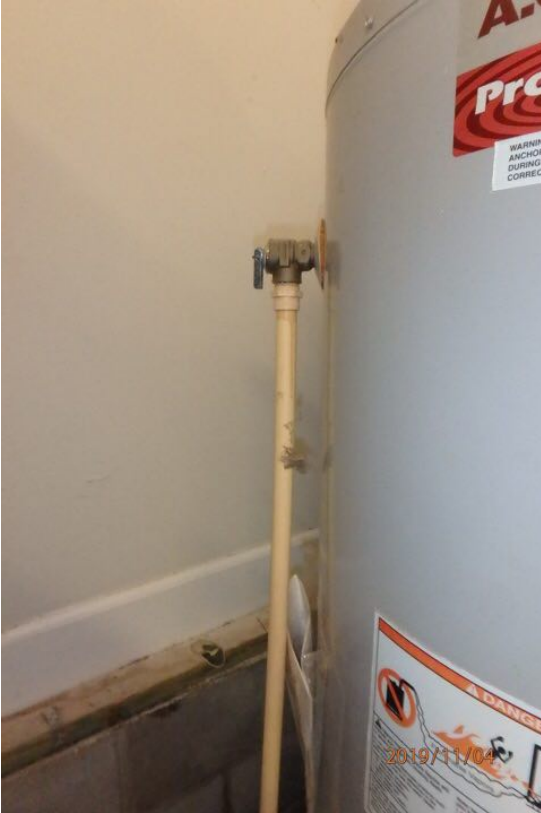
REPR 225: A leaking TPR (temperature pressure relief) valve was noted at the water heater. Excessive water pressure, excessive water temperature, and a defective valve are common causes of this condition. UltraSound recommends further investigation and repair by a qualified professional.

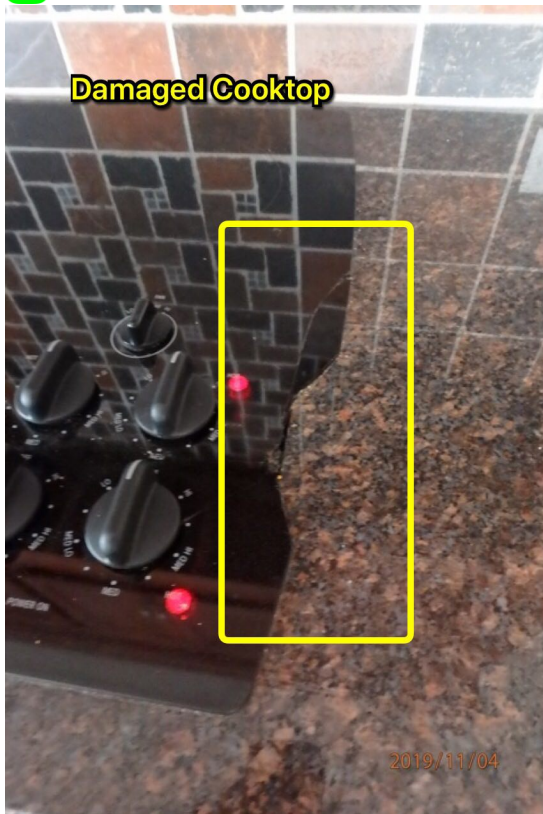
REPR 262: The glass surface of the cooktop is damaged and may possible need to be replaced.

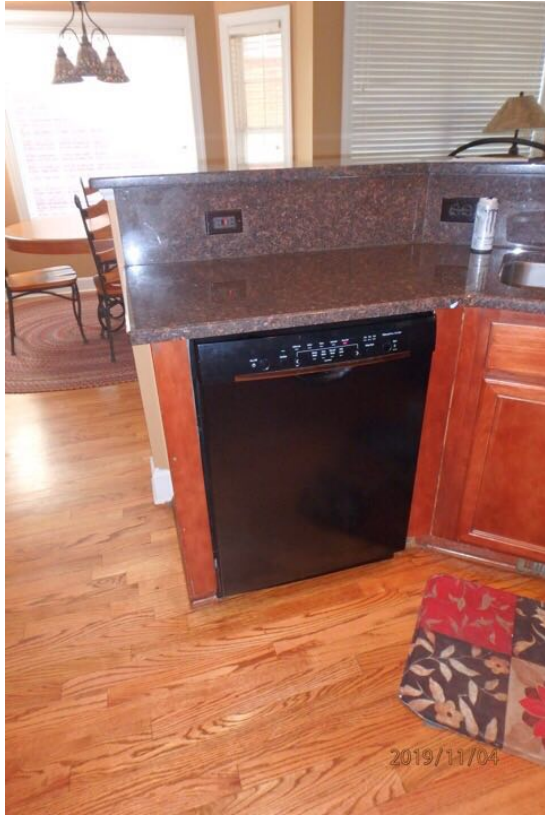
265: The dishwasher is not properly attached to the under side of the countertop or the sides of the base cabinet. This leaves the unit in an unstable condition that should be corrected. Safety issue.
