Confidential Inspection Report

LOCATED AT:
1459 Crimson Clover Ct
Brentwood, TN 37027

INSPECTED ON:
Monday, November 4, 2019

Inspector, Veo A. Moore TN00198
Ultrasound Home Inspections

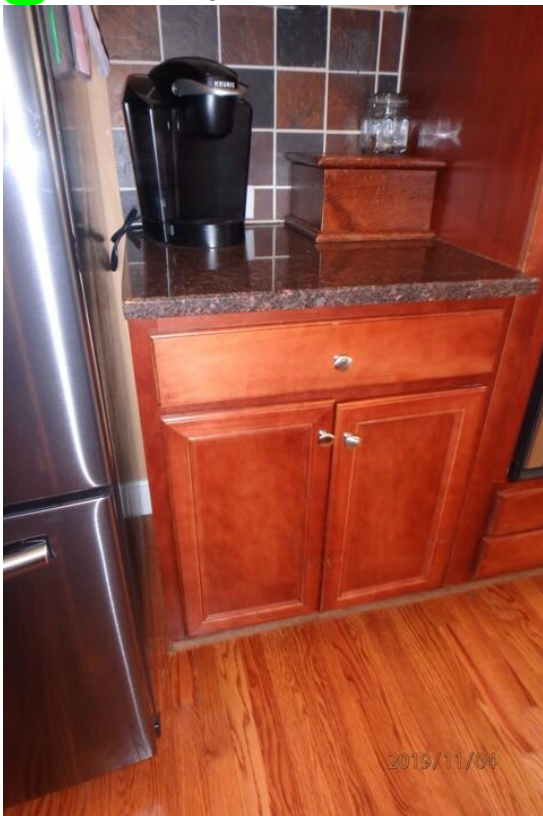
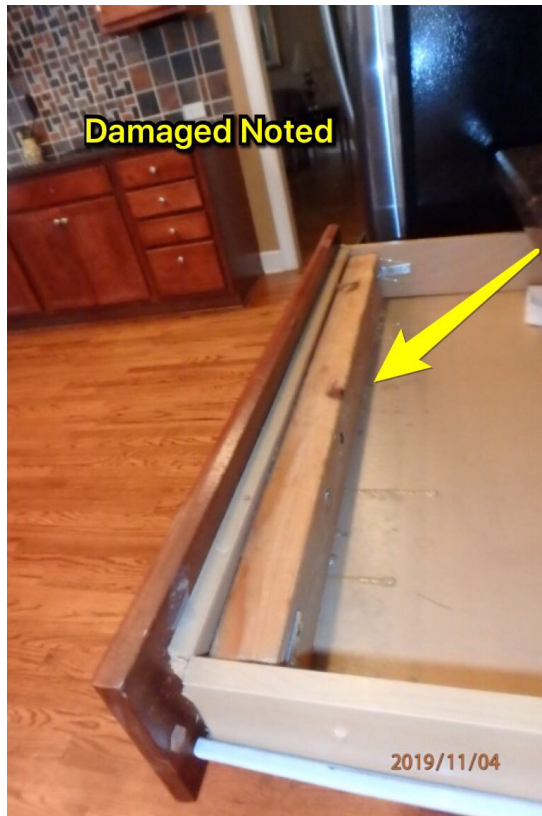
REPR 273: Damage was found to one of the cabinet drawers.

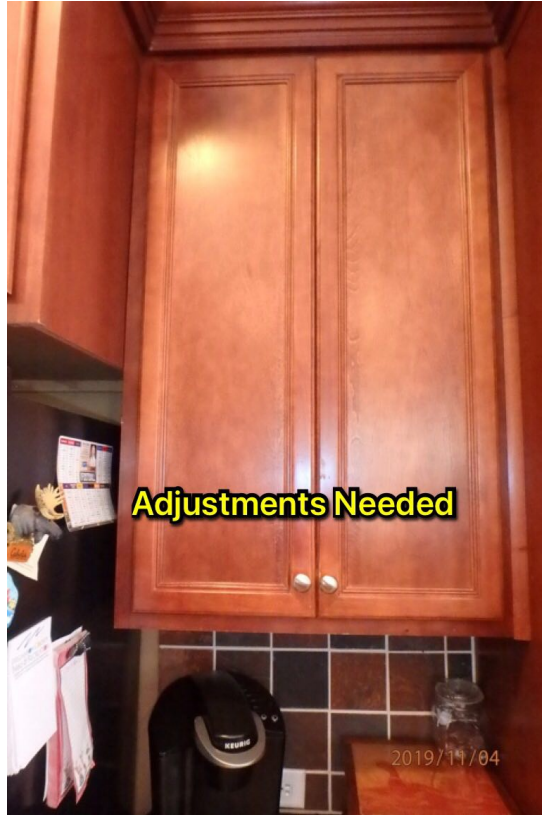
REPR 274: The cabinet door(s) indicated in the photos are misaligned or out of adjustment. The hinges need to be adjusted for the doors to function smoothly.

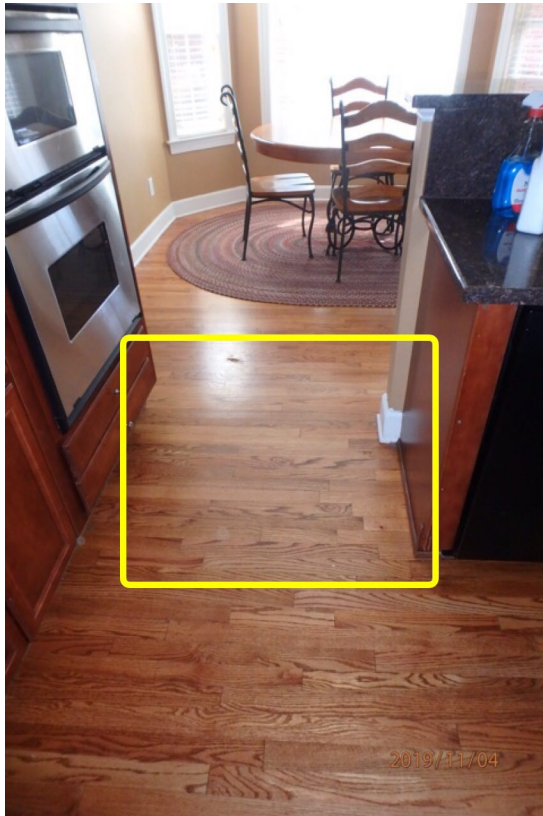
REC 283: Slight Water damage was found in the kitchen floor to the left of the dishwasher. No elevated moisture levels were measured in the floor at the time of the inspection and the extent of any hidden damage was undetermined. Further investigation is needed by a qualified professional.

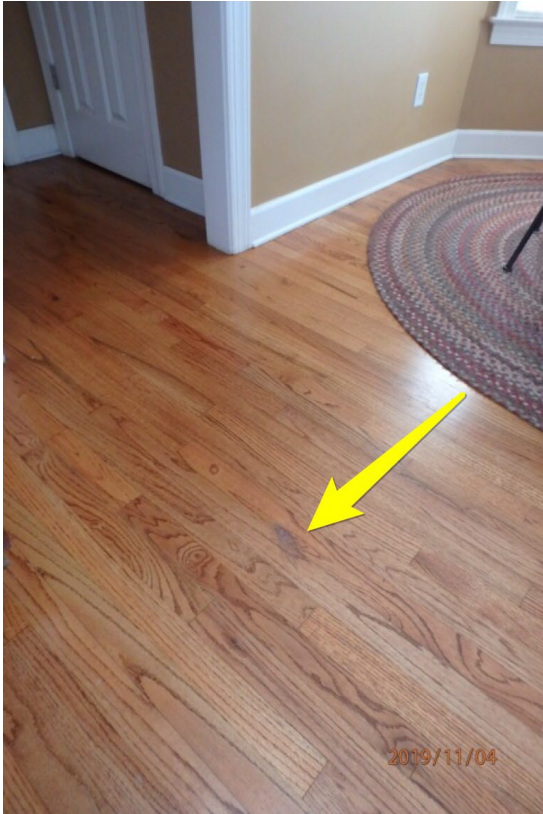
284: Damage was found in the wood floor covering in the kitchen.

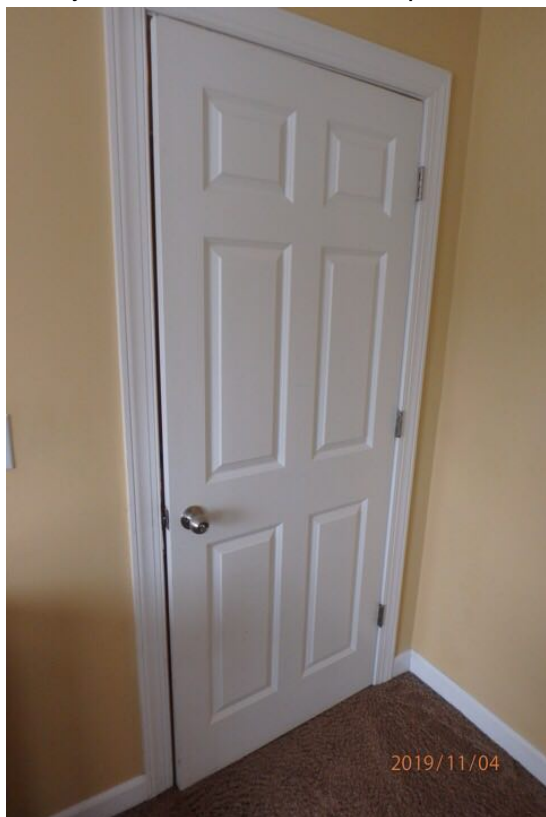
REPR 321: The upstairs front bedroom entry door appears to have been forced open causing damage to the door jamb in the latch area. Repairs and/or replacement is needed for the door to latch properly.

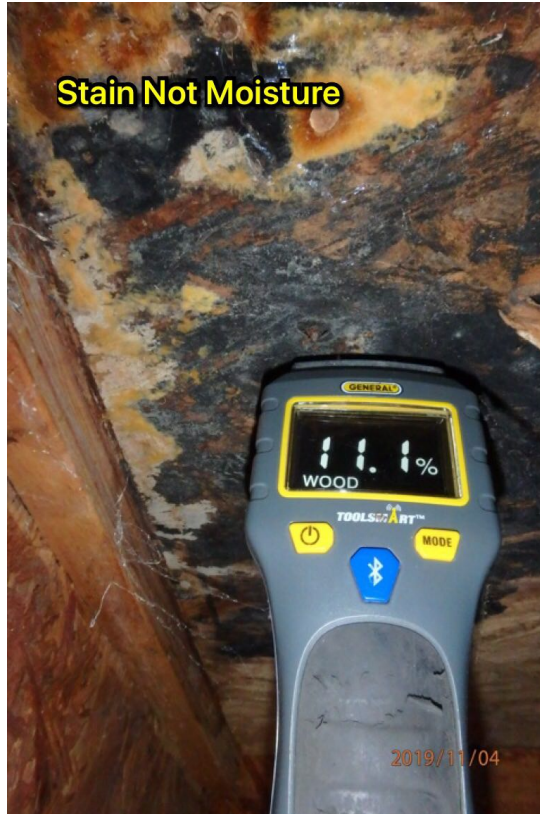
REPR 395: Water stains were noted in the subfloor under the master bathroom toilet. No elevated moisture levels were measured in the area of the stains however leaks may not occur until the toilet is being used under normal conditions . Further investigation is needed by a qualified professional to determine if repairs are needed.
