Complete Tennessee Inspections, LLC
3554 Mahlon Moore Road
Spring Hill TN 37174
615-943-0051
Jeffrey.Bonner.JB@gmail.com

Inspection reference: 2021016 David Gilliam

Confidential Inspection Report
832 Barrington Place
Brentwood, TN 37027

March 16, 2021

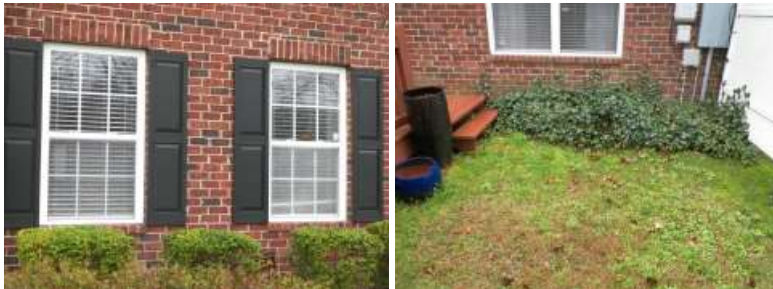
Attention Needed - The climbing vines need to be trimmed or removed to keep them away from the window screens.

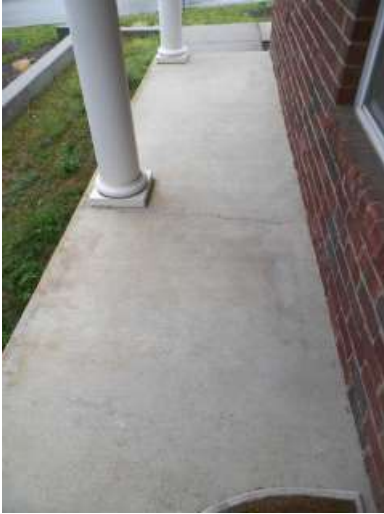
Functional - The slab is in useable condition.

Attention Needed - The slab needs repair in order to prevent further deterioration. Seal cracks.

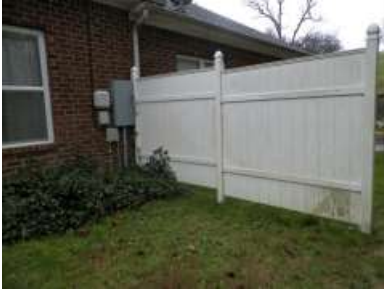
Vinyl privacy fencing. Good - The materials used in the fencing are in as good or better condition than expected.

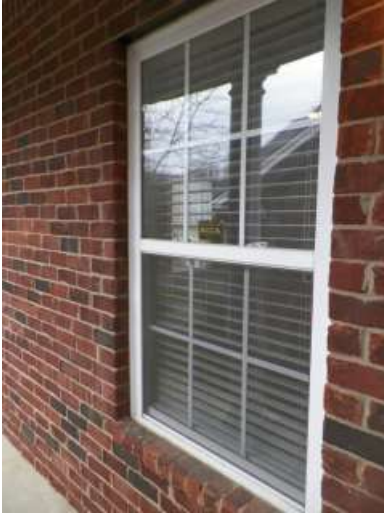
Good - The windows in this structure are of better quality and style than would be expected in a home of similar construction. The window framing and glass are functional. **Attention Needed** - Some of the window screens were damaged and need to be replaced.

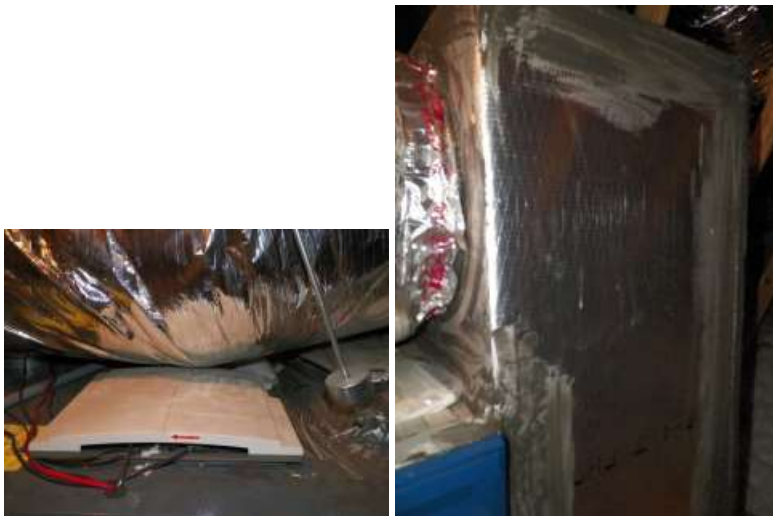
Box duct appeared to have the correct type of sealant.

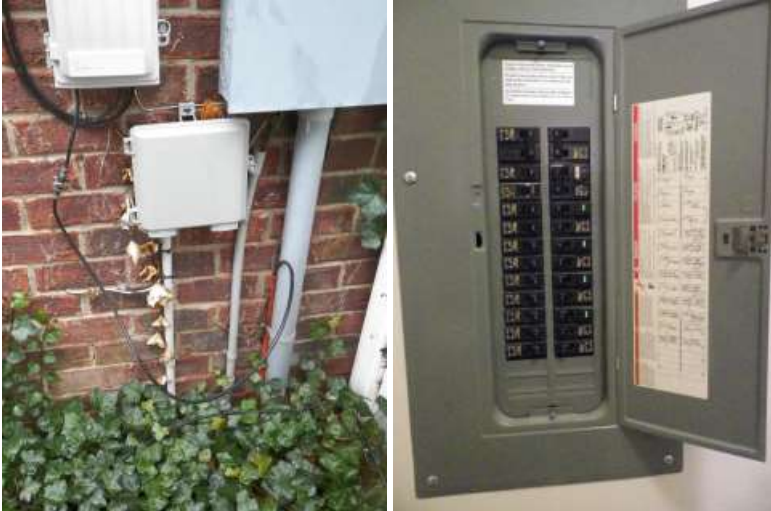
Remove vines from electrical equipment and foundation.
Indoor panel was accessible.

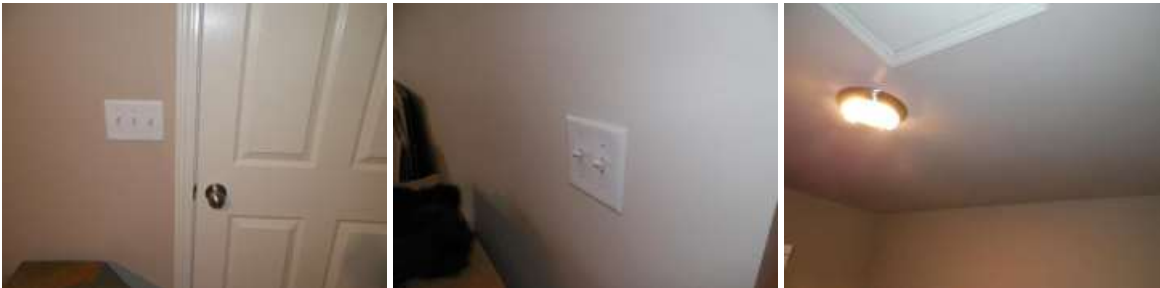
Light fixture appeared to missing the globe.

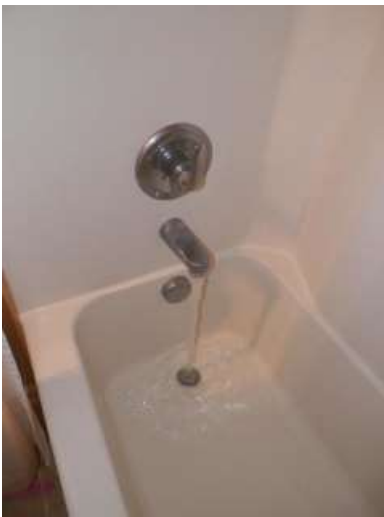
Attention Needed - The caulking in the water contact areas appears to need attention. Damage may result if not corrected. The seam where the tub or the shower meets the flooring needs to be caulked to prevent damage. The wall at the tub or shower seam needs to be caulked to prevent moisture from entering the wallboard.

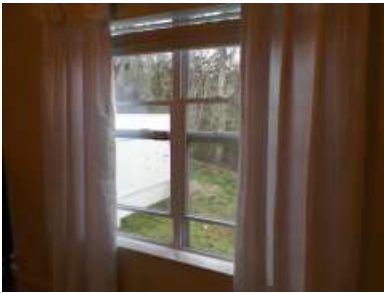
Attention Needed - The screen for this window needs repair.

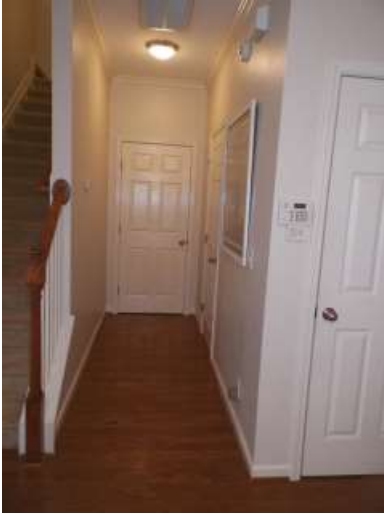
The main hallway walls and floor are without significant issues. There is some minor cracking in the sheetrock. Most likely this is due to slight settlement or shrinkage.

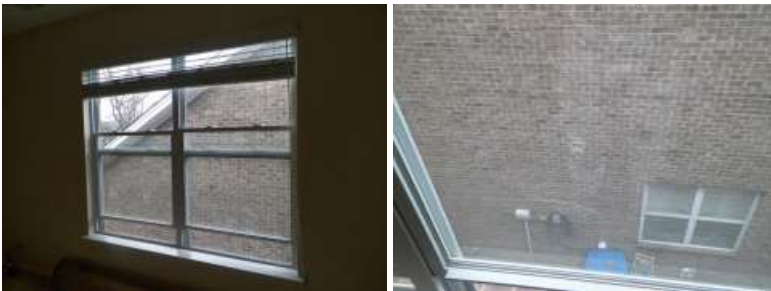
Attention Needed - The screen for this window needs repair.
