Confidential Inspection Report

LOCATED AT:
1459 Crimson Clover Ct
Brentwood, TN 37027

INSPECTED ON:
Monday, November 4, 2019

Inspector, Veo A. Moore TN00198
Ultrasound Home Inspections

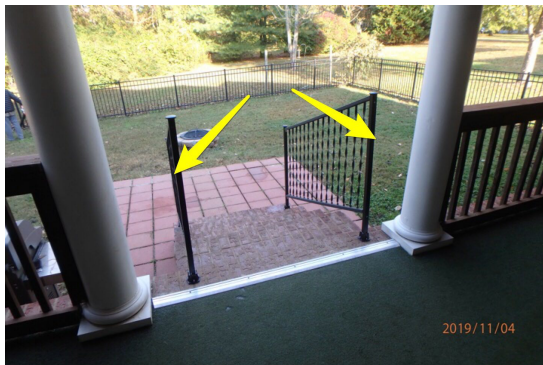
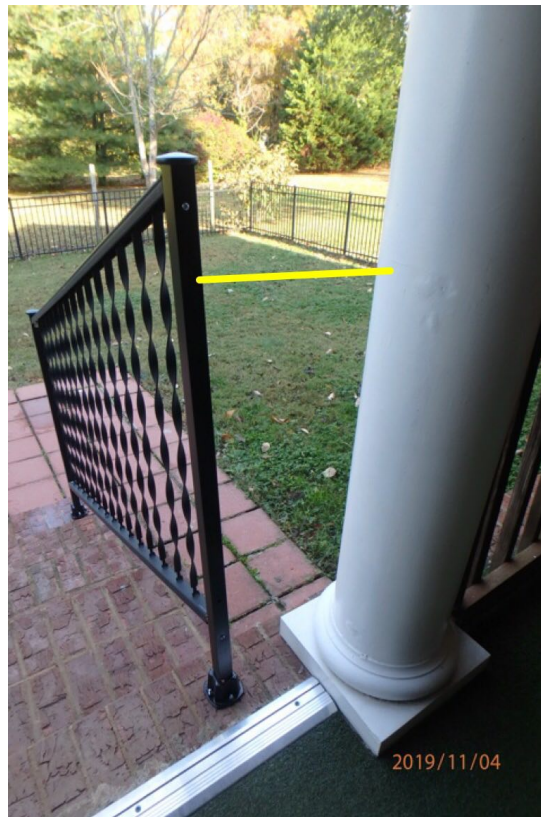
SAFT s-19: The spacing between the guardrail and post at the rear patio area exceeds 4 inches in width which does not meet today's minimum safety standards. Although it may predate this requirement, upgrading should be considered. Safety issue.

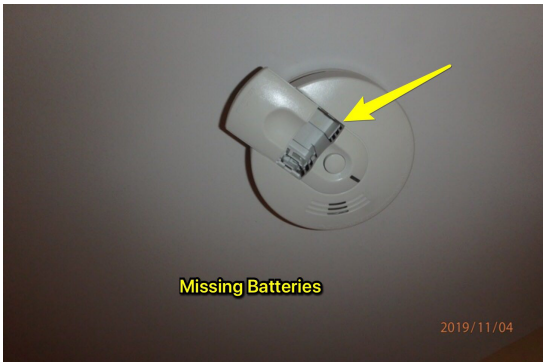
SAFT s-205: The structure is equipped with smoke detectors however the batteries are missing from several of the detectors. They should be tested periodically in accordance with the manufacturer's specifications and the batteries replaced twice a year.

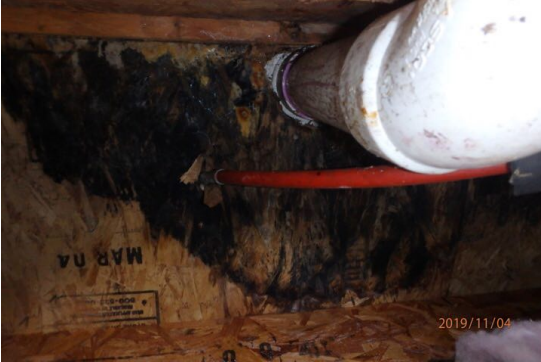
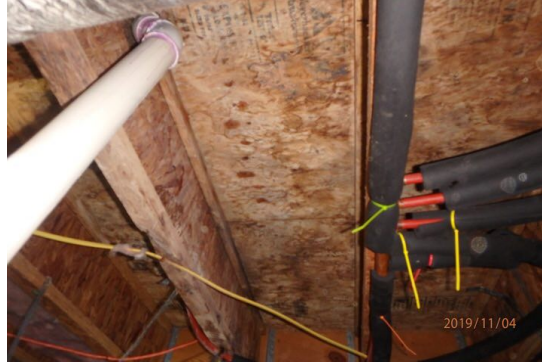
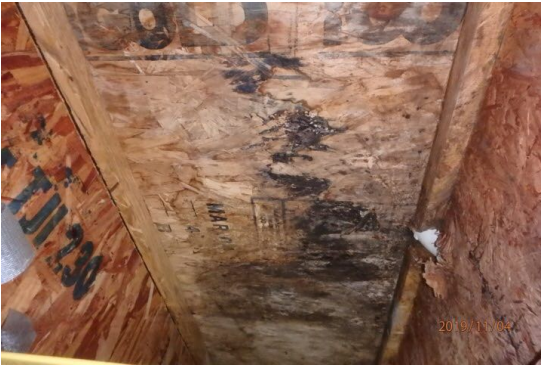
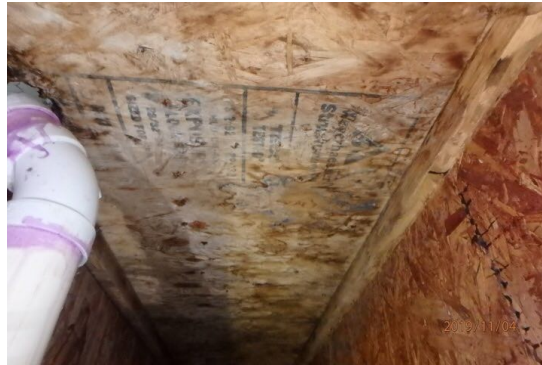
- 1. Master bathroom
- 2. Laundry room

SAFT s-366: A light amount of microbial debris was noted on the floor structure in the crawlspace at the location(s) listed below. Certain types of microbial debris can be toxic to humans. UltraSound inspectors do not inspect for, or determine if mold exists. Inspectors cannot determine what types of microbial debris exists in the noted areas without a test from a qualified laboratory. UltraSound recommends further investigation and repair buy a qualified professional.

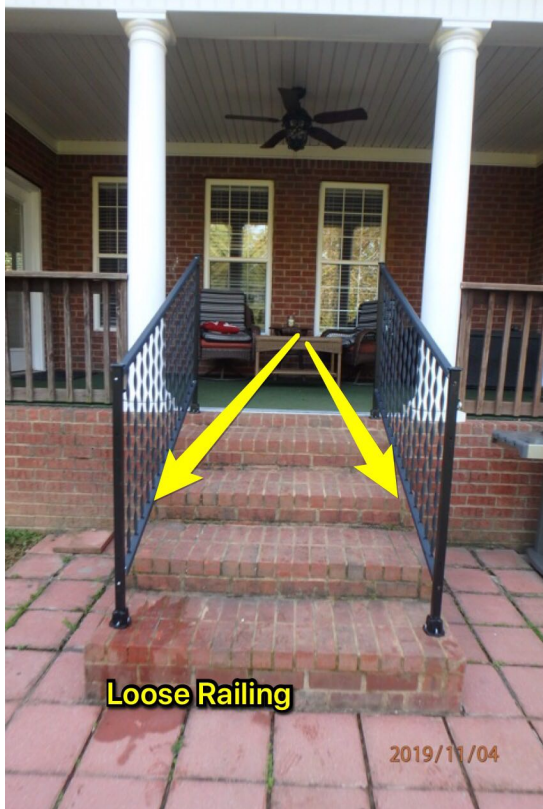
REPR **s-18:** The patio stoop handrails appear loose and need properly re-secured.

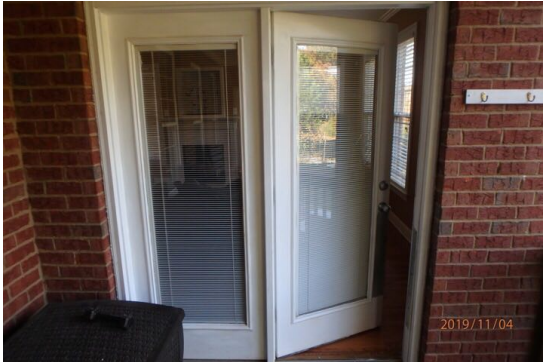
1. Rear patio door

REPR s-41: Damage was noted to the weather strip at the door(s) listed below. Repair/replacement is needed to seal the door from the outside elements and maximum heating and cooling efficiency.

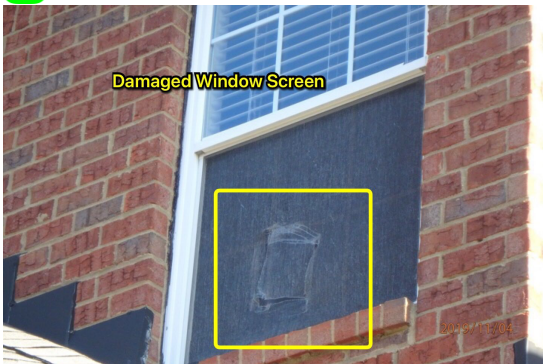
REPR s-43: One of the window screens at the upstairs bedrooms is damaged and in need of replacement.

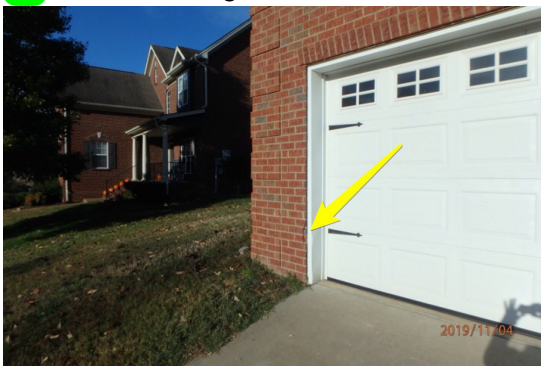
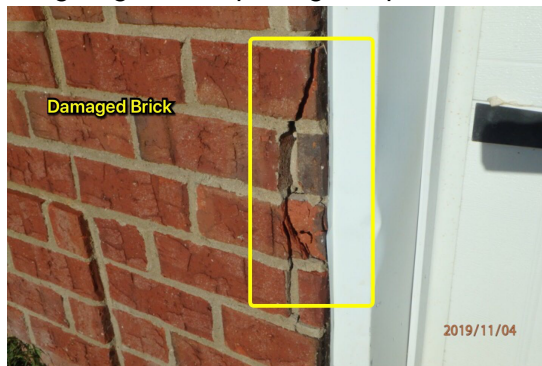
REPR s-56: Damage was noted to the brick at the garage door opening. Repairs needed.

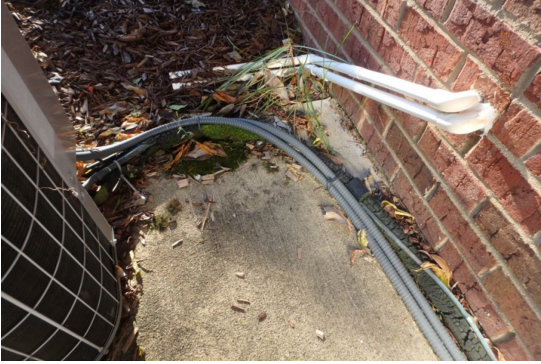
REPR s-88: Missing/decayed insulation was noted on the upper level A/C refrigerant line. All exposed sections of the refrigerant line should be fully insulated for maximum heating and cooling efficiency.

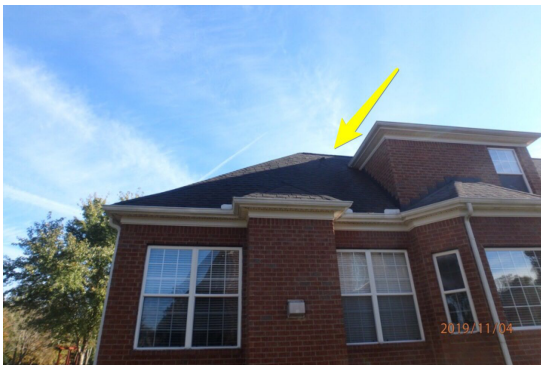
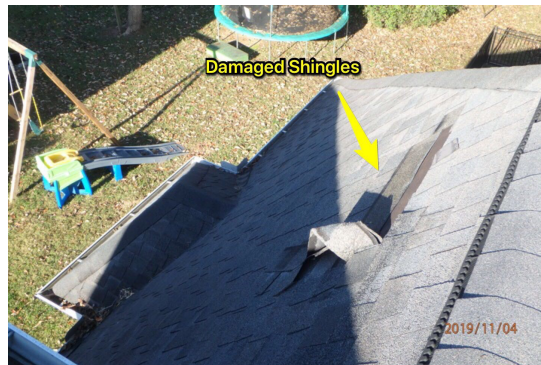
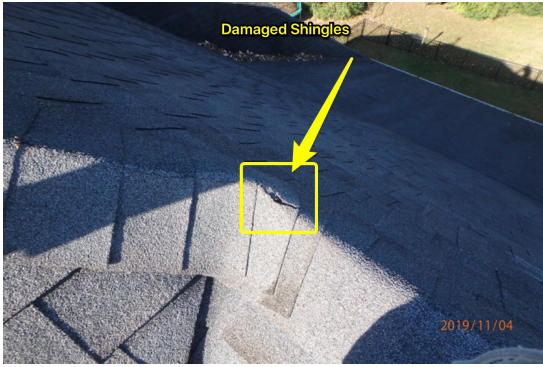
1. Left side
2. Upper ridge

REPR s-143: Damage was noted to a portion(s) of the roof shingles at the locations listed below. UltraSound recommends further investigation and repair by a qualified professional.

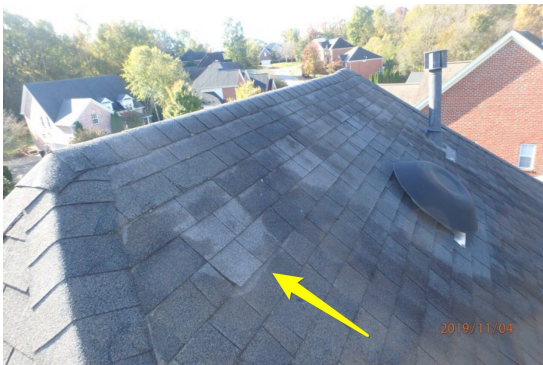
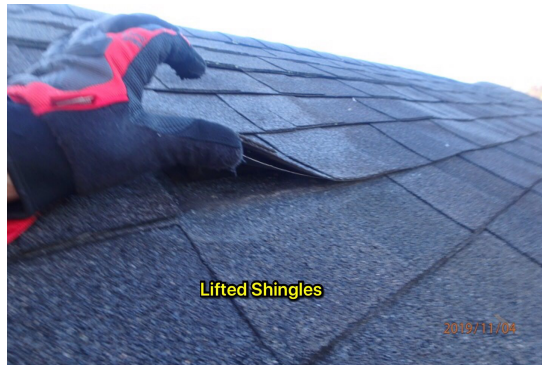
1. Rear

REPR s-144: Lifted shingle(s) were noted on the roof in the location(s) listed below. Repair is needed to prevent wind from damaging the shingle(s).

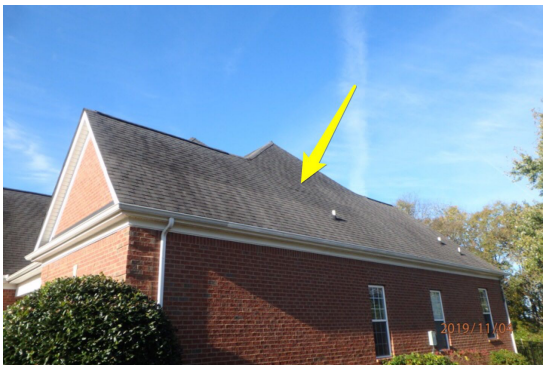
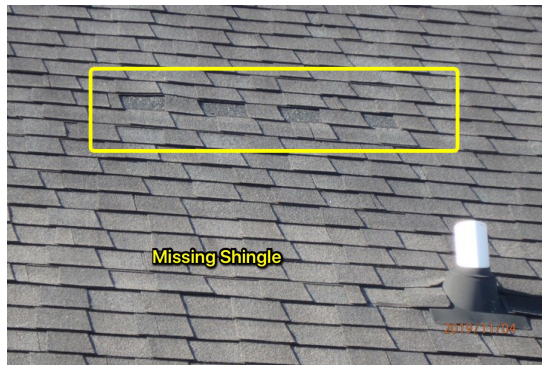
1. Right side

REPR s-145: A missing shingle(s) was noted on the roof at the location(s) listed below. This condition can expose nail heads on the roof covering and adjacent flashing, resulting in possible roof leaks. UltraSound recommends further investigation and repair by a qualified professional.

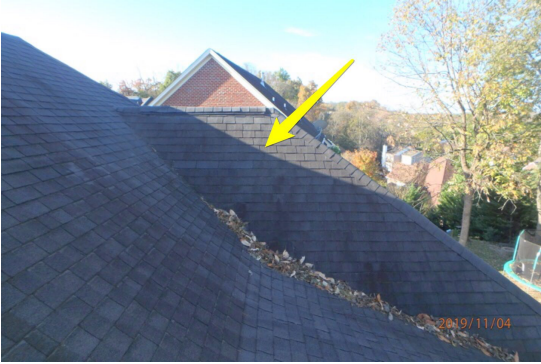
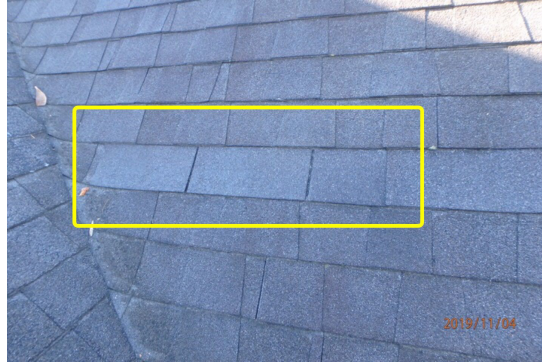
s-147: The incorrect shingle type was found to be installed as a repair at the rear of the home.

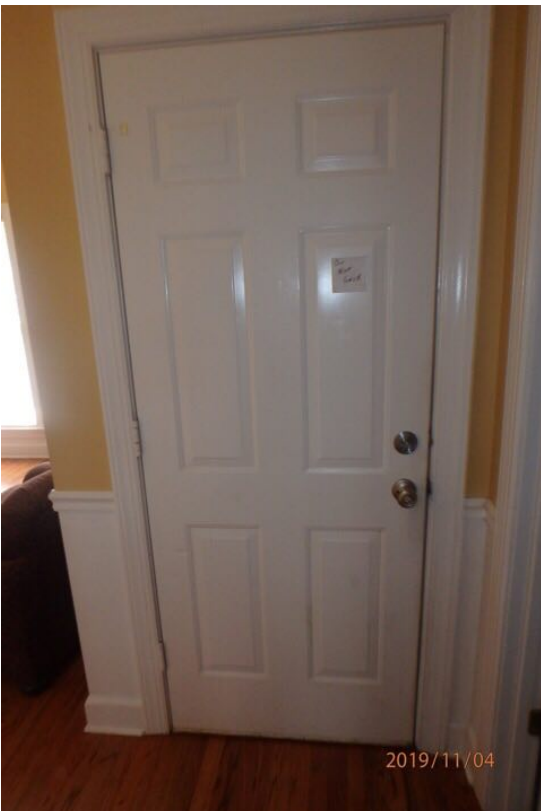
s-173: The weather strip on the garage entry door is damaged and needs replaced for maximum heating and cooling efficiency.

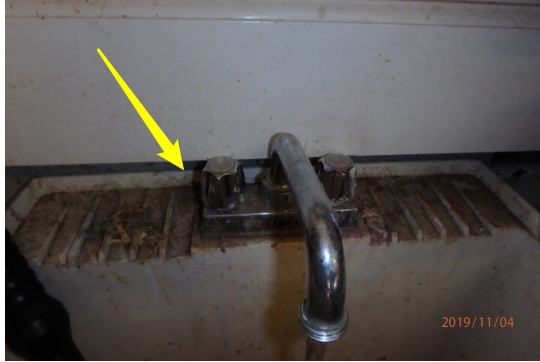
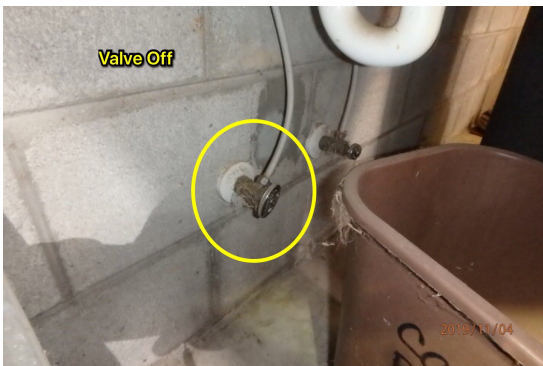
REPR s-184: The hot water shut off valve(s) located under the garage sink was found in the off position at the arrival of the inspection. For flood concerns and to meet the Tennessee Standards of Practice, the inspector is not allowed to open or operated any water valves that have been turned off. For this reason the condition of the hot water supply line and hot water side of the faucet wer undetermined and further investigation is needed.

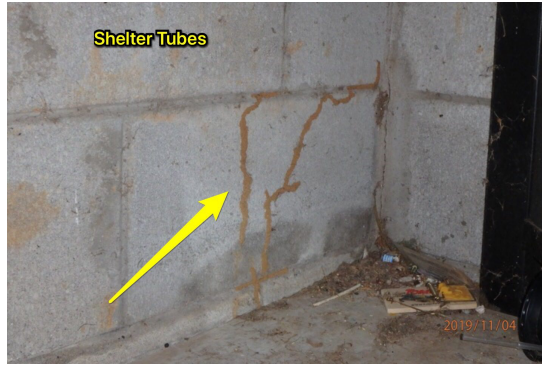
REPR s-185: Wood destroying insect shelter tubes were found along the foundation wall in the garage space. No apparent damage was found during the inspection however further attention is needed by a qualified insect contractor to determine if treatment is necessary.

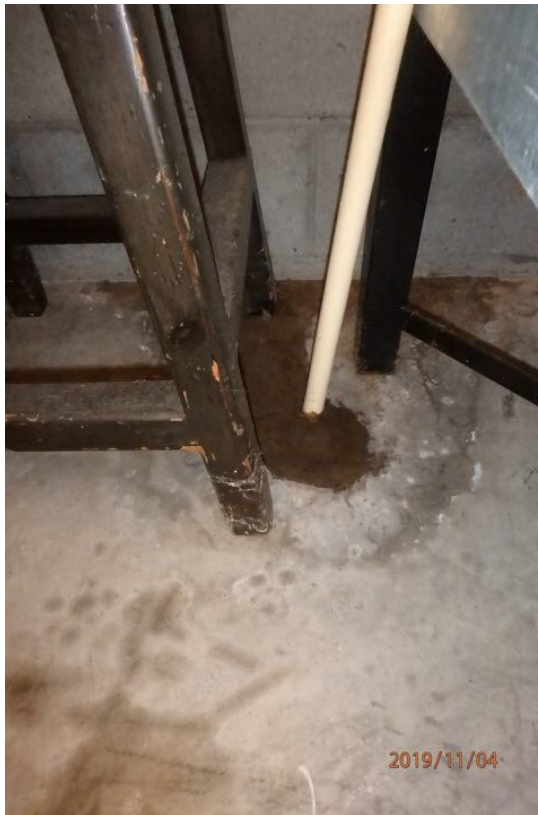
REPR s-225: A leaking TPR (temperature pressure relief) valve was noted at the water heater. Excessive water pressure, excessive water temperature, and a defective valve are common causes of this condition. UltraSound recommends further investigation and repair by a qualified professional.

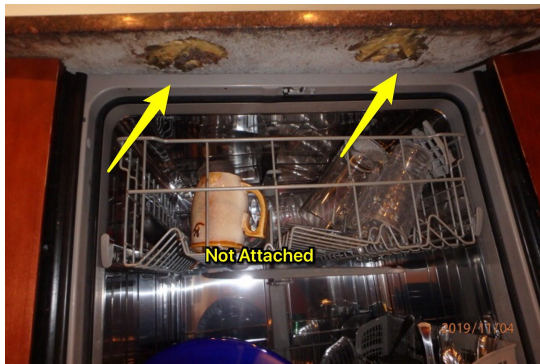
REPR s-265: The dishwasher is not properly attached to the under side of the countertop or the sides of the base cabinet. This leaves the unit in an unstable condition that should be corrected. Safety issue.

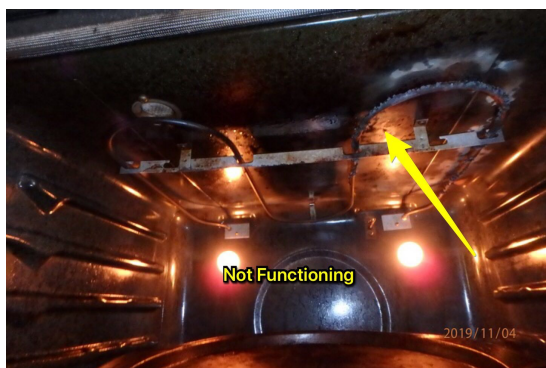
REPR s-268: The upper heating element in the oven did not heat up or function when tested. Replacement is needed.

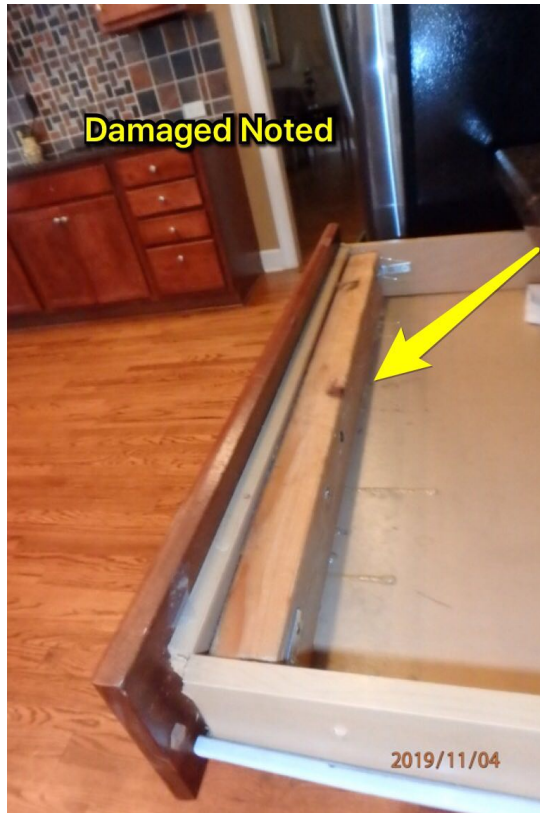
REPR s-273: Damage was found to one of the cabinet drawers.

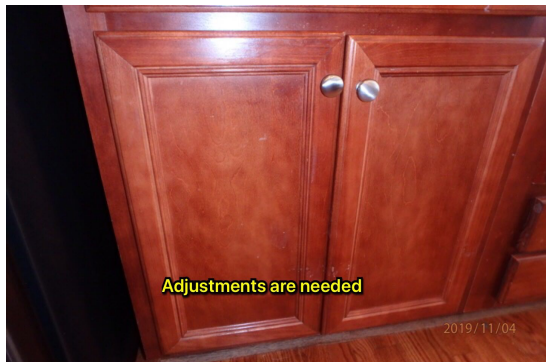
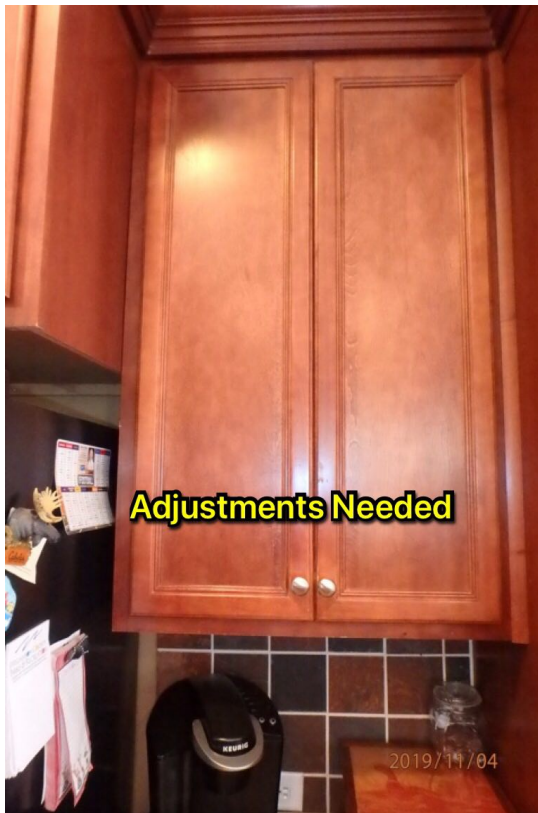
s-274: The cabinet door(s) indicated in the photos are misaligned or out of adjustment. The hinges need to be adjusted for the doors to function smoothly.

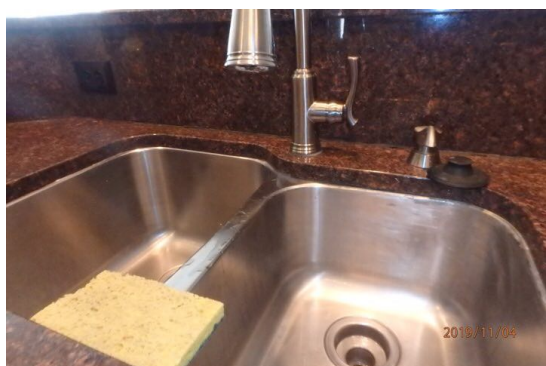
s-276: Caulking is needed where the countertop intersects with the back splash to prevent moisture from possibly penetrating behind the cabinets causing costly damage. This is considered normal maintenance.

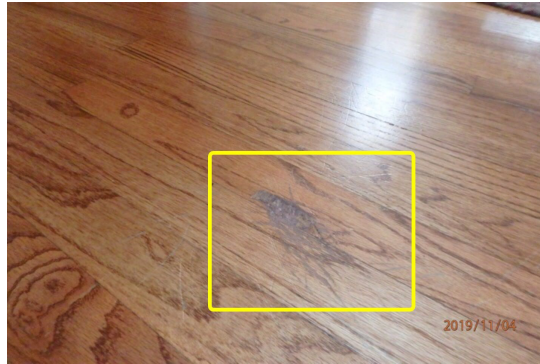
REPR **s-284:** Damage was found in the wood floor covering in the kitchen.

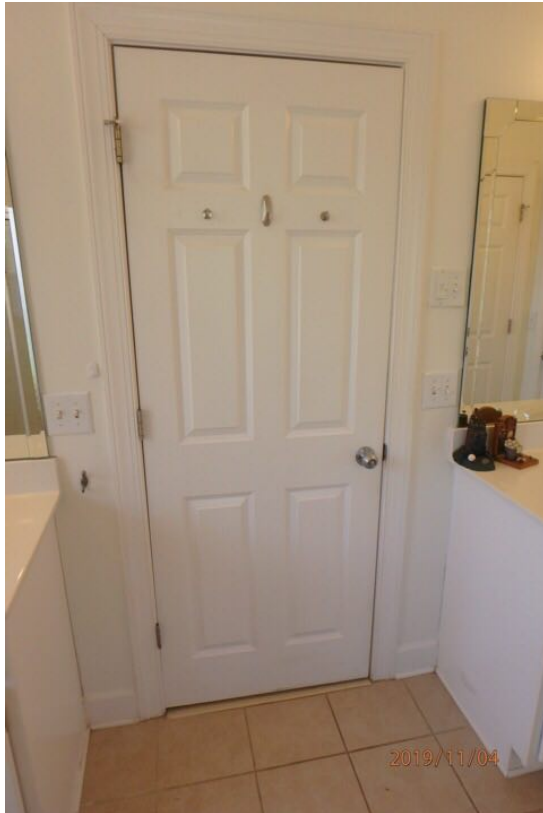
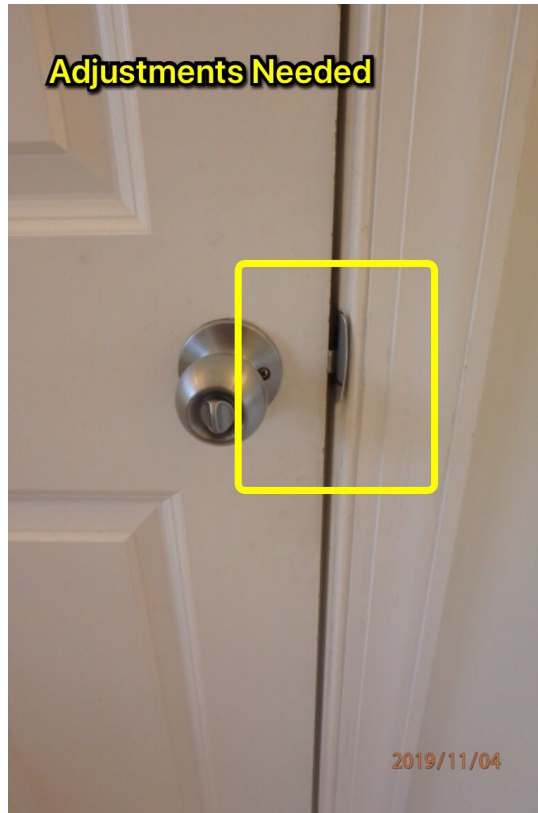
1. Master bathroom

REPR s-290: The door knob assembly on the entry door does not latch on the strike plate in the closed position. Adjustments are needed to the strike plate/door(s) listed below so the door(s) will latch correctly when closed.

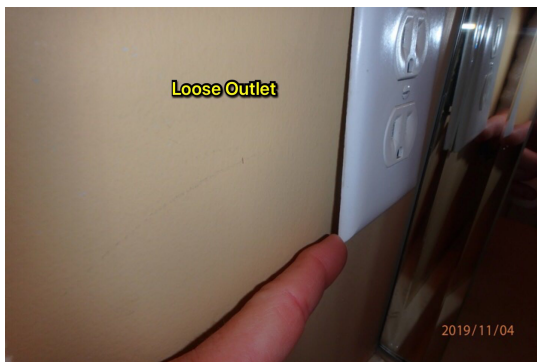
1. Downstairs hall bathroom

REPR s-298: A loose electrical outlet was noted in the bathroom listed below. This can make un-plugging appliances difficult.

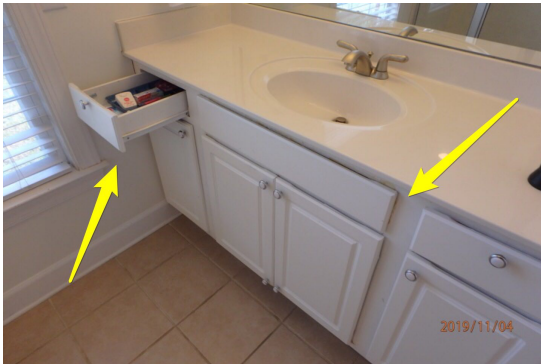
1. Master bathroom (Right side)

REPR s-299: Damage was noted to the bathroom vanity drawer in the bathroom(s) listed below. Repair/replacement is needed.

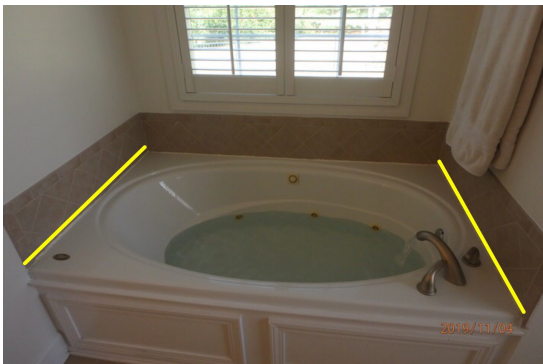
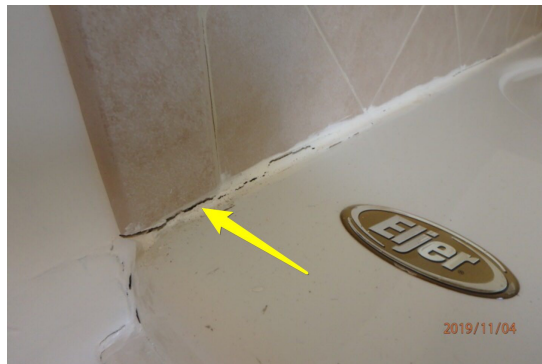
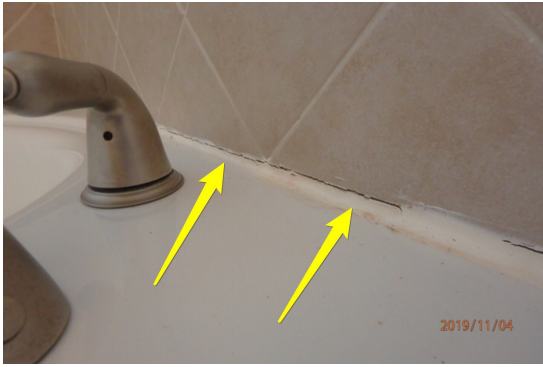
1. Master bathroom

REPR s-312: Additional caulking/sealing is needed around the tub/shower in the location(s) listed below. This condition can allow possible moisture intrusion and may result in damage.

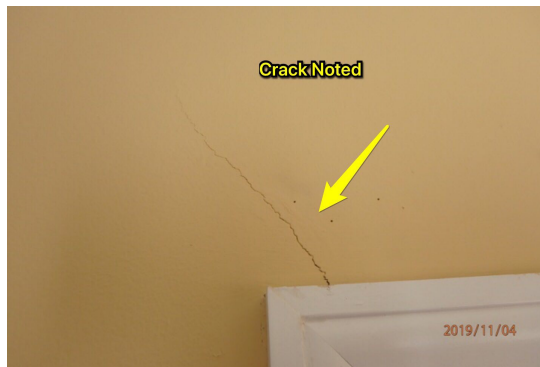
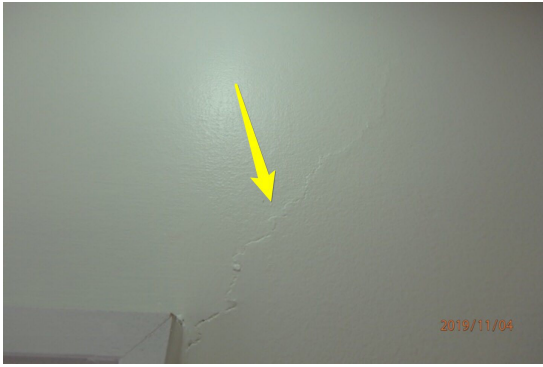
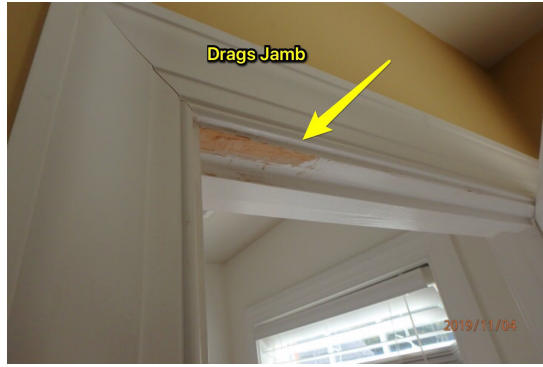
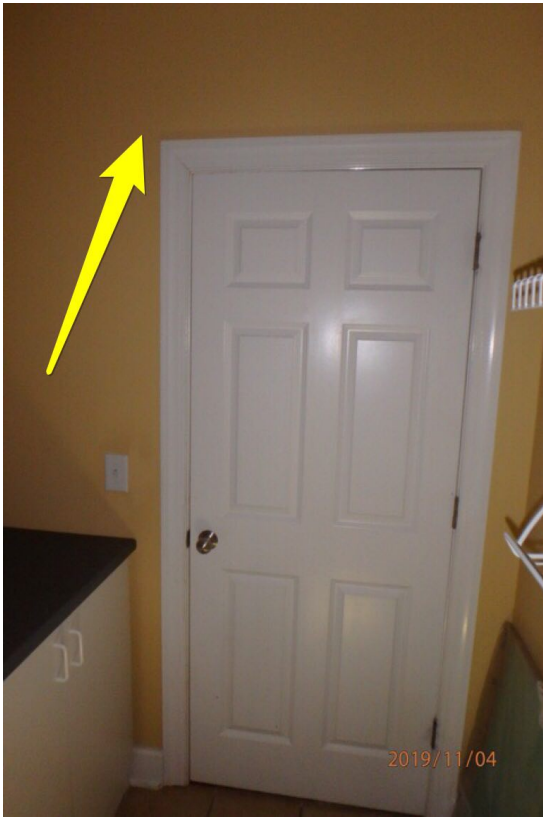
Upstairs Front Bedroom

REPR s-316: A wall crack(s) was noted above the door(s) at the location(s) listed below. This may be the result of excessive movement in the foundation or the framing components. The installed door is drain along the upper jamb as well. Further investigation is needed by a qualified professional and or structural engineer to determine if repairs are necessary.

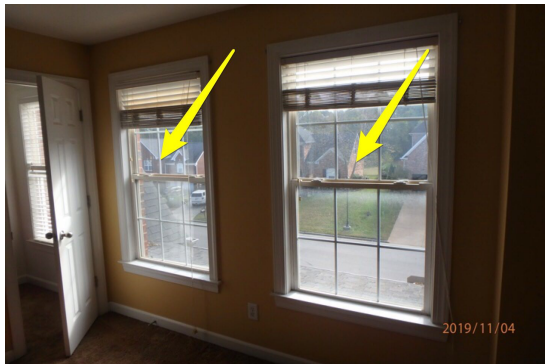
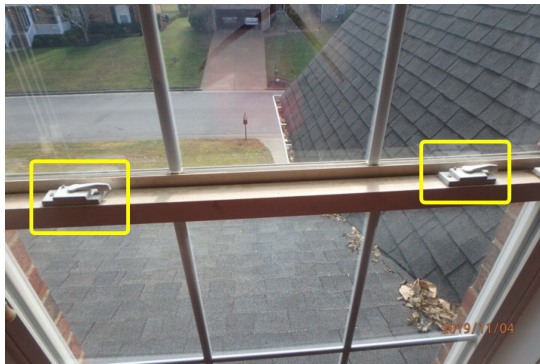
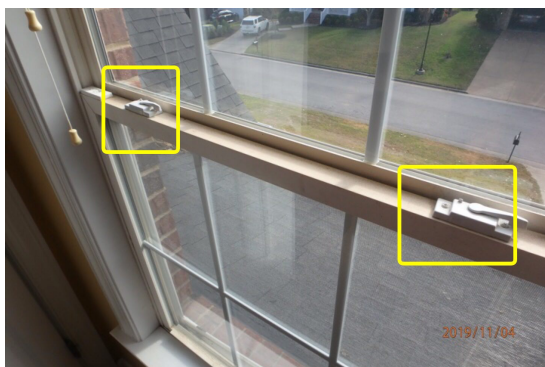
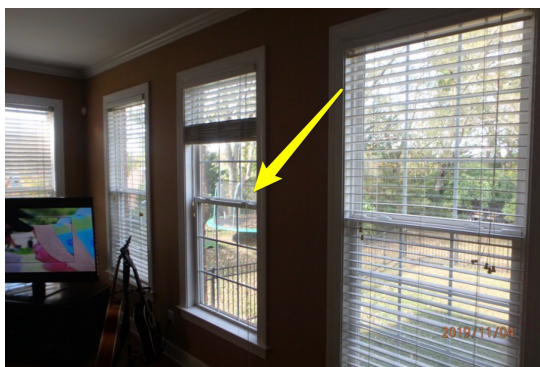
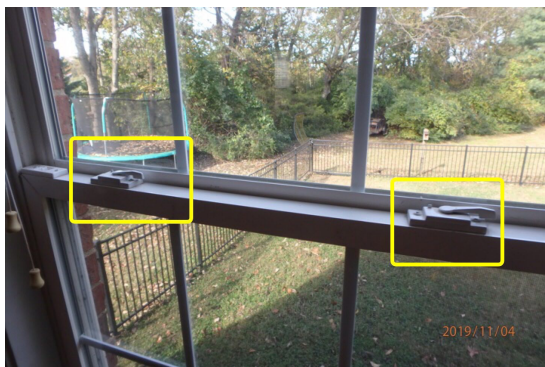
1. Upstairs front bedroom
2. Family room

REPR s-319: Alignment issues were noted at the window hardware, preventing the lock from functioning as designed. The window(s) location(s) is listed below.

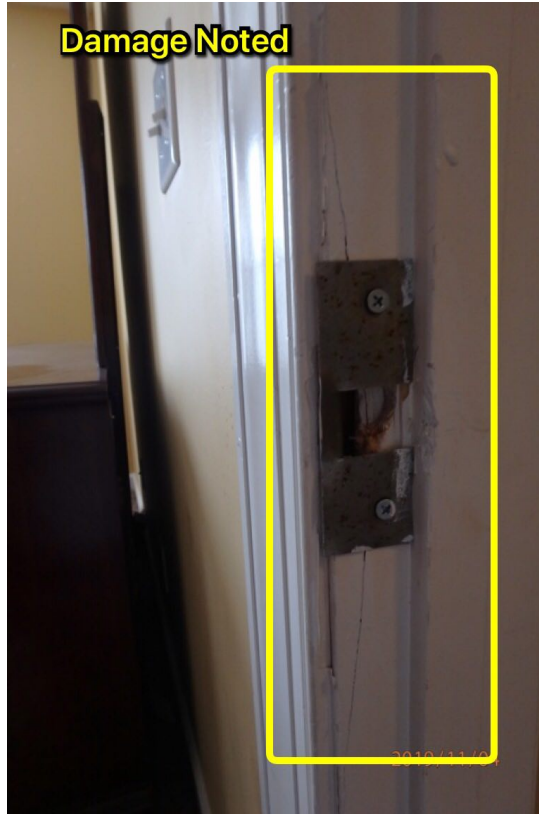
Upstairs Front Bedroom

REPR **s-321:** The upstairs front bedroom entry door appears to have been forced open causing damage to the door jamb in the latch area. Repairs and/or replacement is needed for the door to latch properly.

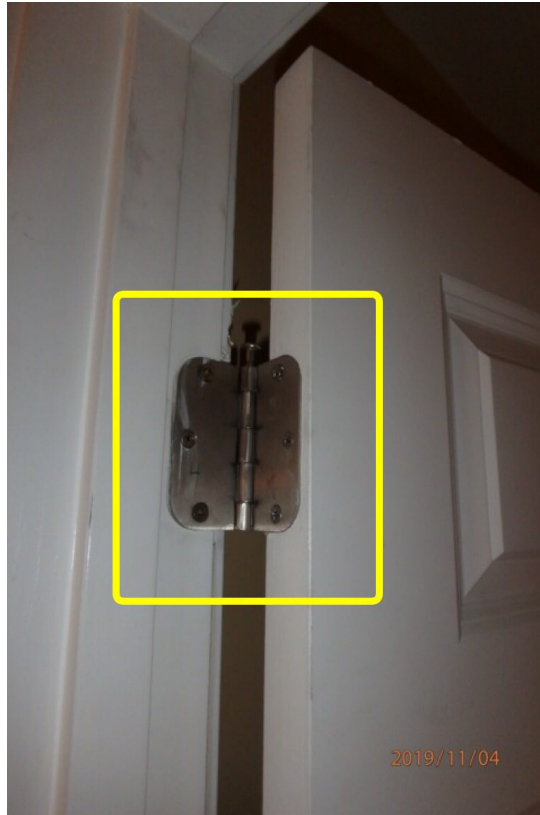
Bonus Room

s-322: The screws that secure door hinge(s) in place are loose/stripped which prevents the door from being properly installed causing it to interfere with the jamb. Repairs are needed for it to function as designed.

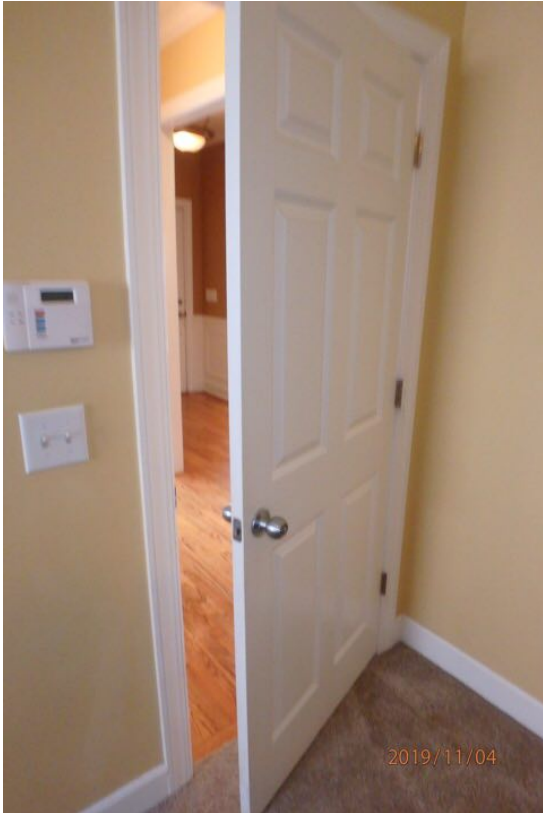
1. Maser bedroom entry door

REPR s-323: The doors mentioned below will not stay open without the use of a doorstop. Adjustments are needed.

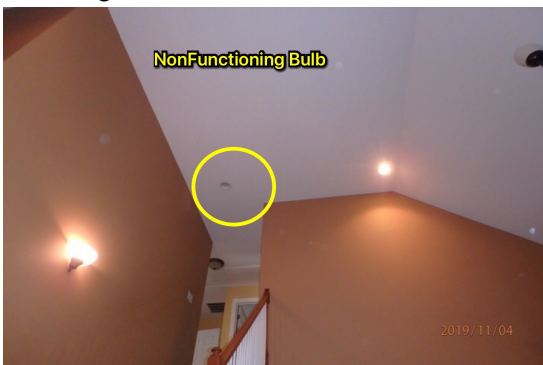
1. Living room

REPR s-335: Non functioning lights were noted in the room(s) listed below. Without replacing light bulbs, the inspector is unable to determine if the issue is in the bulb, the fixture, or the wiring. The bulbs should be changed to determine if the issue goes beyond replacing bulbs. UltraSound recommends further investigation and repair by a qualified professional.

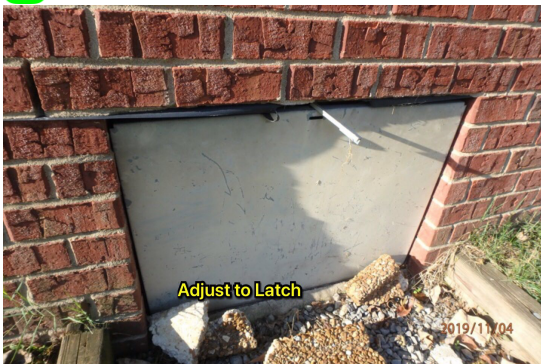
REPR s-357: Adjustments are needed to the crawlspace door for the close and latch as designed.

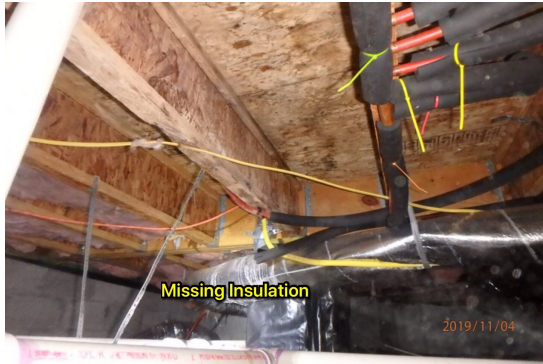
REPR s-375: Insulation batts were found missing from the floor structure under the laundry room. Re-installation on the insulation is needed.

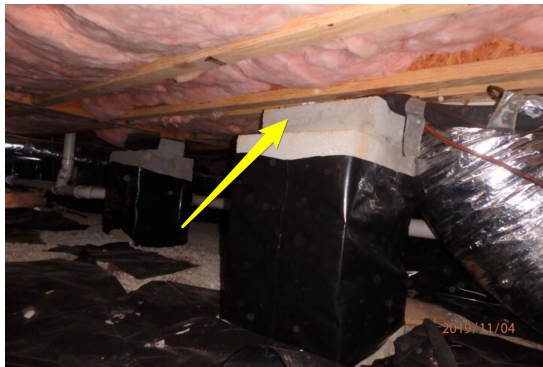
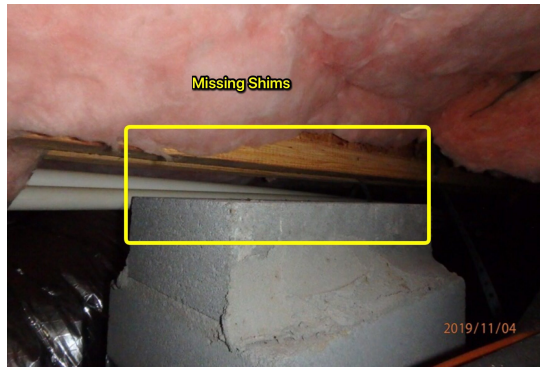
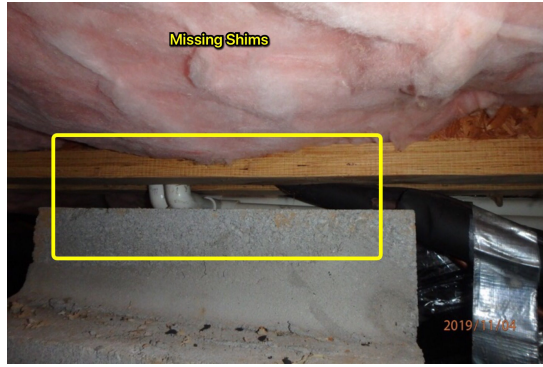
REPR s-379: Missing shims were noted at two of the installed piers in the crawlspace. The shims are needed to ensure the intended joist are properly supported. UltraSound recommends repair by a qualified professional.

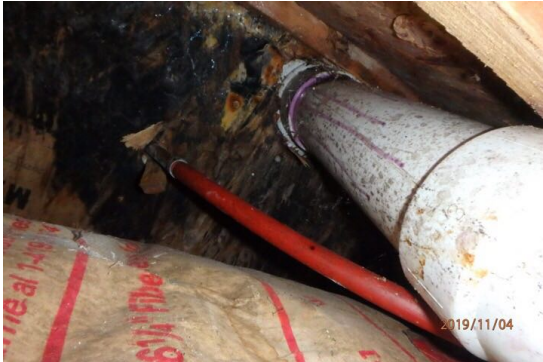
REPR s-395: Water stains were noted in the subfloor under the master bathroom toilet. No elevated moisture levels were measured in the area of the stains however leaks may not occur until the toilet is being used under normal conditions . Further investigation is needed by a qualified professional to determine if repairs are needed.

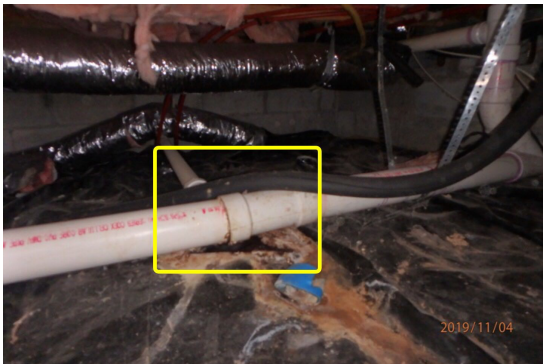
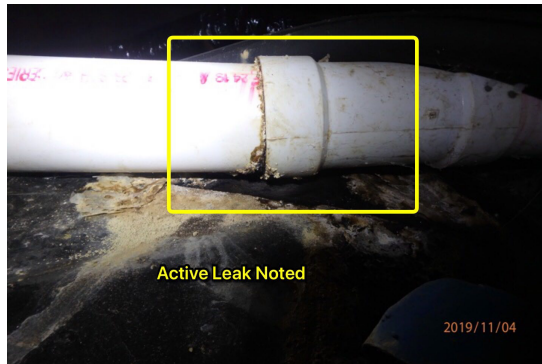
REPR s-396: An active waste line leak was noted in the crawlspace in the main line. UltraSound recommends further investigation and repair by a qualified professional.

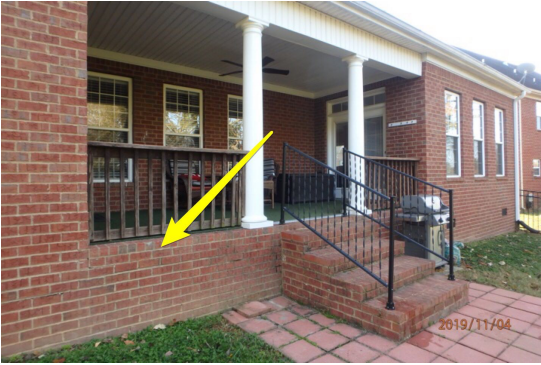
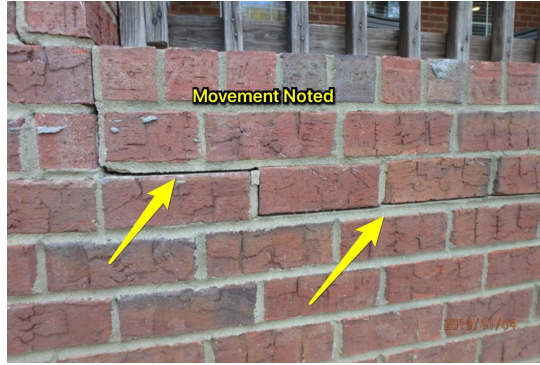
1. Rear @patio area

REC s-55: A crack(s) was noted in the masonry veneer wall at the locations listed below. These type crack(s) are commonly seen by home inspectors however, determining the cause or severity of the crack(s) is beyond the expertise of the home inspector. While the crack(s) appear to have no differential movement at the time of the inspection, structural engineers often have varying opinions regarding this type crack and should be consulted for any immediate concerns.

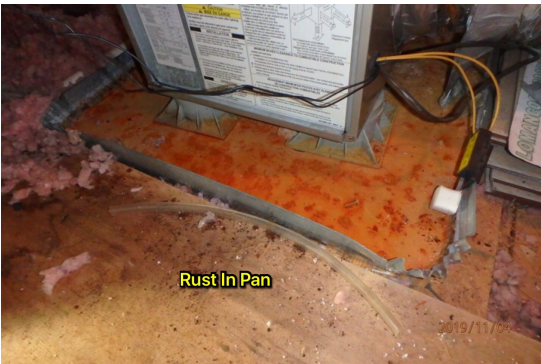
REC s-125: Rust stains were noted in the upper level HVAC secondary drip pan, indicating water was once present and a possible drain pan issue. Further investigation is needed by a qualified professional.

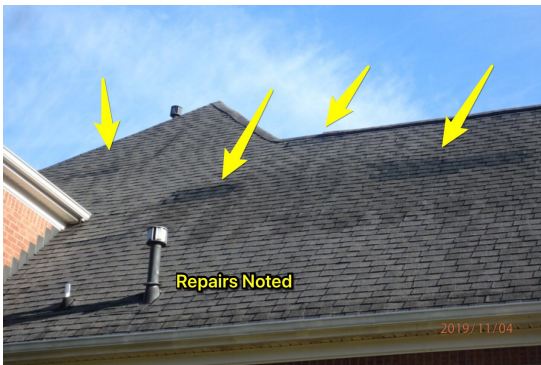
REC s-146: Evidence of roof patching/repairs were found on portions of the roof. It was undetermined if the repairs were successful or the extent of any the damage. The roof should be further inspected by a qualified roofing contractor and any necessary repairs made.

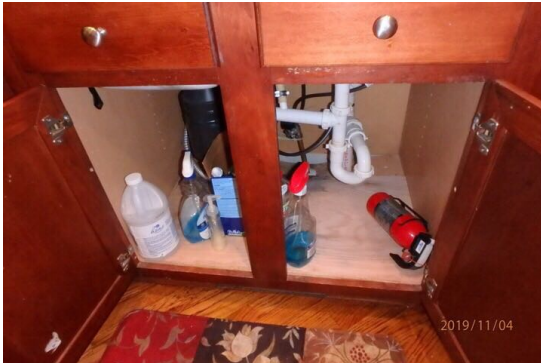
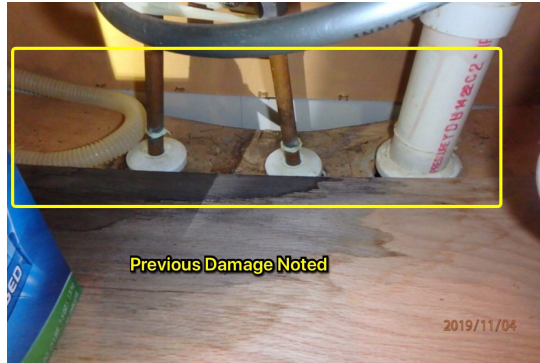
FYI s-275: Decay was found in the floor of the base cabinet where it appears damaged from a leak issue. No elevated moisture levels were measured at the time of the inspection and the extent of the damage was undetermined.

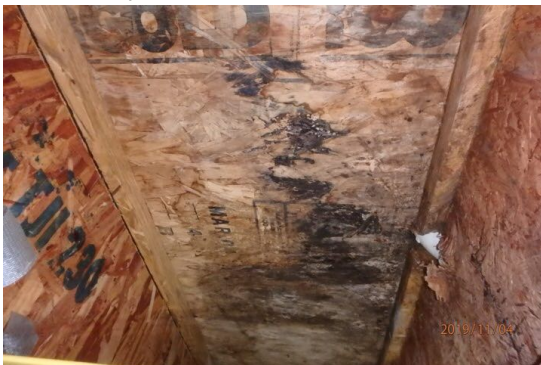
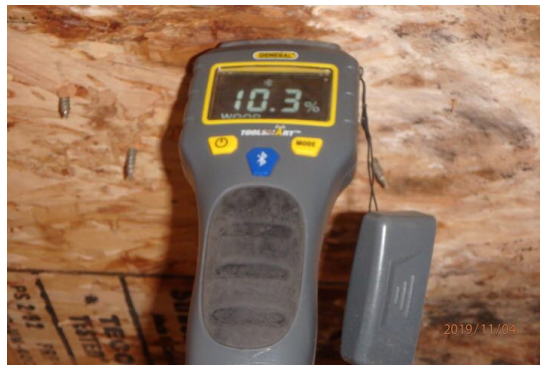
1. Laundry room

FYI s-370: Water stains were noted in the floor framing at the location(s) listed below. No elevated moisture levels were noted at the time of inspection And the reasoning for the staining is unknown to the inspector.

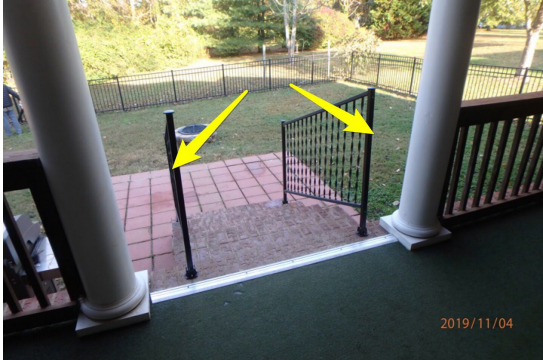
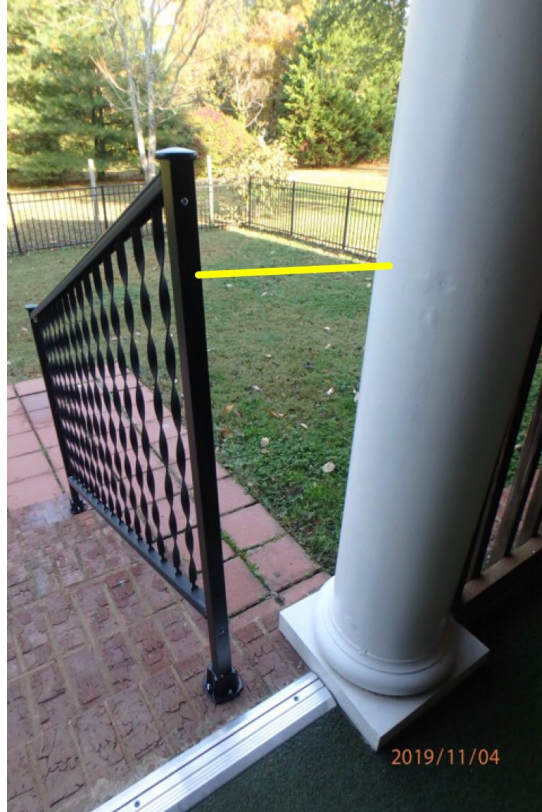
19: The spacing between the guardrail and post at the rear patio area exceeds 4 inches in width which does not meet today's minimum safety standards. Although it may predate this requirement, upgrading should be considered. Safety issue.

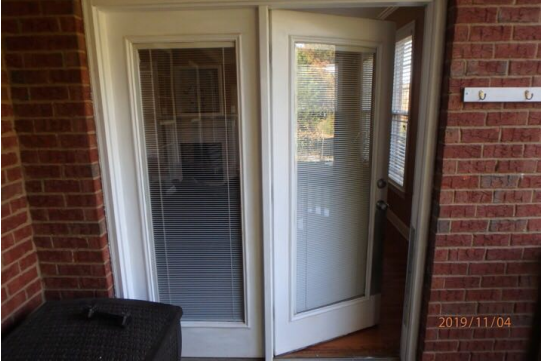
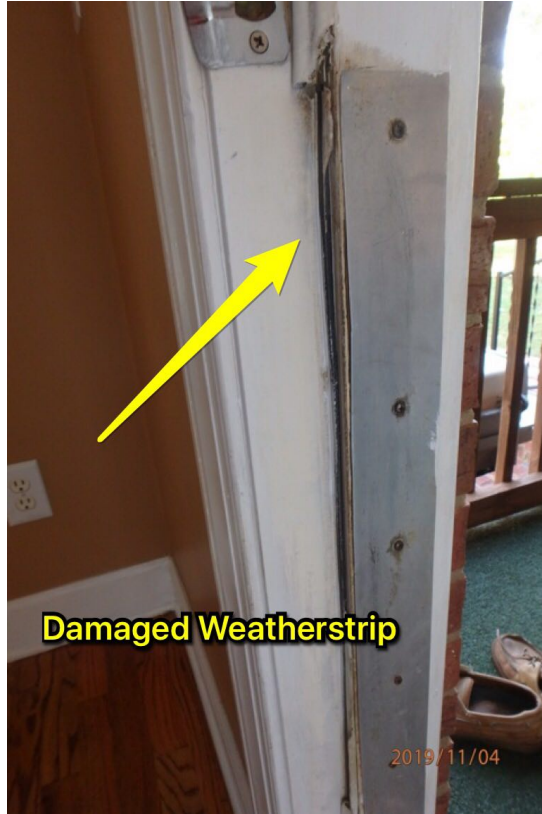
1. Rear patio door

REPR 41: Damage was noted to the weather strip at the door(s) listed below. Repair/replacement is needed to seal the door from the outside elements and maximum heating and cooling efficiency.

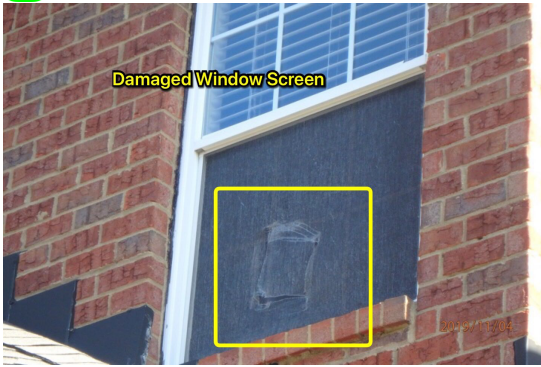
43: One of the window screens at the upstairs bedrooms is damaged and in need of replacement.

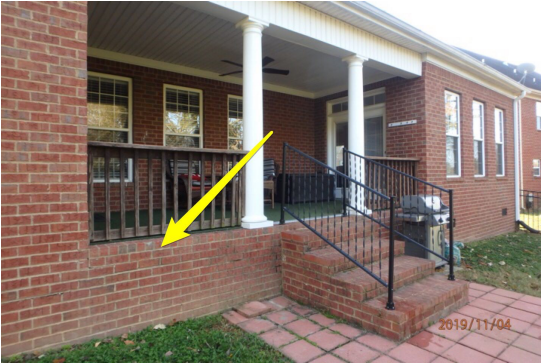
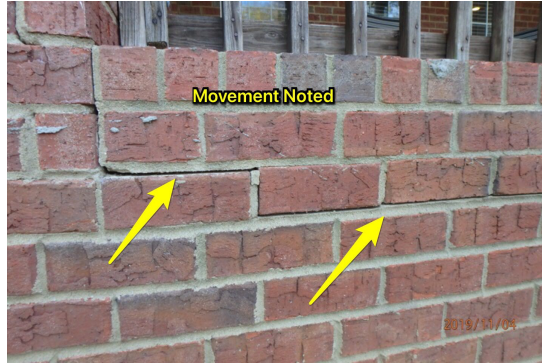
1. Rear @patio area

REC 55: A crack(s) was noted in the masonry veneer wall at the locations listed below. These type crack(s) are commonly seen by home inspectors however, determining the cause or severity of the crack(s) is beyond the expertise of the home inspector. While the crack(s) appear to have no differential movement at the time of the inspection, structural engineers often have varying opinions regarding this type crack and should be consulted for any immediate concerns.

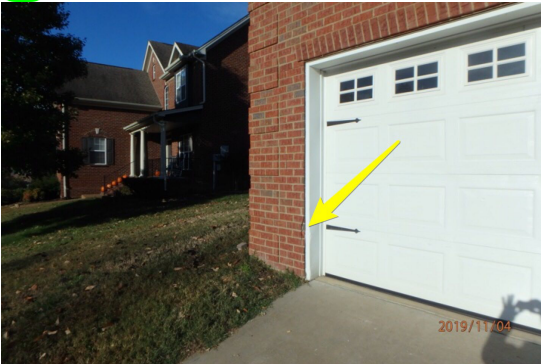
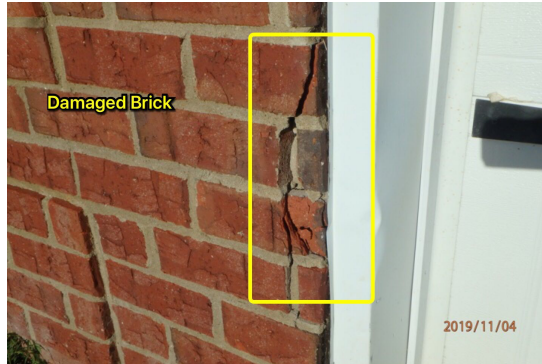
REPR 56: Damage was noted to the brick at the garage door opening. Repairs needed.

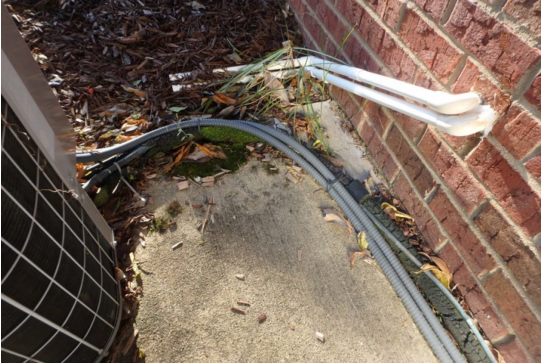
REPR 88: Missing/decayed insulation was noted on the upper level A/C refrigerant line. All exposed sections of the refrigerant line should be fully insulated for maximum heating and cooling efficiency.

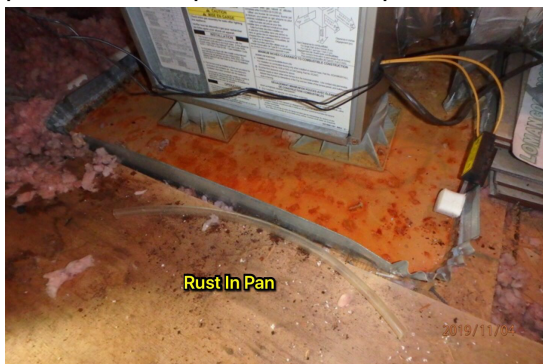
REC 125: Rust stains were noted in the upper level HVAC secondary drip pan, indicating water was once present and a possible drain pan issue. Further investigation is needed by a qualified professional.

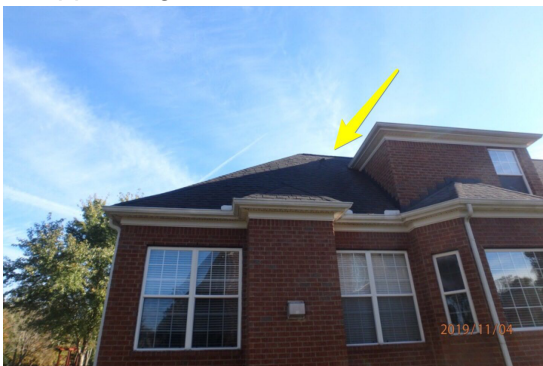
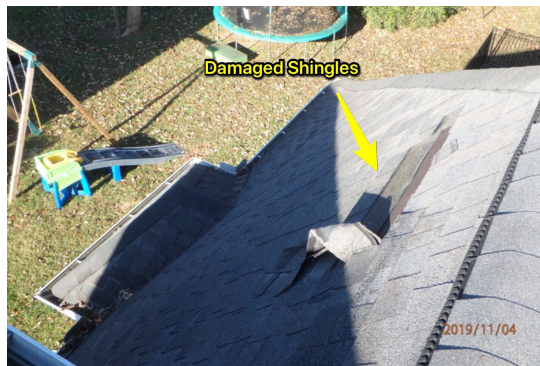
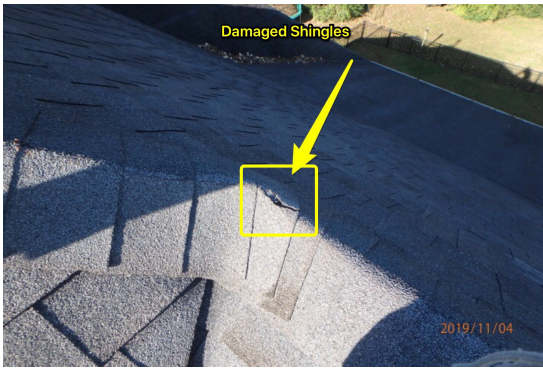
1. Left side
2. Upper ridge

REPR 143: Damage was noted to a portion(s) of the roof shingles at the locations listed below. UltraSound recommends further investigation and repair by a qualified professional.
