Confidential Inspection Report

LOCATED AT:
1459 Crimson Clover Ct
Brentwood, TN 37027

INSPECTED ON:
Monday, November 4, 2019

Inspector, Veo A. Moore TN00198
Ultrasound Home Inspections

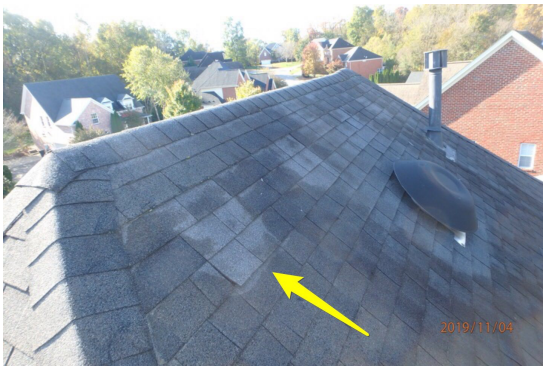
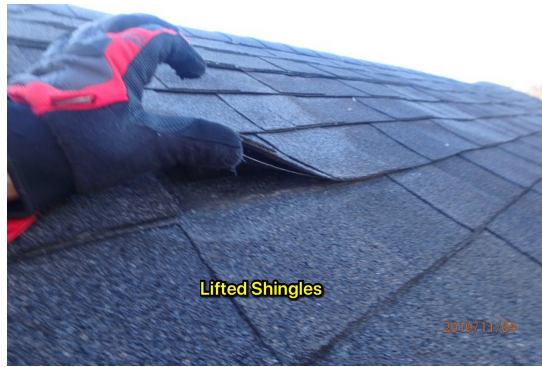
1. Rear

REPR 144: Lifted shingle(s) were noted on the roof in the location(s) listed below. Repair is needed to prevent wind from damaging the shingle(s).

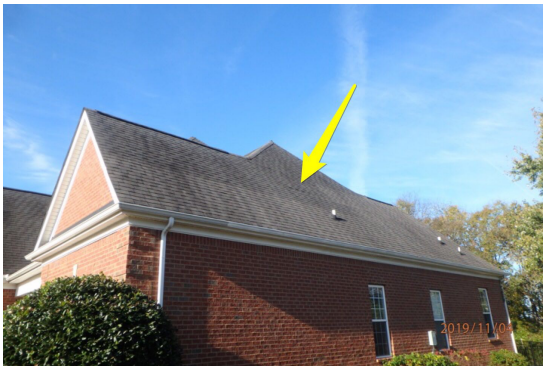
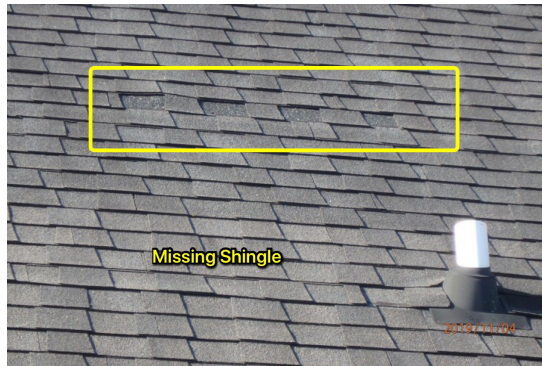
1. Right side

REPR 145: A missing shingle(s) was noted on the roof at the location(s) listed below. This condition can expose nail heads on the roof covering and adjacent flashing, resulting in possible roof leaks. UltraSound recommends further investigation and repair by a qualified professional.

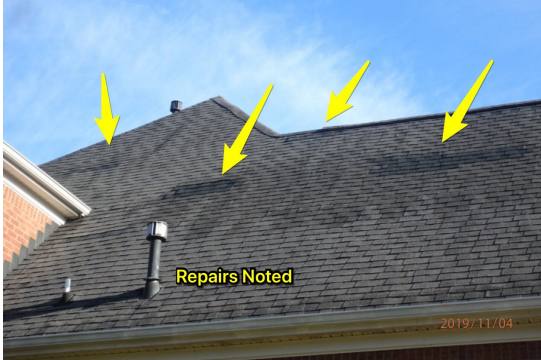
REC 146: Evidence of roof patching/repairs were found on portions of the roof. It was undetermined if the repairs were successful or the extent of any the damage. The roof should be further inspected by a qualified roofing contractor and any necessary repairs made.

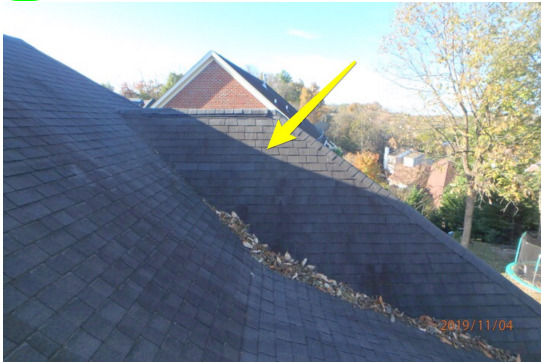
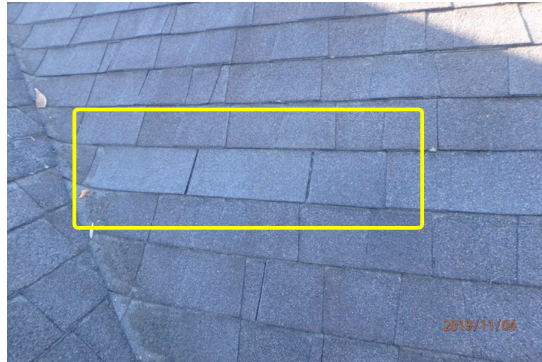
REPR 147: The incorrect shingle type was found to be installed as a repair at the rear of the home.

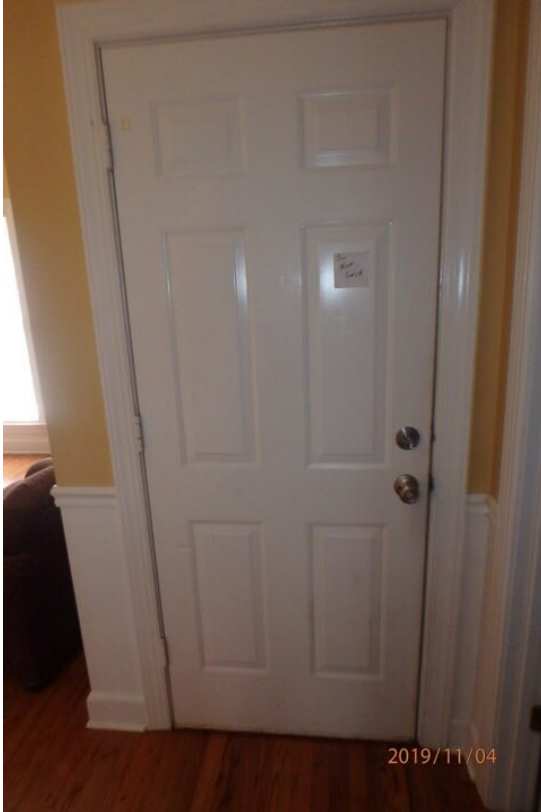
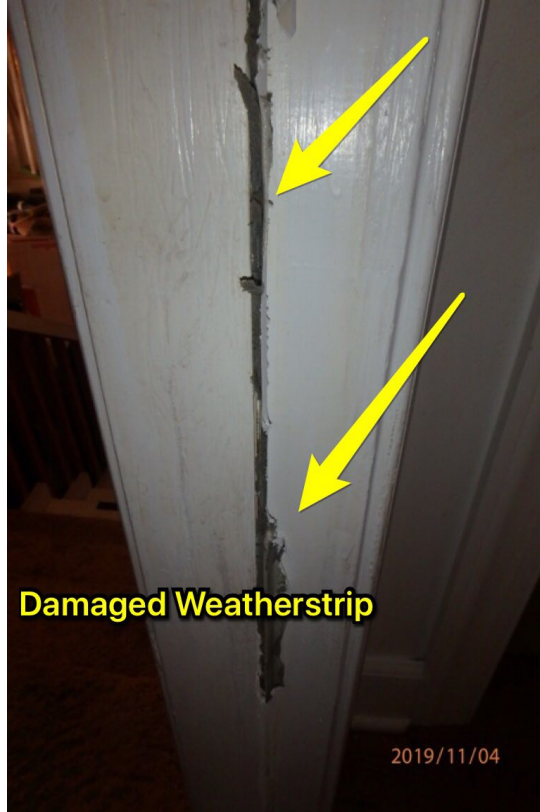
REPR 173: The weather strip on the garage entry door is damaged and needs replaced for maximum heating and cooling efficiency.

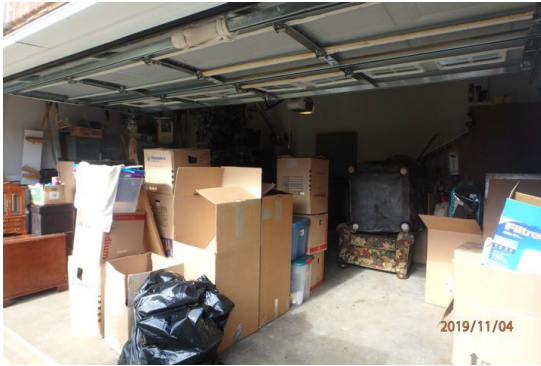
FYI 175: Due to stored items in the garage it was undetermined the condition of the portions of the floor that were not visible. The floor should be further inspected prior to closing once the building is vacant.

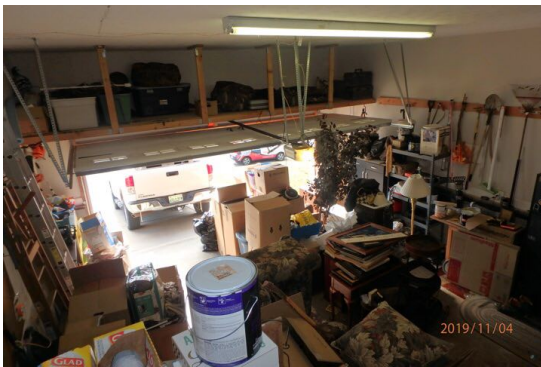
FYI 176: Due to stored items in the garage, it was undetermined the condition of a portion of the walls hidden from view.

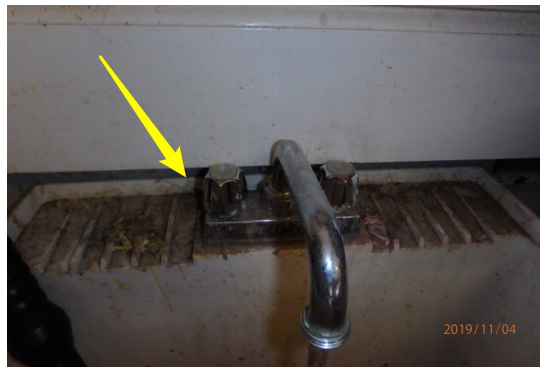
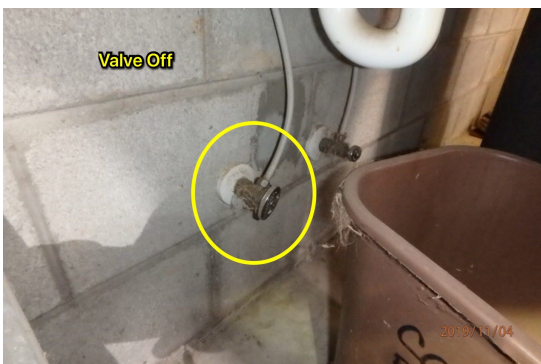
REPR 184: The hot water shut off valve(s) located under the garage sink was found in the off position at the arrival of the inspection. For flood concerns and to meet the Tennessee Standards of Practice, the inspector is not allowed to open or operated any water valves that have been turned off. For this reason the condition of the hot water supply line and hot water side of the faucet wer undetermined and further investigation is needed.

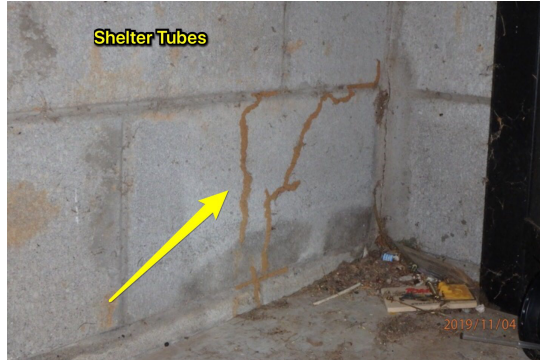
REPR 185: Wood destroying insect shelter tubes were found along the foundation wall in the garage space. No apparent damage was found during the inspection however further attention is needed by a qualified insect contractor to determine if treatment is necessary.

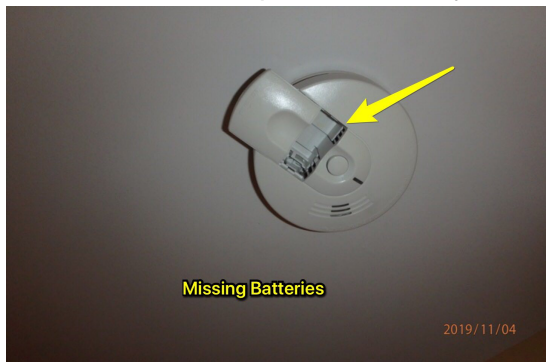
205: The structure is equipped with smoke detectors however the batteries are missing from several of the detectors. They should be tested periodically in accordance with the manufacturer's specifications and the batteries replaced twice a year.

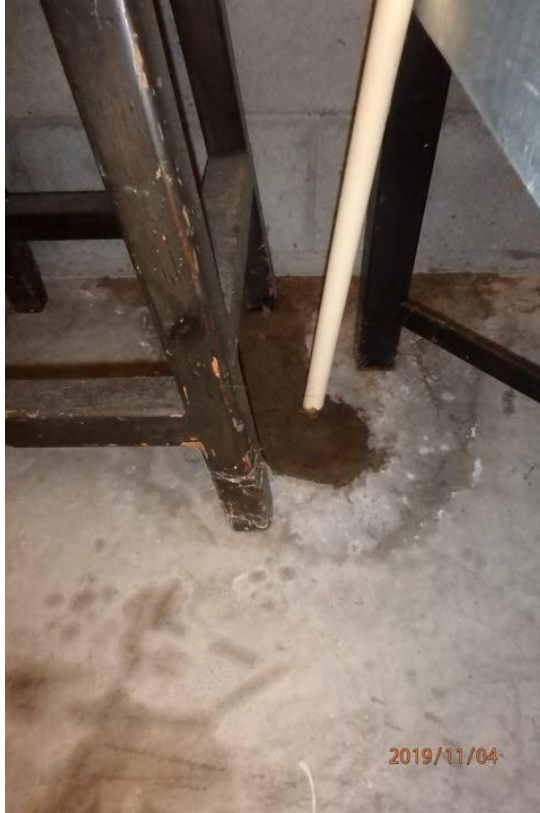
REPR 225: A leaking TPR (temperature pressure relief) valve was noted at the water heater. Excessive water pressure, excessive water temperature, and a defective valve are common causes of this condition. UltraSound recommends further investigation and repair by a qualified professional.

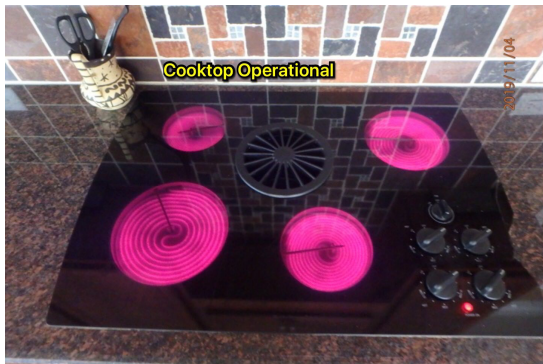
REPR 262: The glass surface of the cooktop is damaged and may possible need to be replaced.

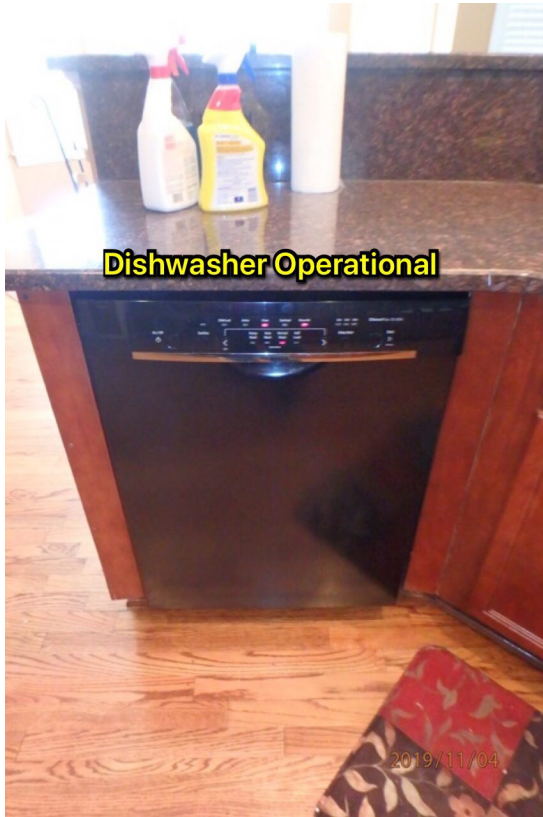
265: The dishwasher is not properly attached to the under side of the countertop or the sides of the base cabinet. This leaves the unit in an unstable condition that should be corrected. Safety issue.

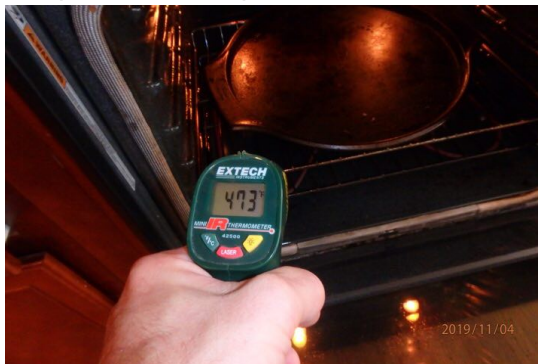
REPR 268: The upper heating element in the oven did not heat up or function when tested. Replacement is needed.

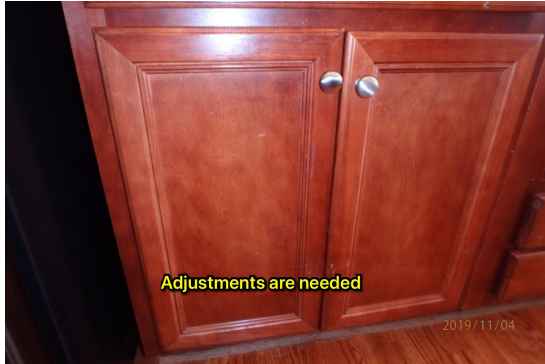
REPR 274: The cabinet door(s) indicated in the photos are misaligned or out of adjustment. The hinges need to be adjusted for the doors to function smoothly.

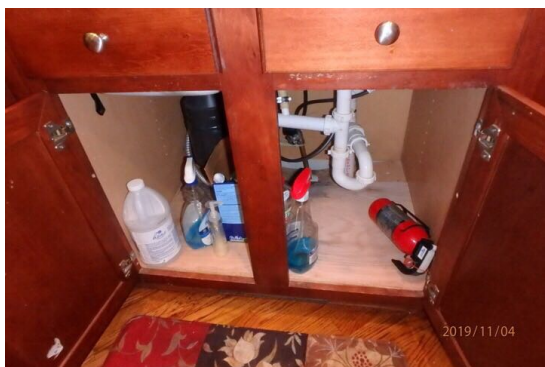
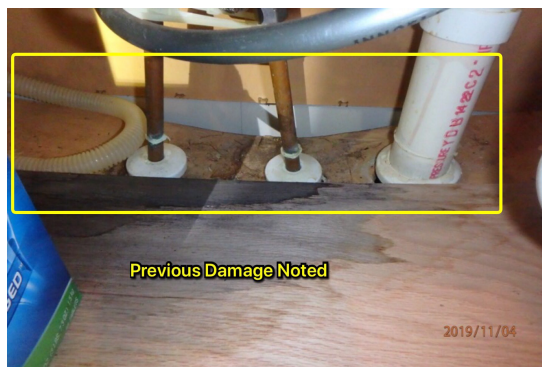
FYI 275: Decay was found in the floor of the base cabinet where it appears damaged from a leak issue. No elevated moisture levels were measured at the time of the inspection and the extent of the damage was undetermined.

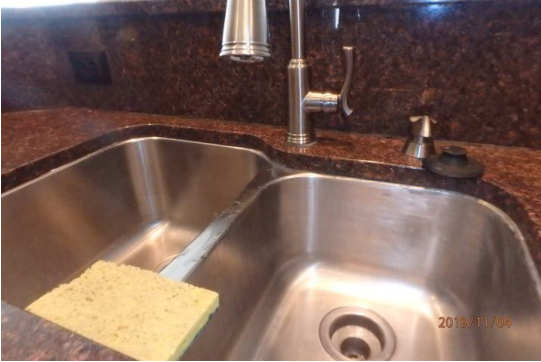
REPR 276: Caulking is needed where the countertop intersects with the back splash to prevent moisture from possibly penetrating behind the cabinets causing costly damage. This is considered normal maintenance.

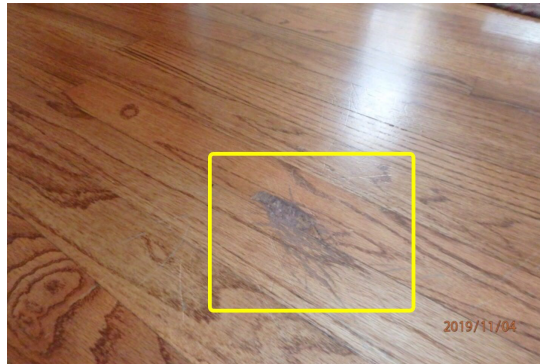
284: Damage was found in the wood floor covering in the kitchen.

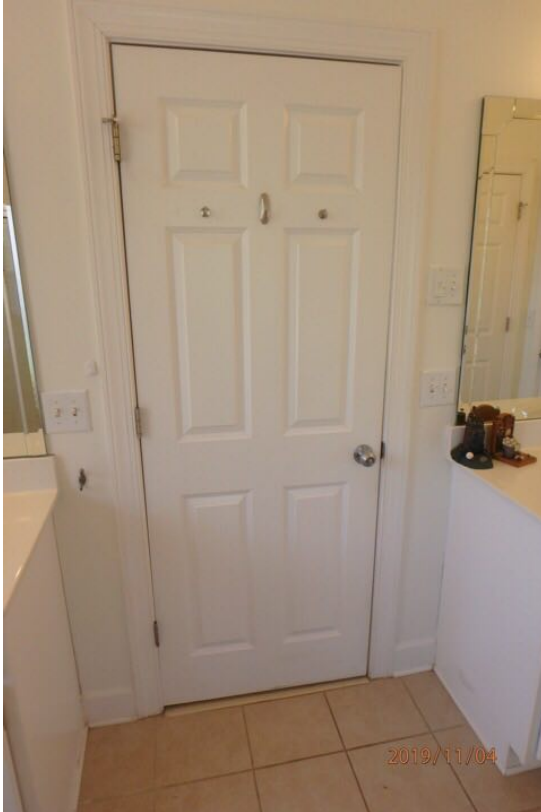
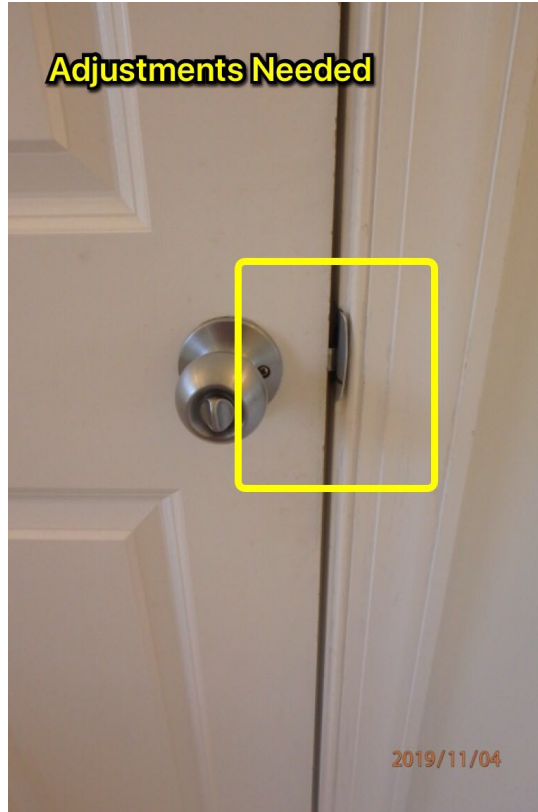
1. Master bathroom

REPR 290: The door knob assembly on the entry door does not latch on the strike plate in the closed position. Adjustments are needed to the strike plate/door(s) listed below so the door(s) will latch correctly when closed.

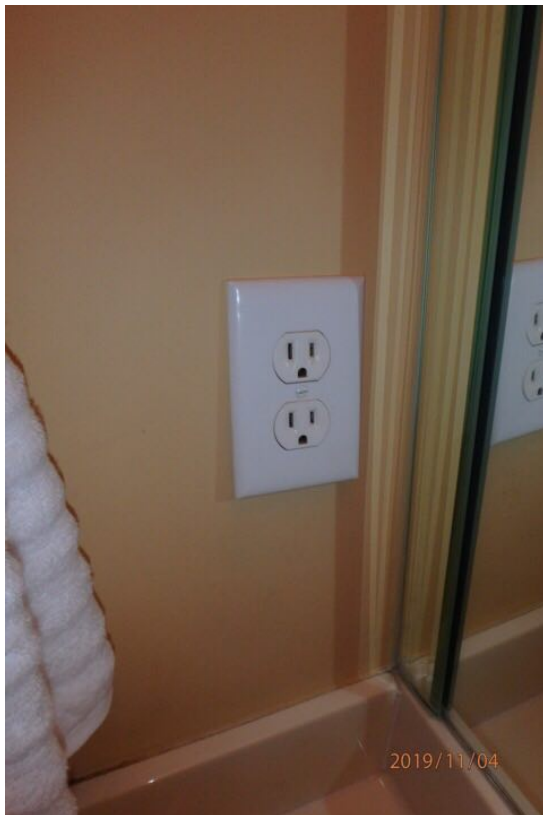
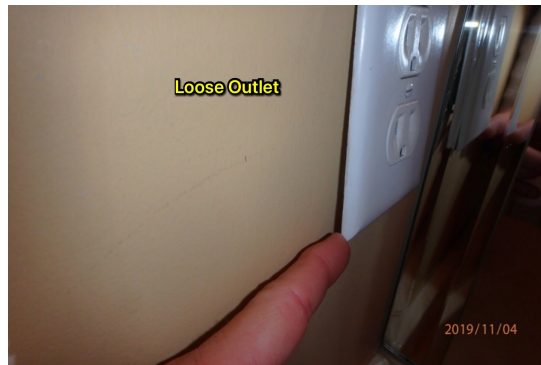
1. Downstairs hall bathroom

REPR 298: A loose electrical outlet was noted in the bathroom listed below. This can make un-plugging appliances difficult.

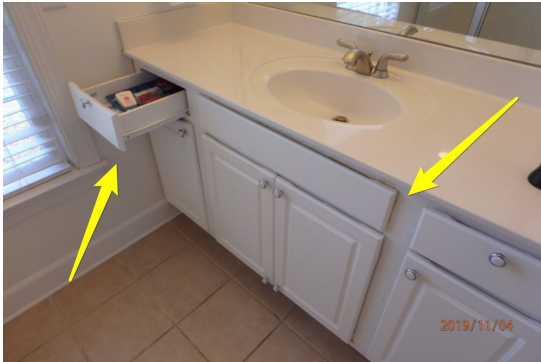
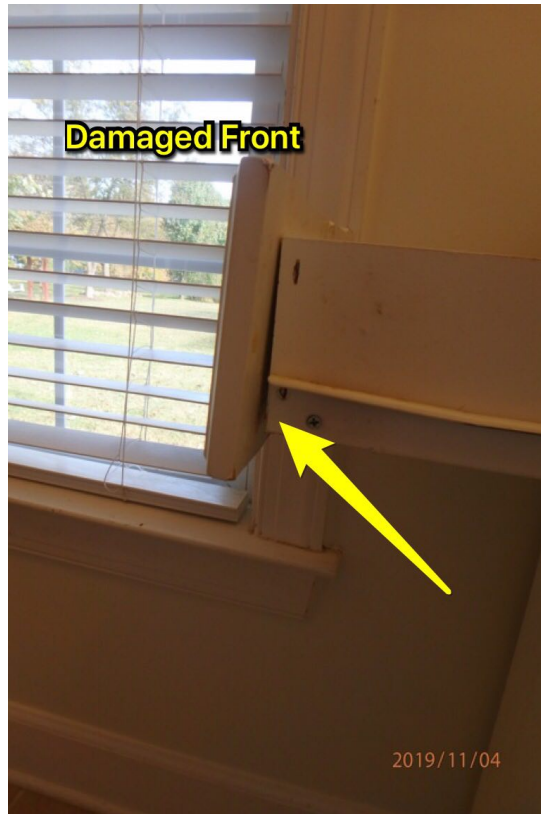
1. Master bathroom (Right side)

REPR 299: Damage was noted to the bathroom vanity drawer in the bathroom(s) listed below. Repair/replacement is needed.

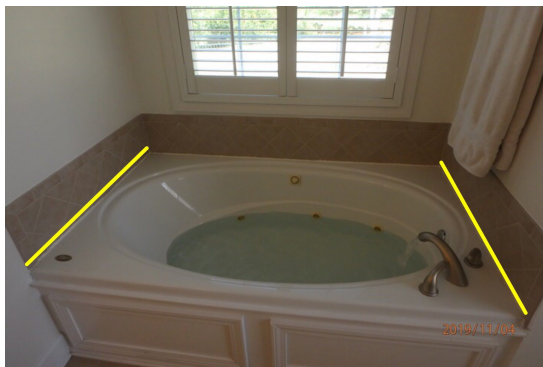
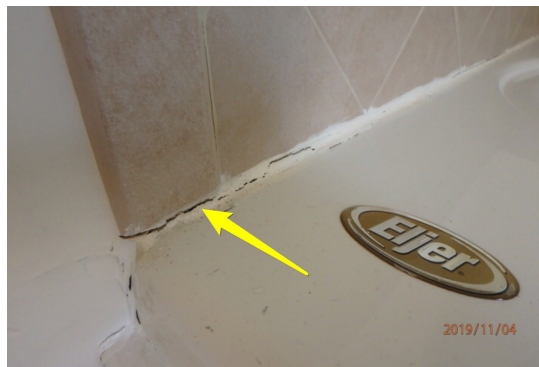
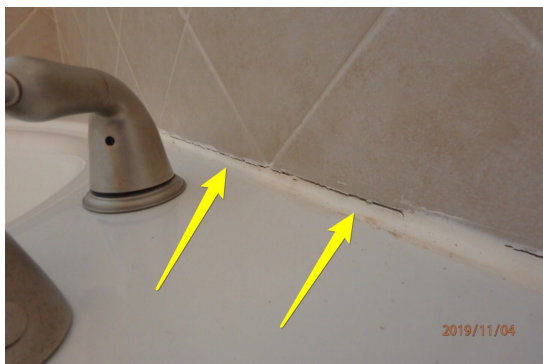
1. Master bathroom

REPR 312: Additional caulking/sealing is needed around the tub/shower in the location(s) listed below. This condition can allow possible moisture intrusion and may result in damage.

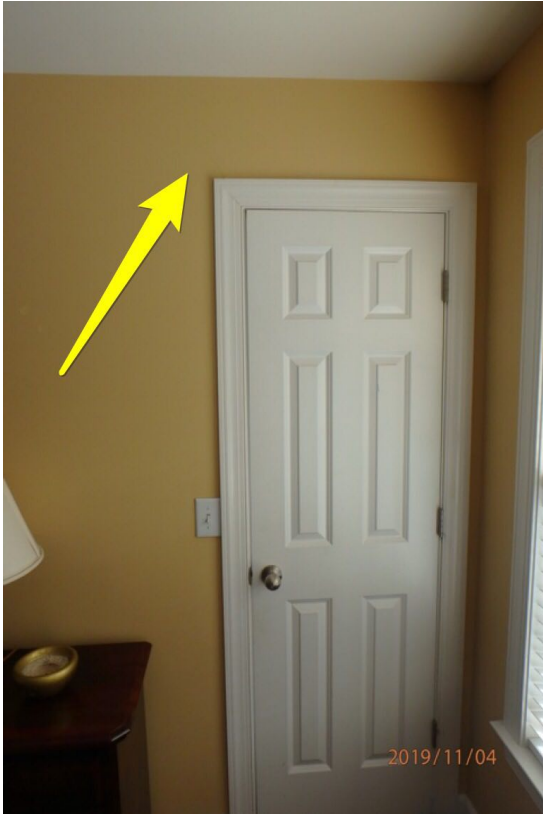
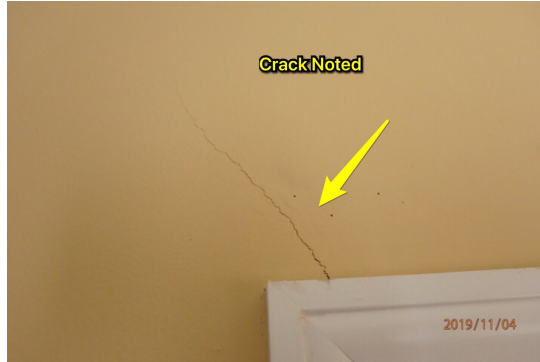
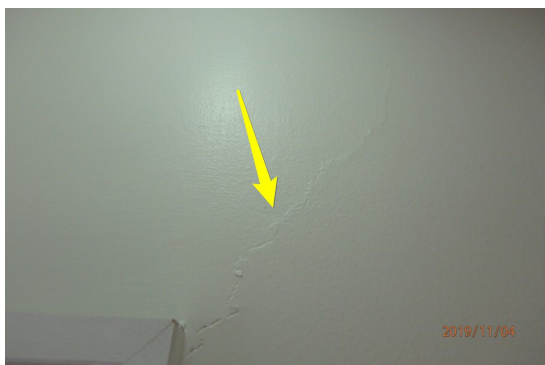
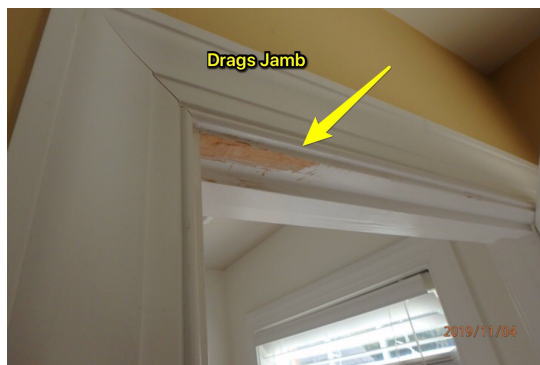
Upstairs Front Bedroom

REPR 316: A wall crack(s) was noted above the door(s) at the location(s) listed below. This may be the result of excessive movement in the foundation or the framing components. The installed door is drain along the upper jamb as well. Further investigation is needed by a qualified professional and or structural engineer to determine if repairs are necessary.

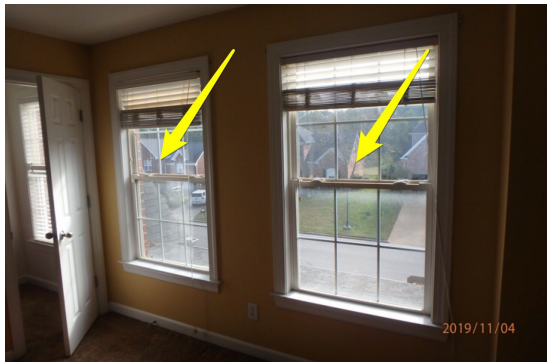
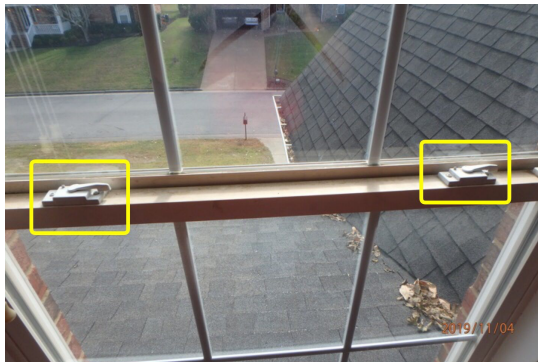
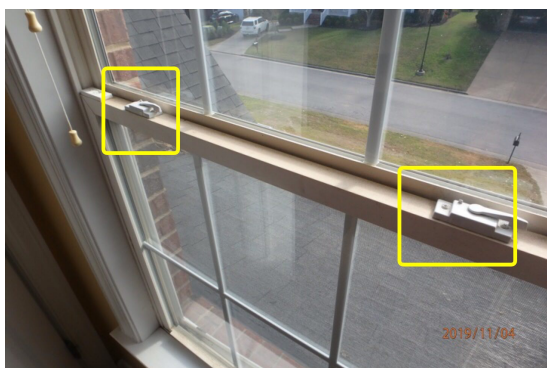
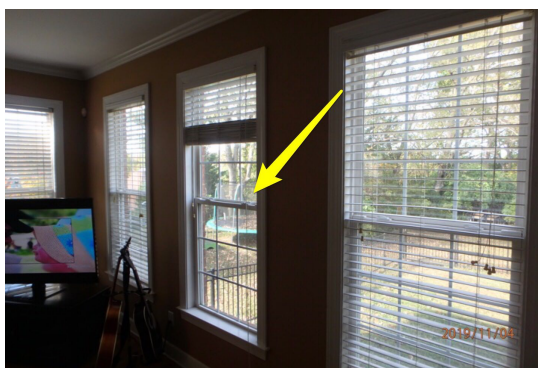
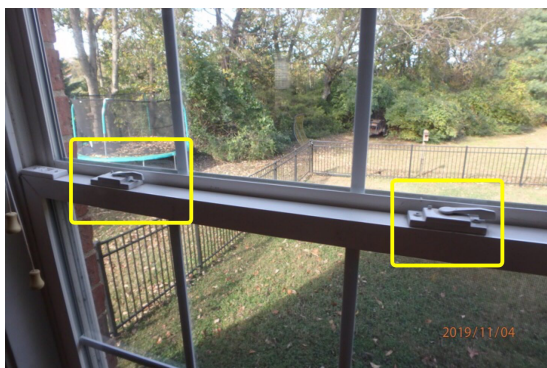
1. Upstairs front bedroom
2. Family room

REPR 319: Alignment issues were noted at the window hardware, preventing the lock from functioning as designed. The window(s) location(s) is listed below.

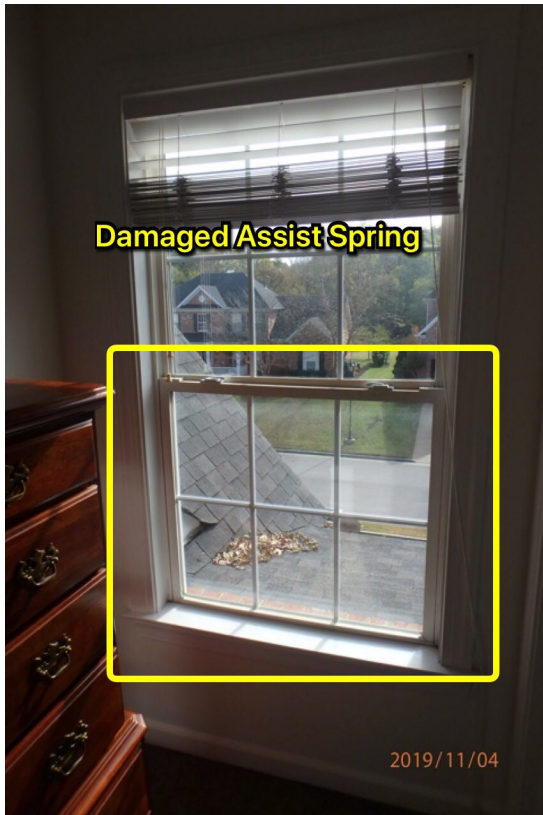
1. Upstairs front bedroom closet

320: A damaged assist spring was noted in the window(s) mentioned below. Repair is needed for the window(s) to function as designed.

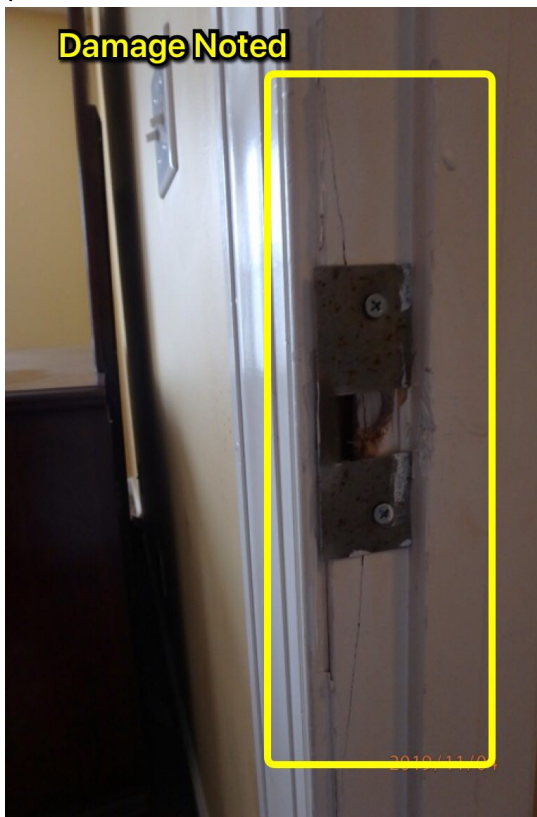
Upstairs Front Bedroom

REPR 321: The upstairs front bedroom entry door appears to have been forced open causing damage to the door jamb in the latch area. Repairs and/or replacement is needed for the door to latch properly.

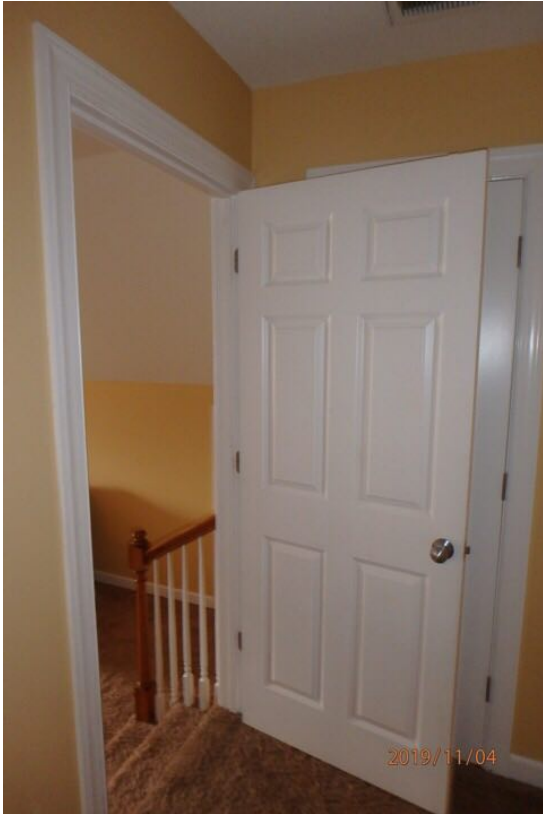
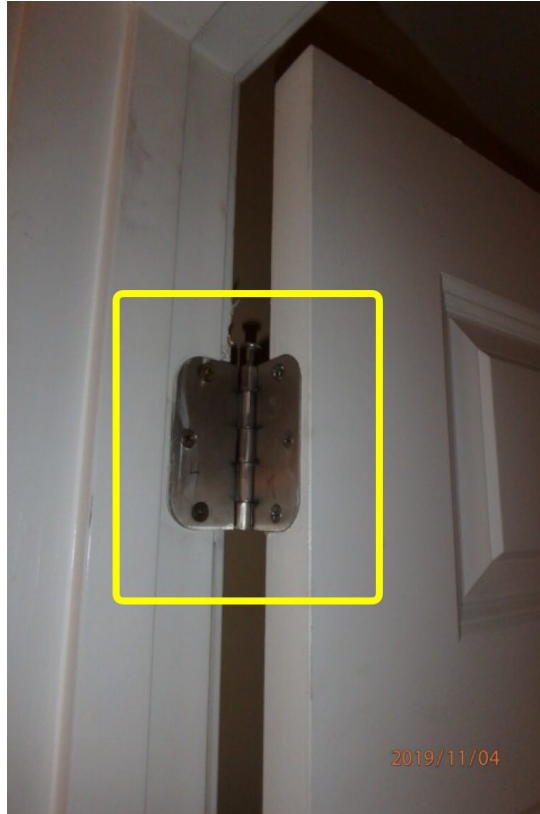
Bonus Room

322: The screws that secure door hinge(s) in place are loose/stripped which prevents the door from being properly installed causing it to interfere with the jamb. Repairs are needed for it to function as designed.

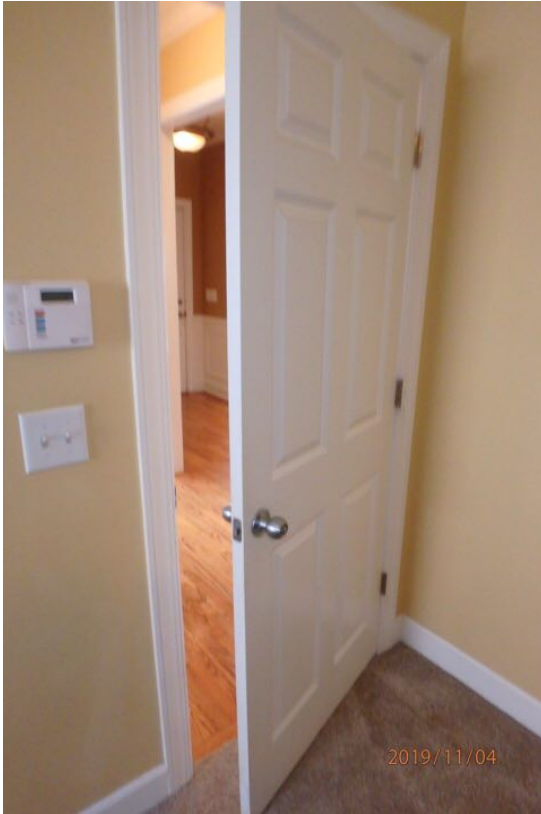
1. Maser bedroom entry door

REPR 323: The doors mentioned below will not stay open without the use of a doorstop. Adjustments are needed.

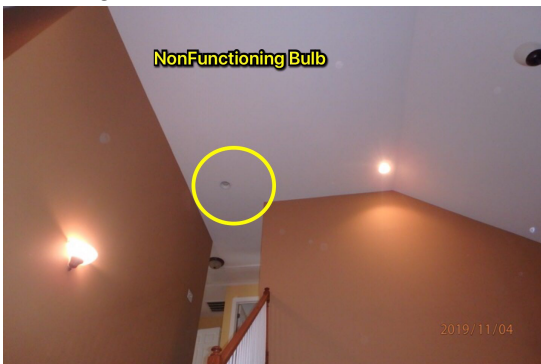
1. Living room

REPR 335: Non functioning lights were noted in the room(s) listed below. Without replacing light bulbs, the inspector is unable to determine if the issue is in the bulb, the fixture, or the wiring. The bulbs should be changed to determine if the issue goes beyond replacing bulbs. UltraSound recommends further investigation and repair by a qualified professional.

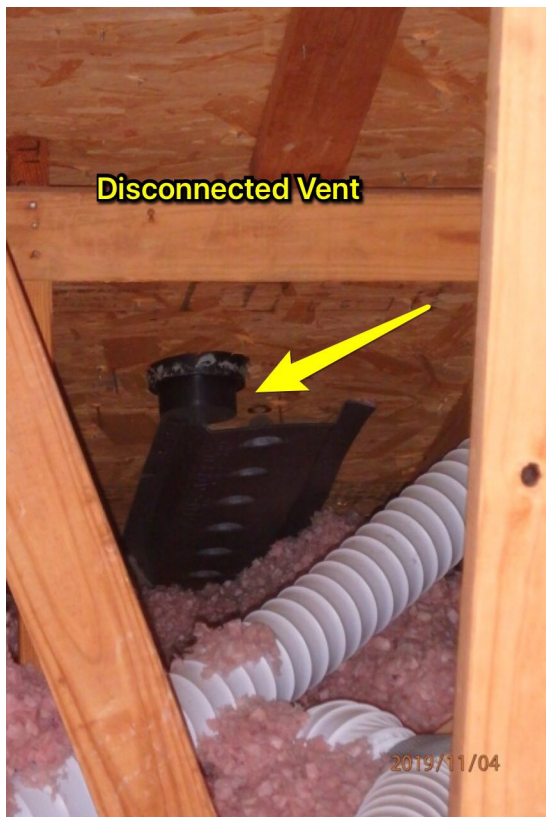
1. Left side

REPR 353: A disconnected bathroom exhaust duct was noted in the attic at the location(s) listed below. The vent should be reattached to prevent moisture from exhausting into the attic.

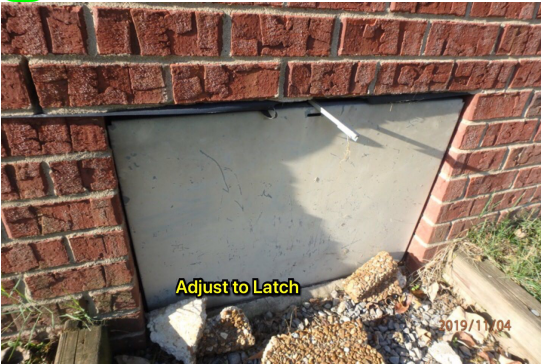
REPR 357: Adjustments are needed to the crawlspace door for the close and latch as designed.

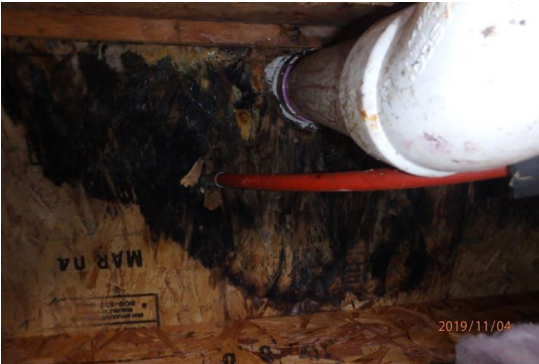
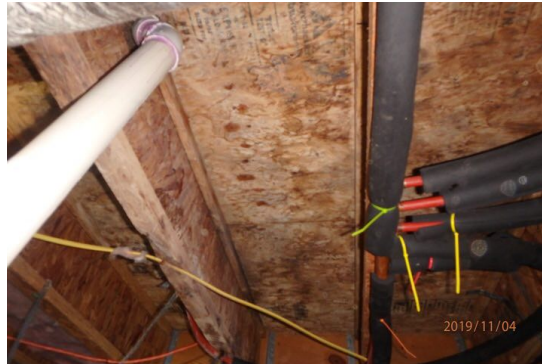
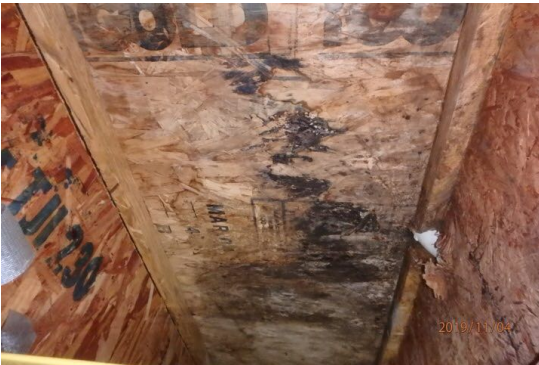
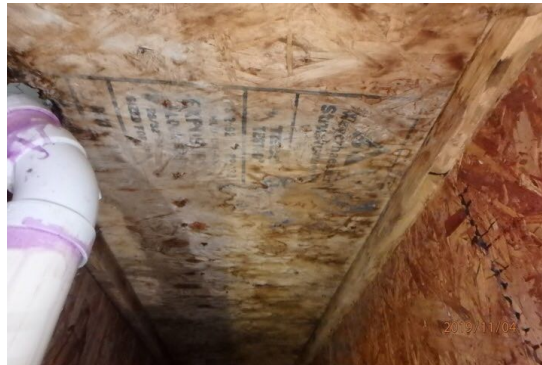
1. Master bathroom
2. Laundry room

SAFT 366: A light amount of microbial debris was noted on the floor structure in the crawlspace at the location(s) listed below. Certain types of microbial debris can be toxic to humans. UltraSound inspectors do not inspect for, or determine if mold exists. Inspectors cannot determine what types of microbial debris exists in the noted areas without a test from a qualified laboratory. UltraSound recommends further investigation and repair by a qualified professional.

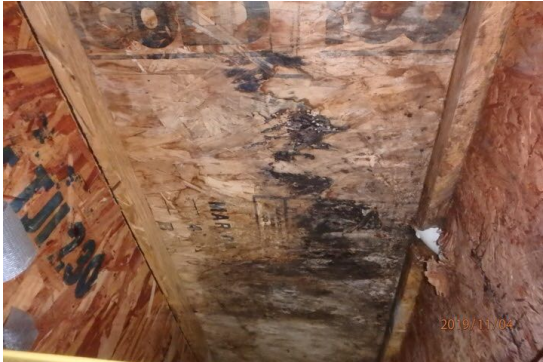
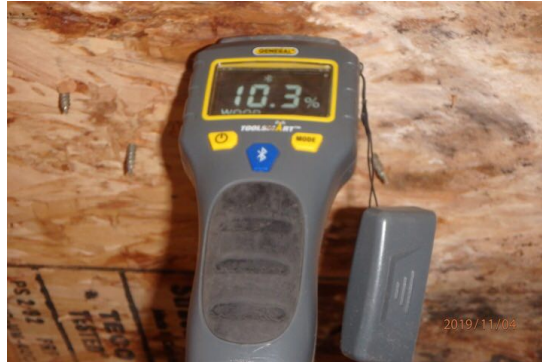
1. Laundry room

FYI 370: Water stains were noted in the floor framing at the location(s) listed below. No elevated moisture levels were noted at the time of inspection And the reasoning for the staining is unknown to the inspector.

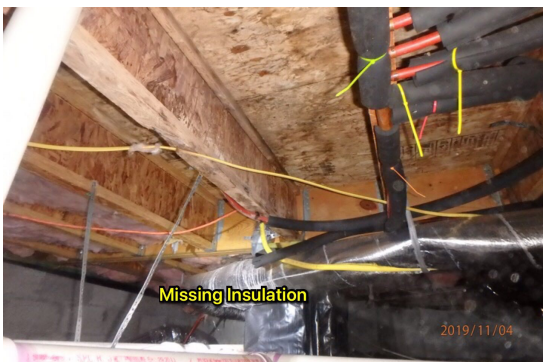
REPR 375: Insulation batts were found missing from the floor structure under the laundry room. Re-installation on the insulation is needed.

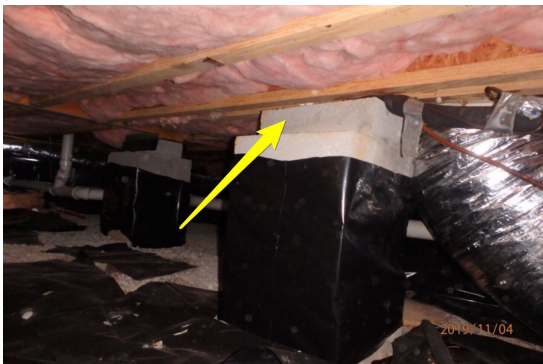
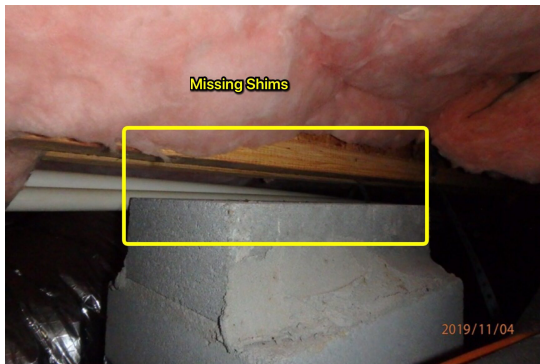
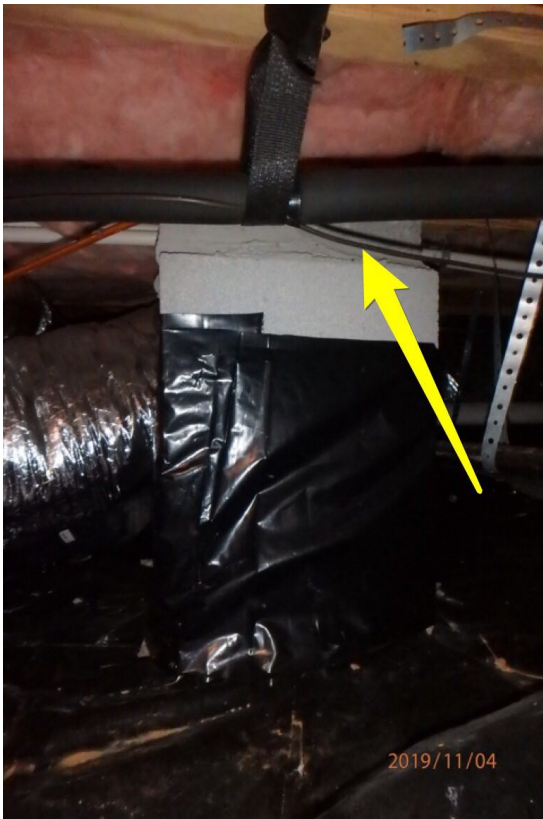
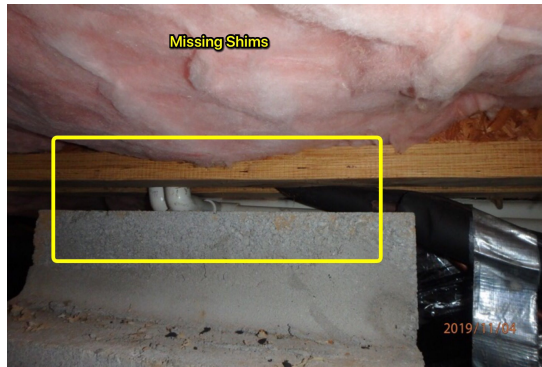
REPR 379: Missing shims were noted at two of the installed piers in the crawlspace. The shims are needed to ensure the intended joist are properly supported. UltraSound recommends repair by a qualified professional.

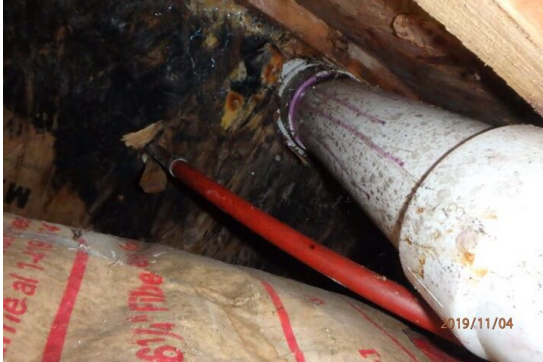
REPR 395: Water stains were noted in the subfloor under the master bathroom toilet. No elevated moisture levels were measured in the area of the stains however leaks may not occur until the toilet is being used under normal conditions . Further investigation is needed by a qualified professional to determine if repairs are needed.

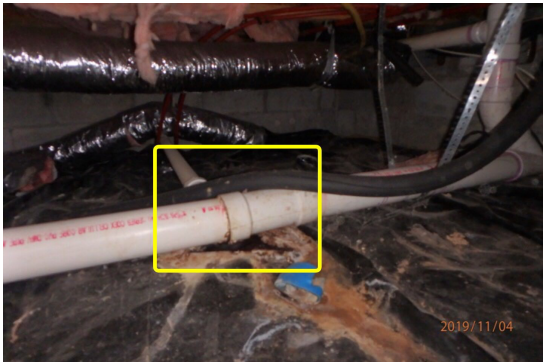
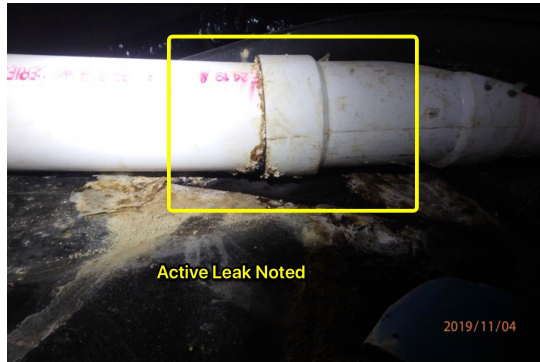
REPR 396: An active waste line leak was noted in the crawlspace in the main line. UltraSound recommends further investigation and repair by a qualified professional.
