Complete Tennessee Inspections, LLC
3554 Mahlon Moore Road
Spring Hill TN 37174
615-943-0051
Jeffrey.Bonner.JB@gmail.com

Inspection reference: 2021016 David Gilliam

Confidential Inspection Report
832 Barrington Place
Brentwood, TN 37027

March 16, 2021

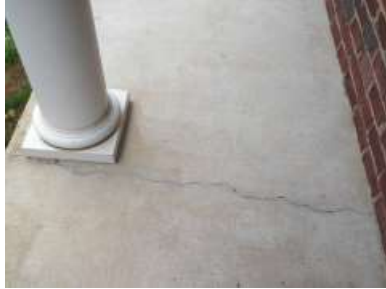
Slab Condition:

Attention Needed - The slab needs repair in order to prevent further deterioration. Seal cracks.

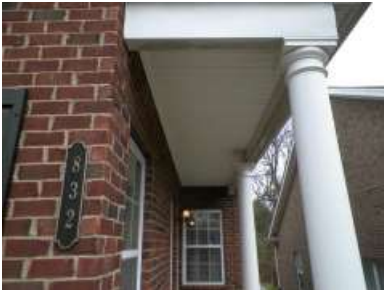
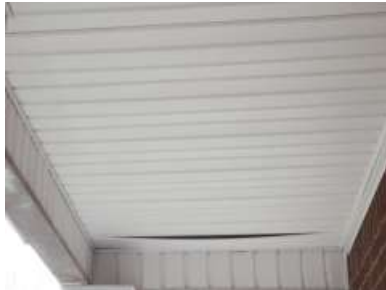
Patio or Porch Cover Condition:
The patio cover was functional.

Attention Needed - The patio cover needs minor adjustment or repair to function properly.

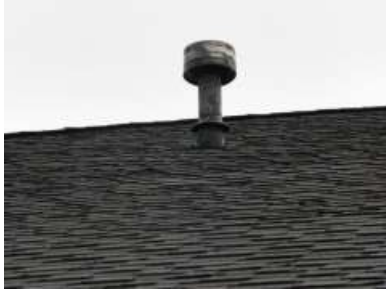
Vents Noted From Roof View:

There is at least one gas-fired vent stack through the roofline. The stacks appear to be installed two feet higher than the adjacent roof line.

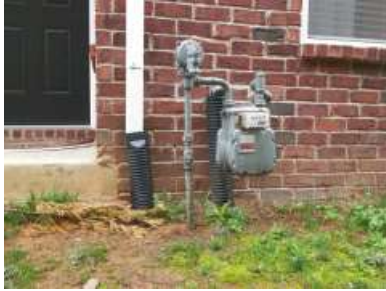
Yes - At least one end of the footer drain exposed to daylight was noted. This inspection does not warrant the effectiveness of the drainage system. I merely noted that there appears to be one present.

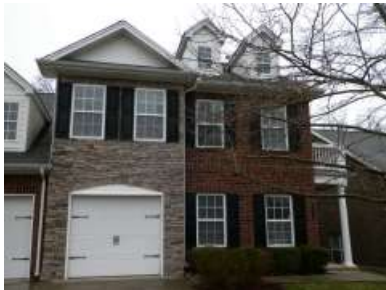
Type Roof:
Gable.

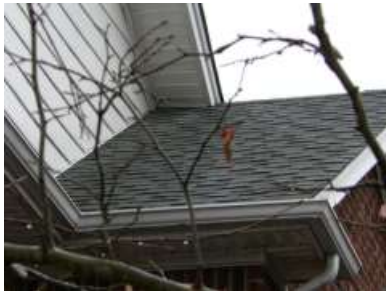
The roof covering on the main structure appears to be the first covering. The number of layers was determined by counting the number of layers of shingles or material at the attic vent from the underside.

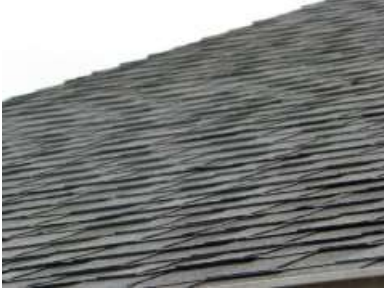
The roof covering material is in a condition that is consistent with its age and method of installation, showing no deficiency or cause for immediate concern.

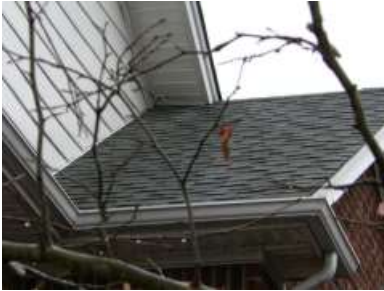
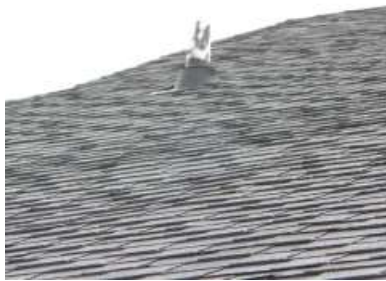
The flashings around openings in the roof covering appear to be watertight and caulked as needed. Apron flashing was noted at the wall joints.

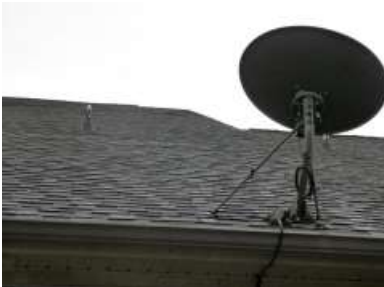
The ridge covering material appears to be in functional condition.

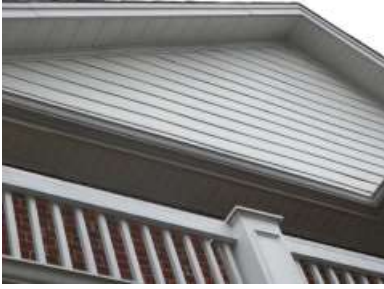
Extended roof framing appeared to be in usable condition.

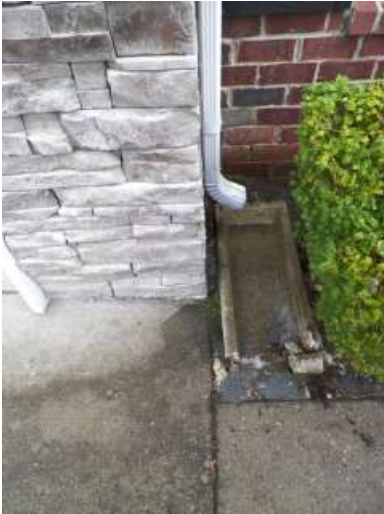
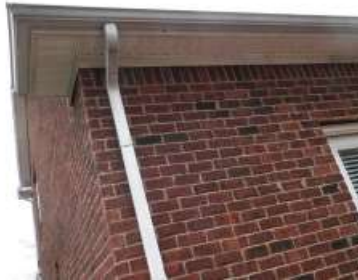
The gutter system on the roof edge appears to be functional and adequately sloped to carry the water to the downspouts. **Action Necessary** - The splash blocks appear to need repair or replacement.

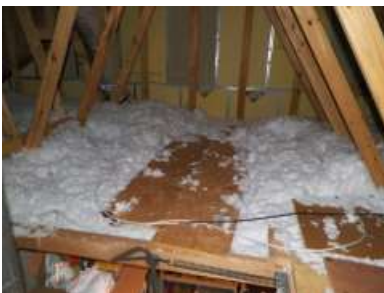
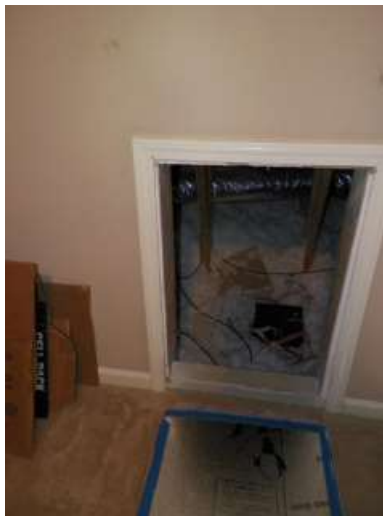
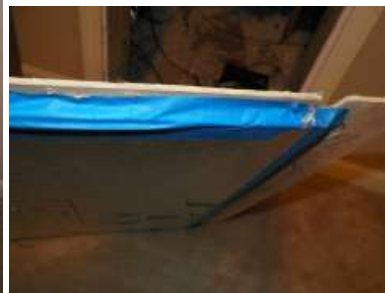
The upper attic cavity was inspected by entering the area. Attic not completely walked due to no walk boards, electrical wires or other conditions not favorable to the inspector.

The lower attic cavity was inspected from the attic access with only head and shoulders in the attic. Only the areas of the attic visible from the attic access way are included as a part of this inspection.

Lower attic cover was made of thin materials. The new owner might want to upgrade in the future.

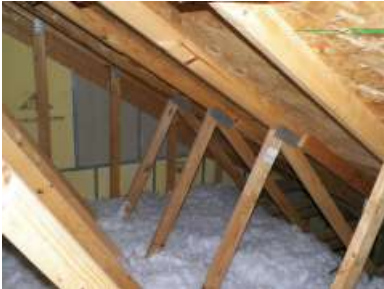
A truss system is installed in the attic cavity that is used to support the roof decking and transmit the roof load to the exterior walls. The rafters or truss system appears to be in functional condition. The rafter spacing is 24 inch on center.

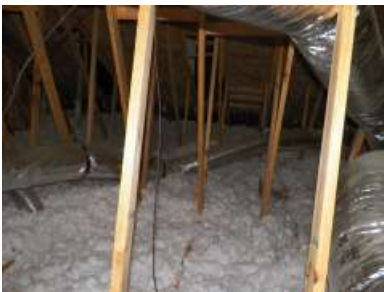
The roof framing appears to be in functional condition.

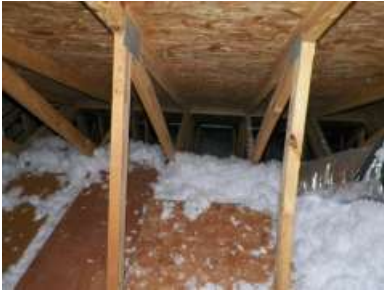
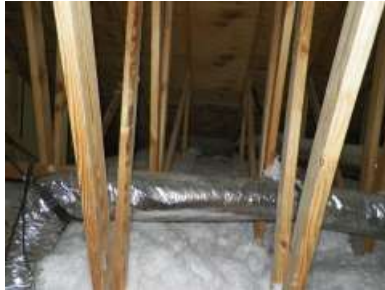
The roof decking material is oriented strand board sheathing.

The roof decking material is 1/2" plywood sheathing on the lower roof. I could not see if Ply clips were in place.

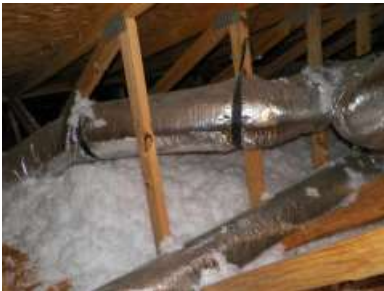
There was no evidence of current water leaks into the accessible attic spaces at the time of inspection.

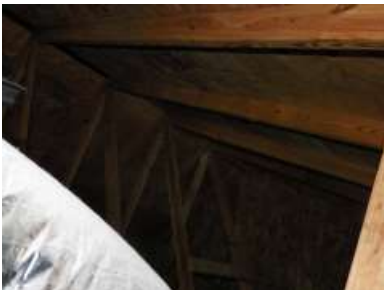
There appears to be adequate ventilation installed. Vents are located both in the ridge area and low in the eaves area. There are ridge vents installed. There are soffit vents installed.

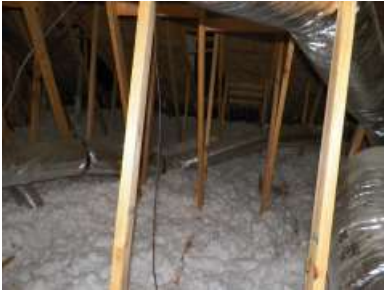
The attic insulation appears to be adequate and properly installed. The following type of insulation was noted in the attic: Fiberglass. Loose bagged or blown in place. There is an average of at least 6" of insulation installed.

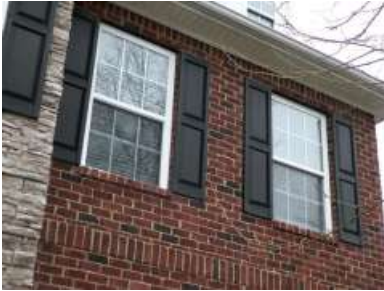
Good - The exterior siding materials are of a better grade or condition than I would normally expect to see.

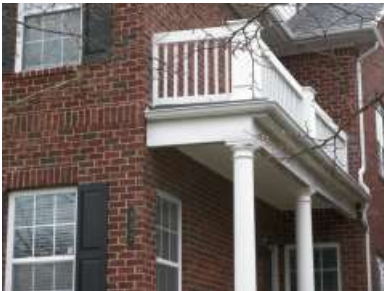
The trim was intact and functional.

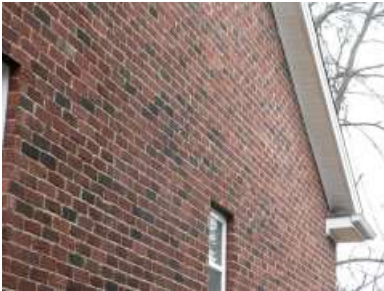
The soffit/eaves appeared to be adequate and showed only signs of normal wear.

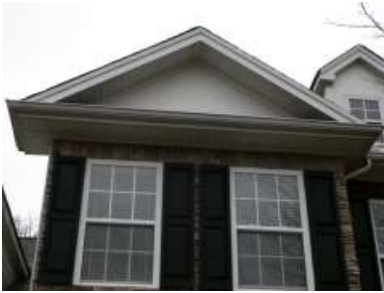
The fascia and rake boards appear to be in adequate condition and show only signs of normal wear.

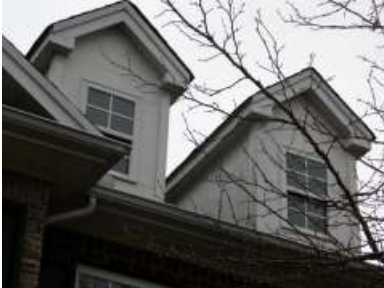
The finish or exposed painted surfaces are functional.

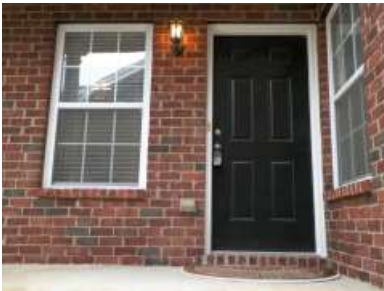
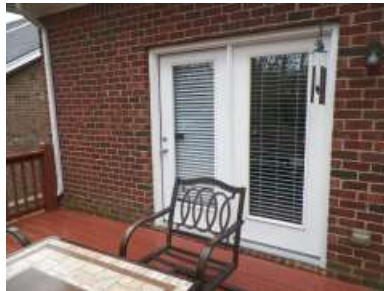
The noted door(s) is located at the front of the building, Steel door, The outside entry door(s) was functional as noted from the exterior. There is a deadbolt installed on the entry door, and it is operational. This is a recommended safety feature.

The noted door(s) is located at the rear of the building, Good - The outside entry door is of insulated glass. The outside entry door(s) was functional as noted from the exterior. There is a deadbolt installed on the entry door, and it is operational. This is a recommended safety feature.

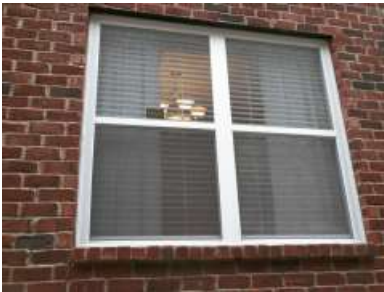
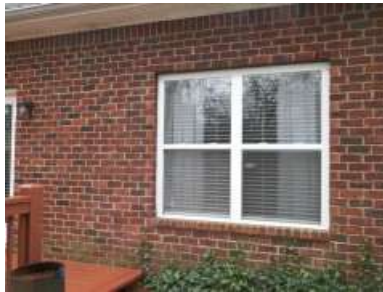
Window Condition:

Good - The windows in this structure are of better quality and style than would be expected in a home of similar construction. The window framing and glass are functional. **Attention Needed** - Some of the window screens were damaged and need to be replaced.

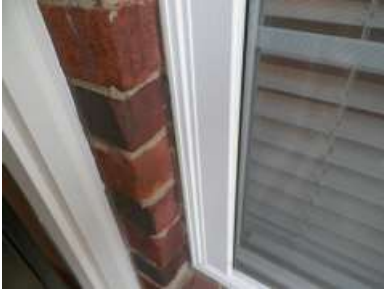
Structural Caulking:

Attention Needed - Several spots around the structure were noted that need to be caulked. Original caulking had shrunken or cracked in some areas.

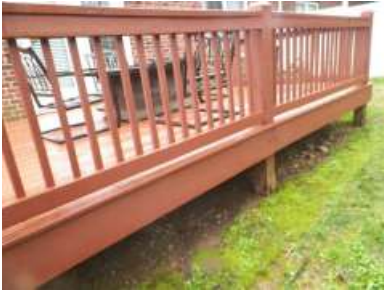
Deck or Porch Railings:

The railings as installed are functional. The spacing between balusters is 6". New construction allows only 4" spacing. This was instituted as a safety issue to prevent small children from getting caught between the balusters.

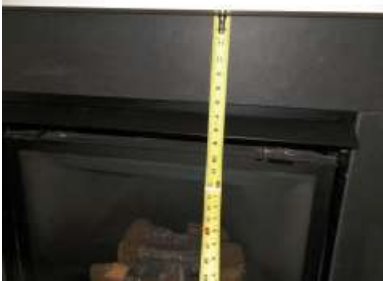
**Mantle:**

Yes - There is a mantle installed, but it does not meet the 12" minimum clearance above the firebox. If the mantle protrudes over 1 1/2 inches, it may overheat during normal use.

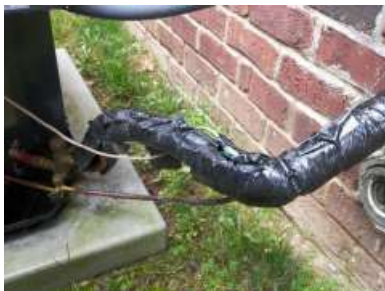
Insulation Wrap on the Suction Line:

Attention Needed - The insulation wrap on the suction line to the condenser/compressor is in need of attention due to deteriorated or missing insulation. Replacing this insulation is an inexpensive repair.

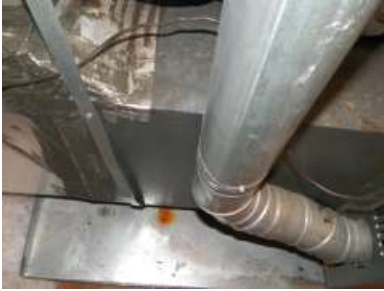
Capacity & Efficiency:
Heat Capacity in British Thermal Units (BTUs) per hour: Estimated at least 100,000 BTUs input and 80,000 + BTUs output to the home.

Approximate Age:
The unit may be original to the house or about 15 years old. The typical service life for a forced air natural gas furnace is 18 - 20 years. Although operational at the time of the inspection, the age and/or condition of this unit is such that you may need to replace it in the near future.

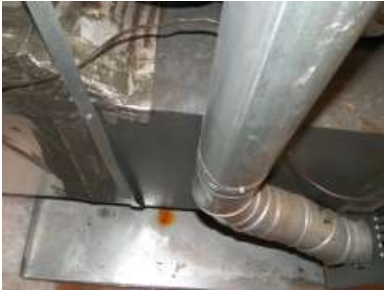
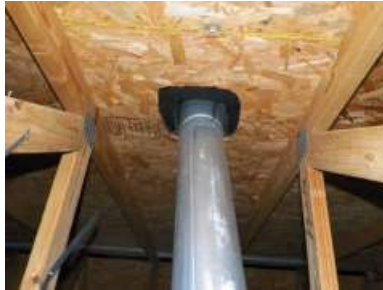
Flues, Vents, Plenum:

The flue pipe is metal.

The visible portions of the flue/vent system appear to be installed correctly and appear to be functional.

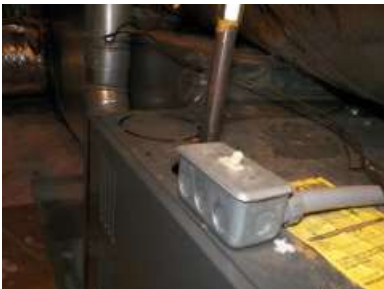
Burners / Heat Exchangers:

Closed System - I was unable to inspect inside as this was limited to a general visual inspection of the exterior. Dismantling cabinets to inspect heat exchangers should only be done by a specialist, a licensed Heating and Air technician.

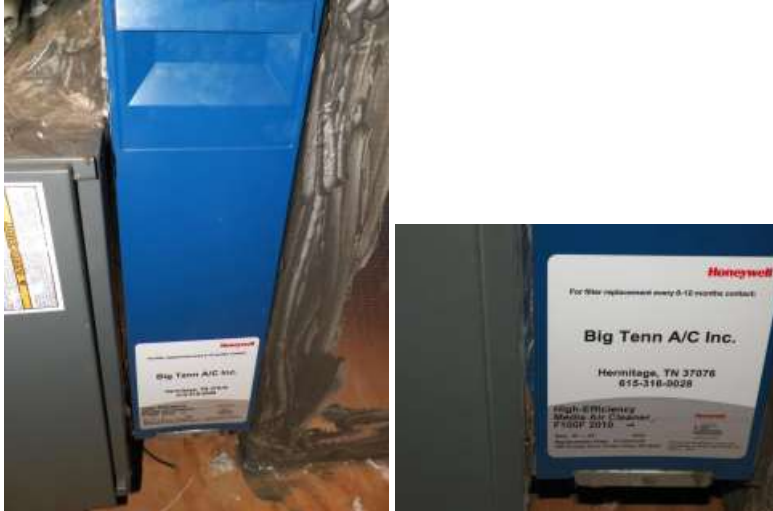
**Electronic Air Cleaner Installed:**

Yes - There is an electronic air cleaner installed. The efficiency and effectiveness of these far exceed that of conventional filters. Cleaning on a regular basis is still required. Check with the manufacturer or service technician for recommended service and cleaning.

Yes - There is an electronic air cleaner installed. The efficiency and effectiveness of these far exceed that of conventional filters. Cleaning on a regular basis is still required. Check with the manufacturer or service technician for recommended service and cleaning. Replace filter on schedule as per the directions from the dealer or installer.

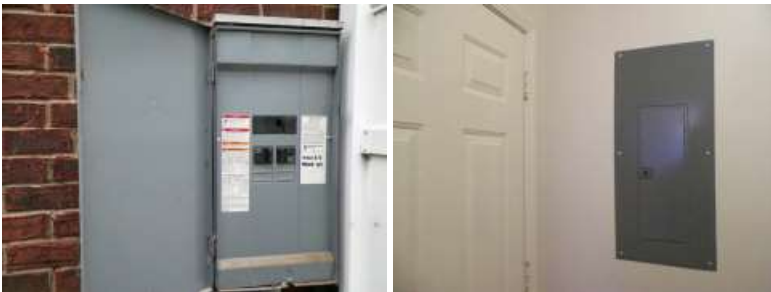
Electrical Distribution Panels:

Main Panel Location:

Exterior of house.
Laundry - Utility Area.

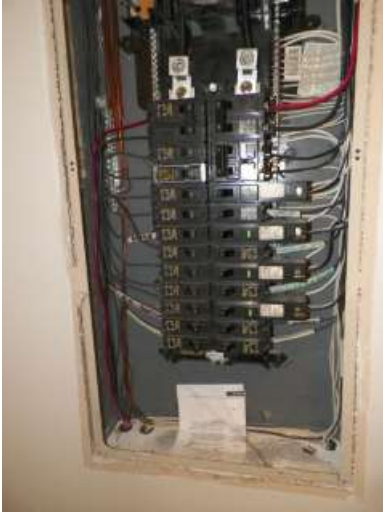
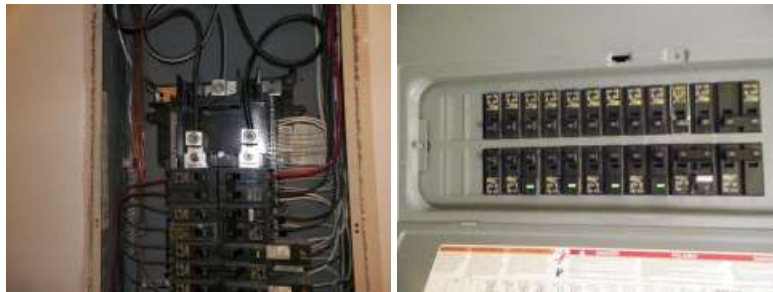
Main Panel Observations:

Circuit and wire sizing correct so far as visible, The power panel, as a container for safely covering electrical circuitry and components, is functioning as intended, minimizing the risk of electrical shock. Electrical circuitry wiring in the panel appears neatly arranged with no unallowable splices.

Grounding system is present.

Panel cover returned. Breakers with GFCI capability also noted here.

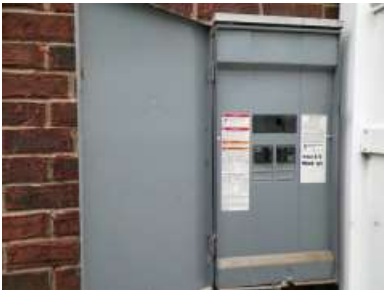
Utility Services:

The underground service appears adequate.

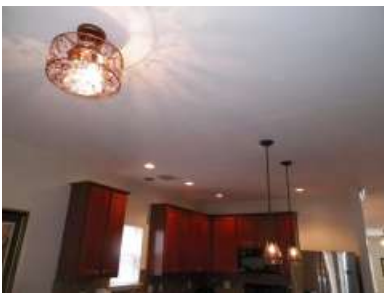
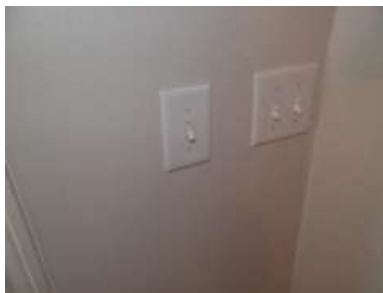
Kitchen Interior

The ceiling lights in the kitchen were functional.

A representative sampling of switches was tested. As a whole, switches throughout the room are in serviceable condition.

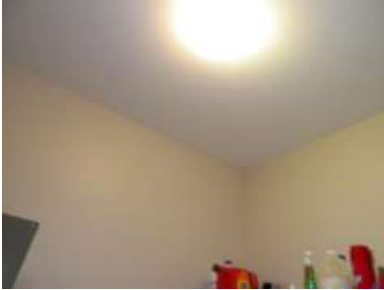
Laundry:

Lighting in the laundry appeared to be adequate. The new owner might desire to add lighting if necessary.

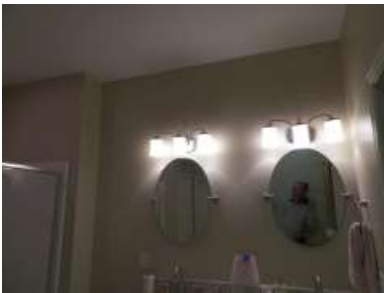
Master Bathroom:

The ceiling light and fixture in this bathroom are in functional condition.

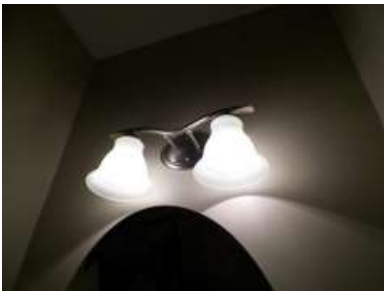
Bathroom #2:

The ceiling light and fixture in this bathroom are in functional condition.

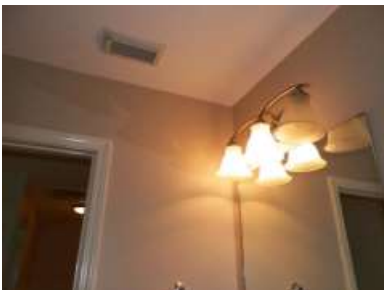
Bathroom #3:

The ceiling light and fixture in this bathroom are in functional condition.

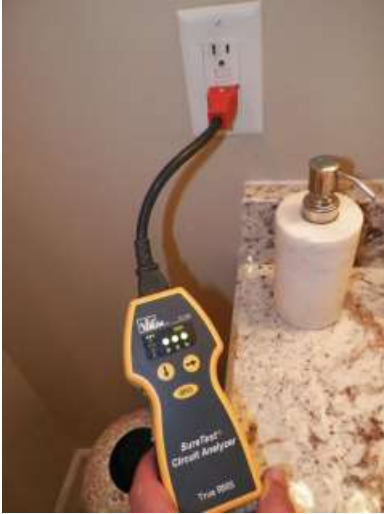
Master Bathroom:

There is a functional Ground Fault Circuit Interrupt outlet installed in the area of the bathroom vanity.

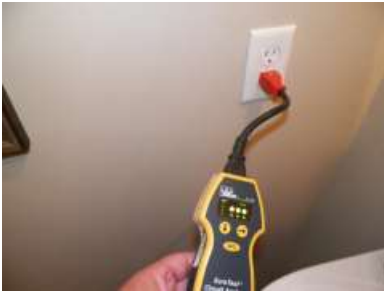
Bathroom #2:

There is a functional Ground Fault Circuit Interrupt outlet installed in the area of the bathroom vanity.

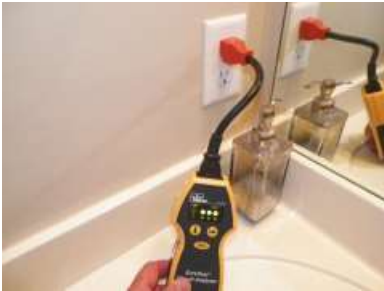
Bathroom #3:

There is a functional Ground Fault Circuit Interrupt outlet installed in the area of the bathroom vanity.

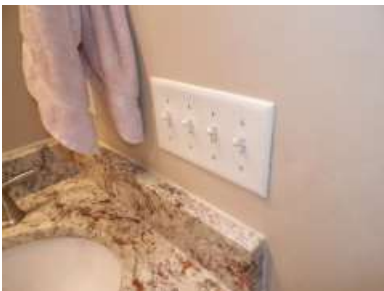
Master Bathroom:

The light switch is functional.

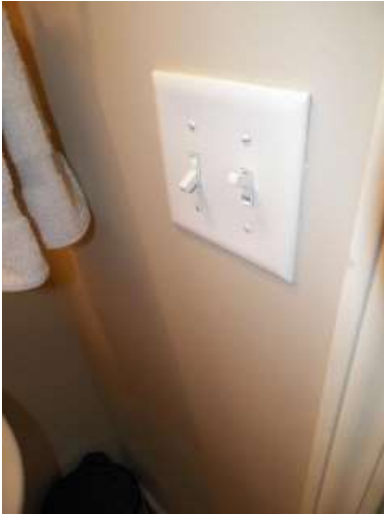
Bathroom #2:

The light switch is functional.

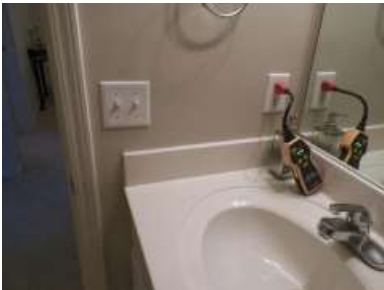
Bathroom #3:

The light switch is functional.

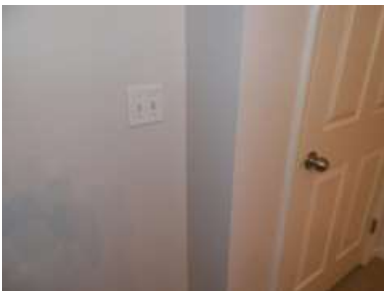
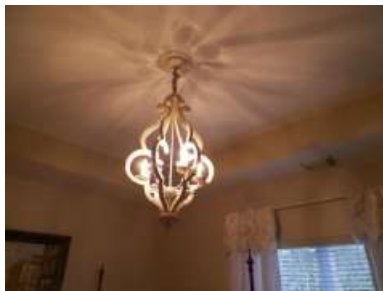
Master Bedroom:

The light and light switch were functional at the time of the inspection.

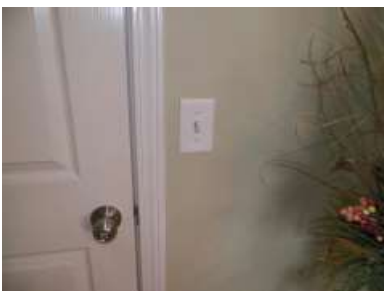
Bedroom #2:

The light and light switch were functional at the time of the inspection.

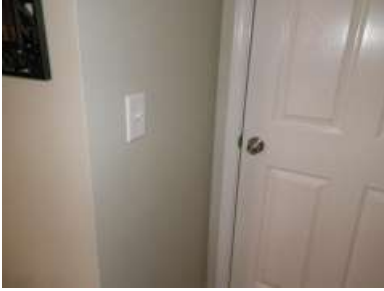
Bedroom #3:

The light and light switch were functional at the time of the inspection.

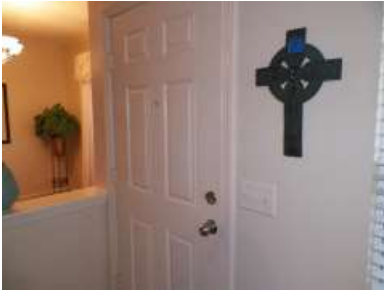
Living Room:

The light and light switch were functional at the time of the inspection.

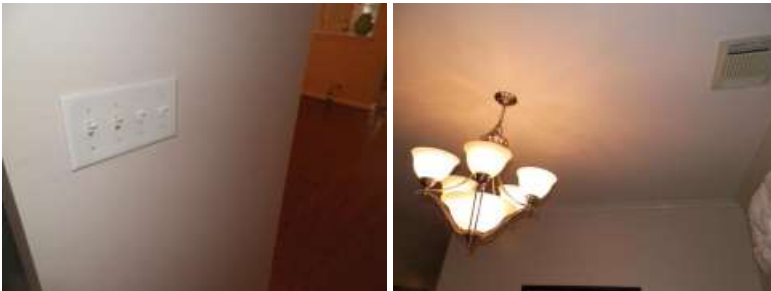
Dining Room:

The light and light switch were functional at the time of the inspection.

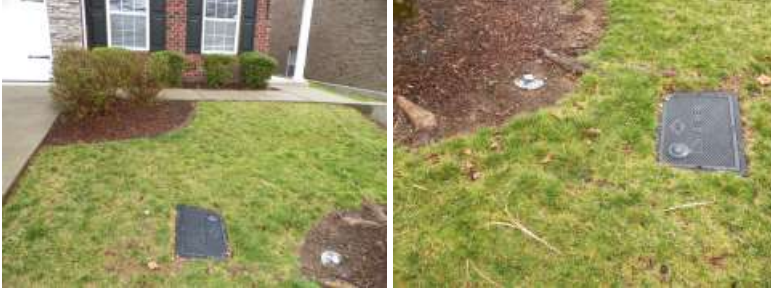
The source of the water supply was determined by the presence of a water meter on the property and no other source of water supply noted.

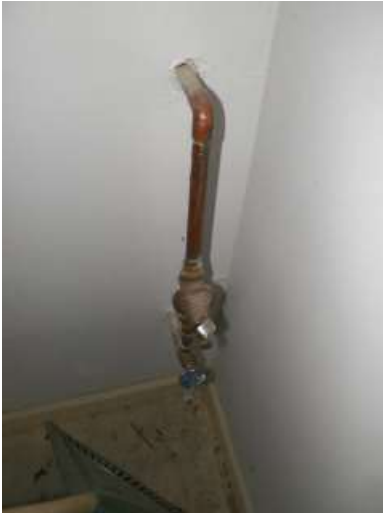
3/4" water service line from the meter to the main cutoff.

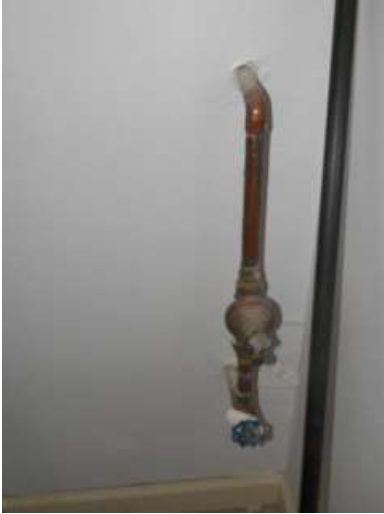
Main Water Line Cutoff Location:

Garage wall at the bottom. Water was turned on for testing and turned off at the conclusion.

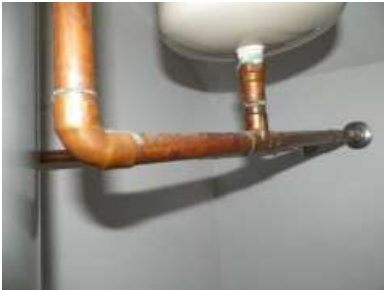
Visible Mineral Deposits or Encrustations:
No.

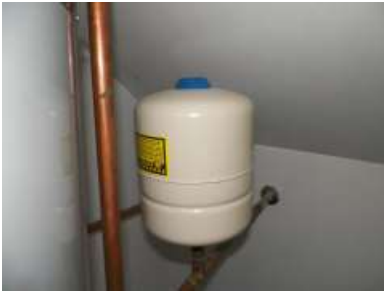
Interior Supply Piping Size:
The interior water supply piping is 3/4" in diameter. It then reduces to 1/2" or 3/8" risers.

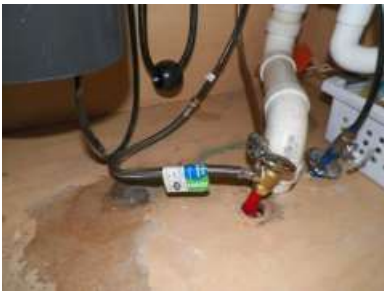
Interior Supply Piping Material:
The interior supply piping in the structure is predominantly copper at the water heater and PEX plastic piping at the fixtures.

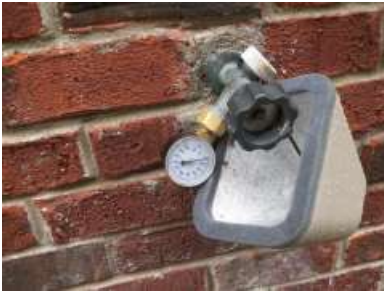
Water Pressure:

Water pressure was checked at an exterior hose bib noted water was off. Then water was turned on. Water pressure from 40 to 80 pounds per square inch is considered within normal/acceptable range. There is a water pressure regulator valve correctly installed. This allows adjustment of the incoming water pressure.

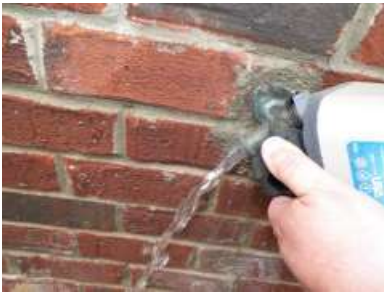
Exterior Hose Bibs Functional:

The exterior hose bib(s) appeared to function normally.

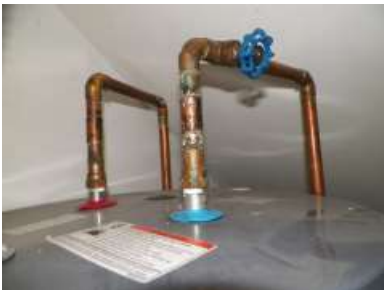
By testing multiple fixtures at one time, functional flow of the water supply was verified.

No leaks were seen at the time of the inspection. Not all pipes were visible.

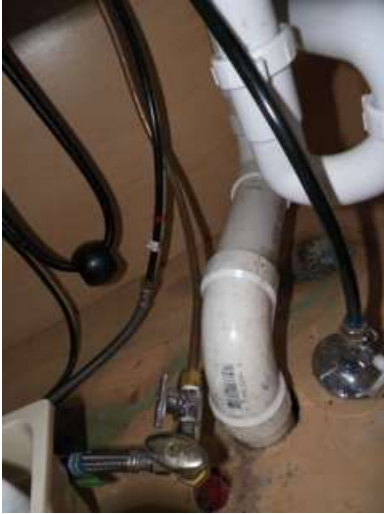
The predominant waste line material is plastic.

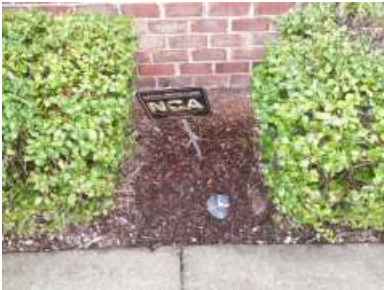
Waste Piping Condition:

Limited View of pipes as much is buried in the slab foundation.

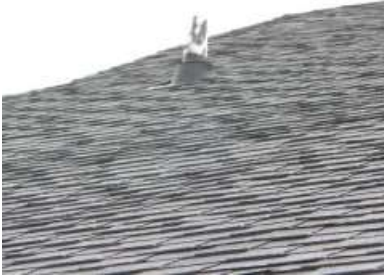
Vent Piping Condition:

The visible plumbing vent piping appears functional.

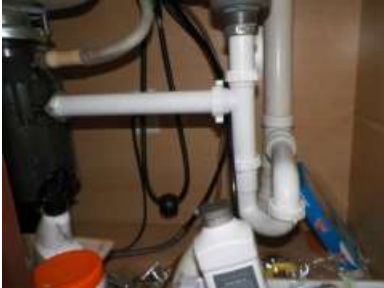
Supply/Waste Piping Supports:

The tie straps and hangers supporting supply and waste piping appear adequate.

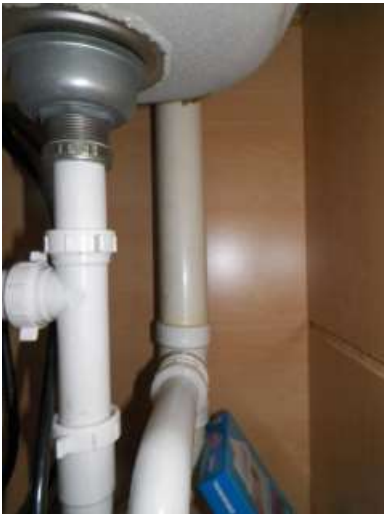
Functional Drainage:

Yes - Functional drainage has been verified. Water drained from a random sample of fixtures or drains flows at a rate faster than was supplied.

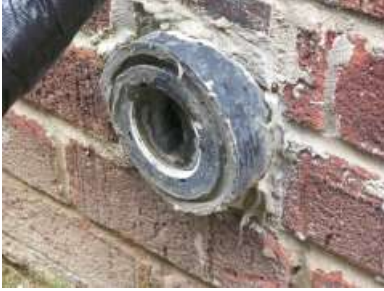
Exterior Slab or Wall and exterior front.

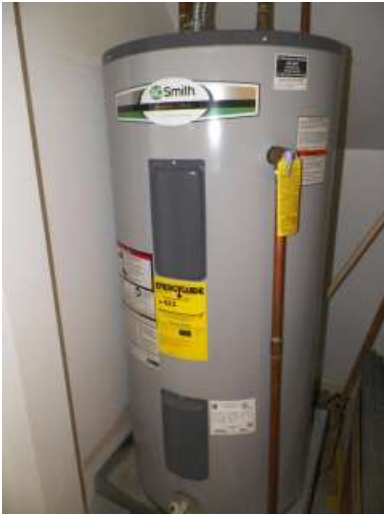
Garage, Utility Closet.

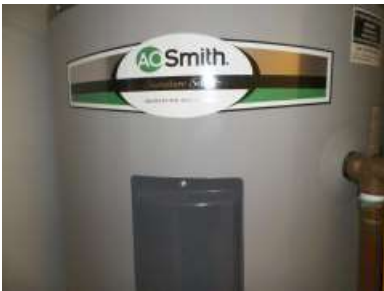
System is A O Smith.

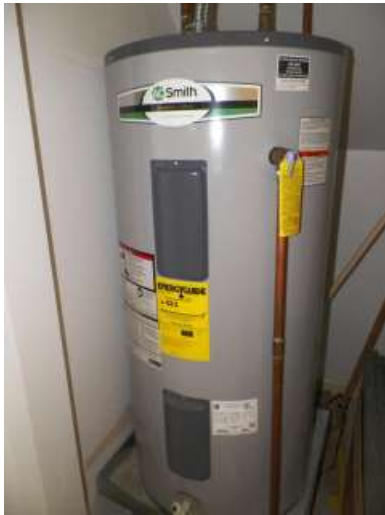
Exposed Water Heater Condition:

It shows some age, but it appears sound.

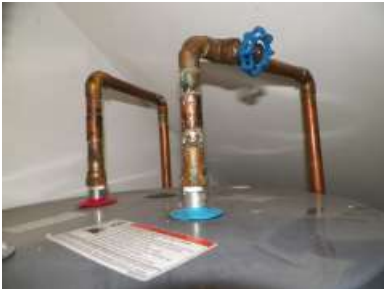
Insulated Hot Water Piping:

Action Necessary -There is no insulation installed on the exposed water piping in unheated areas. Not only is this inefficient, but there is the potential for freeze damage.

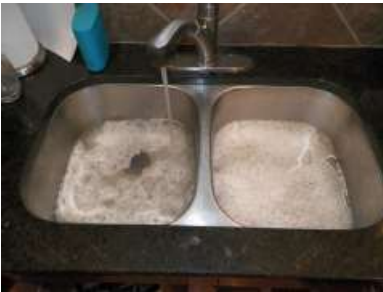
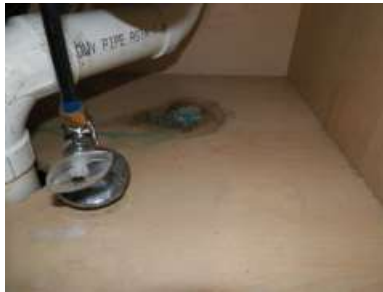
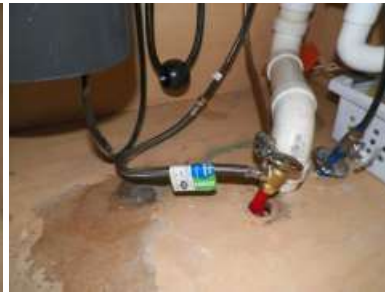
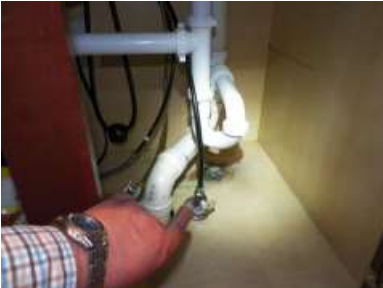
Sink and Drain Lines:

Attention Needed - There was evidence of a prior leak at the sink or drain connection.

Action Necessary - There is evidence of deterioration or leakage in the P-trap or waste line. Replacement of the affected parts is recommended.

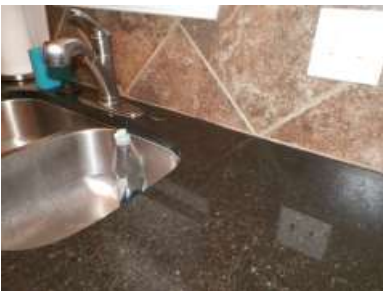
Caulking Water Contact Areas:

Limited visibility: I could not see if caulking was in place. **Attention Needed** - The caulking in water contact areas appear to need attention. If left unsealed, water can cause costly damage.

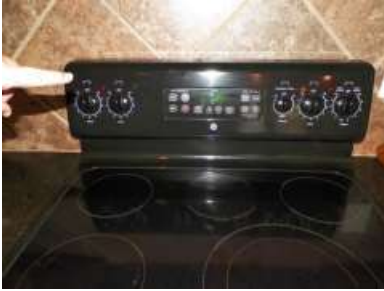
Range/Oven:

Stove has not been secured as required by manufacturer's installation instructions. A tip-over hazard exists for small children. Stove should be properly secured right-away.

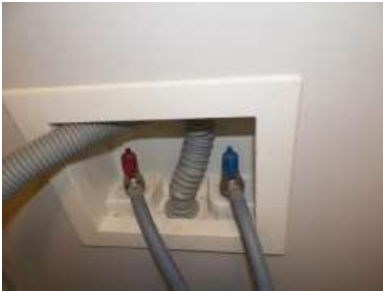
Washer Hookup:

There is a connection box installed in the wall with both hot and cold water and a drain pipe. The drain pipe was not flood tested.

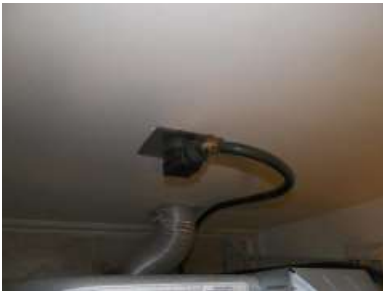
Dryer Hookup:

Yes - There is a 220/240-volt outlet provided for an electric dryer. If you intend to use a gas clothes dryer, you will need to have a gas line installed.

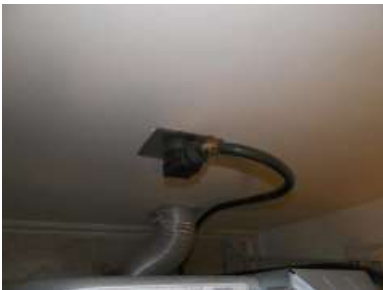
Dryer Ventilation:

The dryer ventilation as installed appears adequate. The vent hood outside is clean, and the flapper is functional.

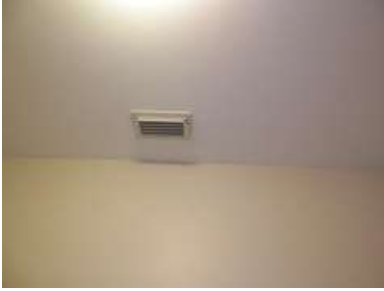
Area Ventilation:

The area ventilation appeared to be adequate.

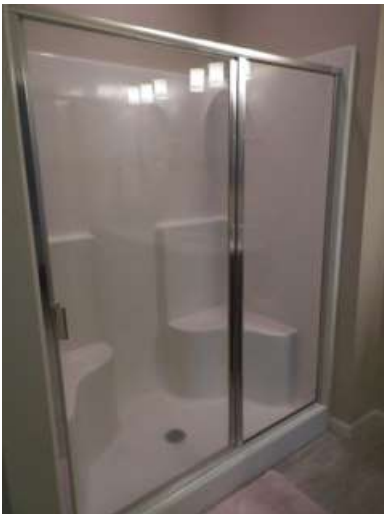
Glass Tub/Shower Door:

Yes, Safety Glass? - There is a set of sliding glass doors installed. I was not able to determine if they are made of safety glass.

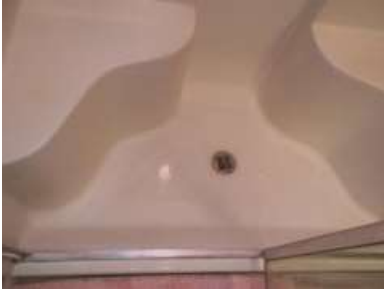
Caulking/Water Contact Areas:

Attention Needed - The caulking in the water contact areas appears to need attention. Damage may result if not corrected.

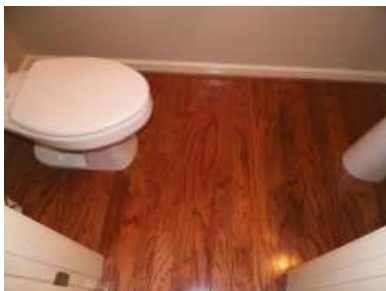
Caulking/Water Contact Areas:

Attention Needed - The caulking in the water contact areas appears to need attention. Damage may result if not corrected.

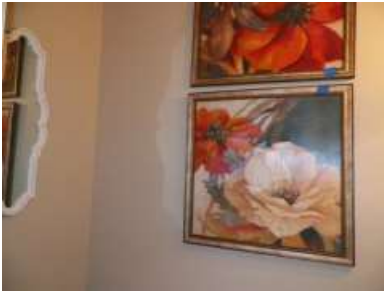
Walls:

The walls in this bathroom are functional. **Attention Needed** - The walls in this bathroom show some minor cracks. They do not appear to be a serious structural concern at this time.

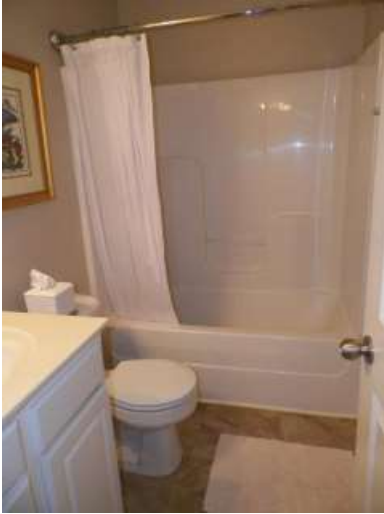
Caulking/Water Contact Areas:

Attention Needed - The caulking in the water contact areas appears to need attention. Damage may result if not corrected. The seam where the tub or the shower meets the flooring needs to be caulked to prevent damage. The wall at the tub or shower seam needs to be caulked to prevent moisture from entering the wallboard.

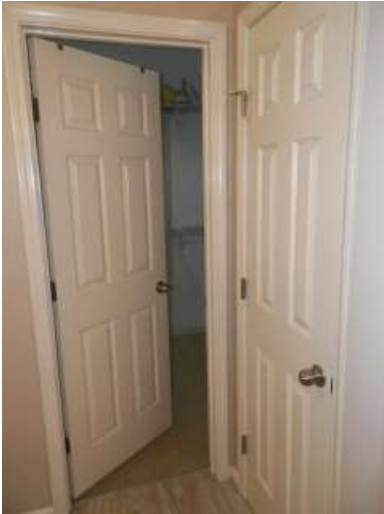
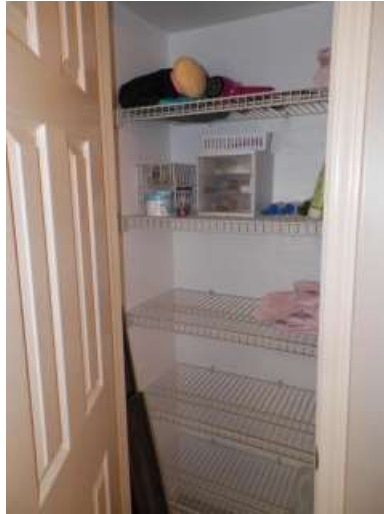
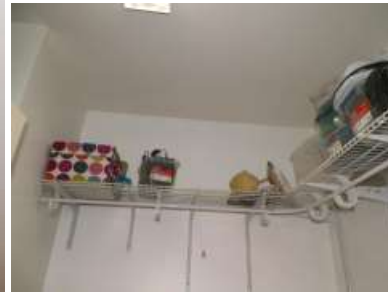
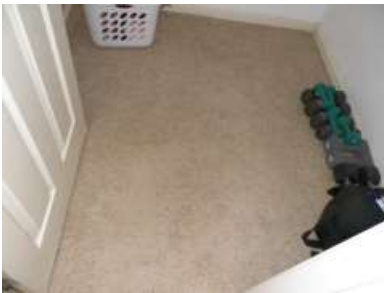
Closet:

The closet is lighted. The exposed bulb could be a fire hazard if stored items come in contact with the exposed bulb. An 18" clearance is recommended.

The closet is functional and of average size. Due to stored items in the closet, it is not possible to determine the condition of the walls and ceiling that are not visible.

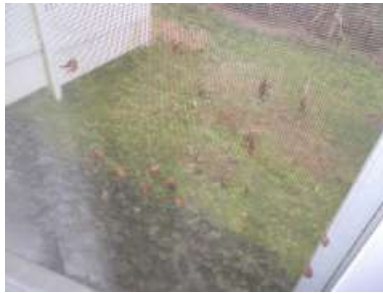
Windows:

Attention Needed - The screen for this window needs repair.

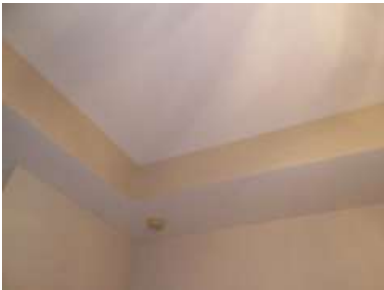
Smoke Detector:

Older Model Detector was noted. The expected service life of this type was 7 to 10 years with the batteries needing annual replacement. It may fail to work reliably in a fire. Replace this with the Newer type with built-in Carbon Monoxide (CO) detection and a 10-year battery. This is an inexpensive upgrade.

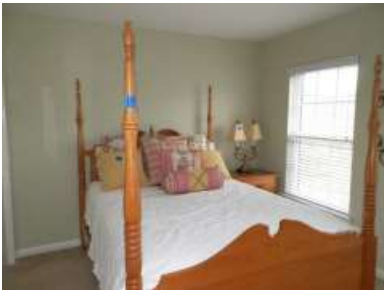
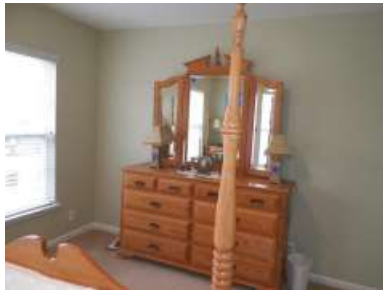
Walls:

The walls in the room appeared to be functional. There was some minor cracking in the sheetrock. Most likely this was due to slight settlement or shrinkage.

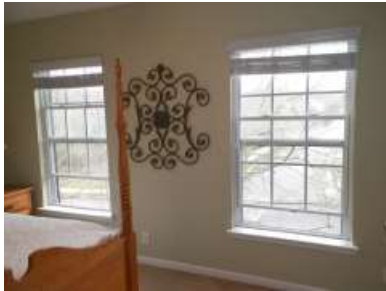
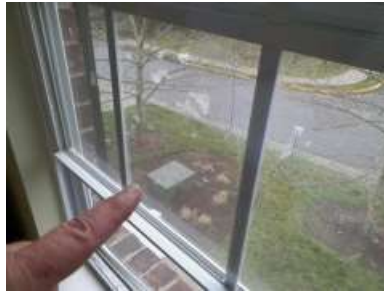
Windows:

Attention Needed - The screen for this window needs repair.

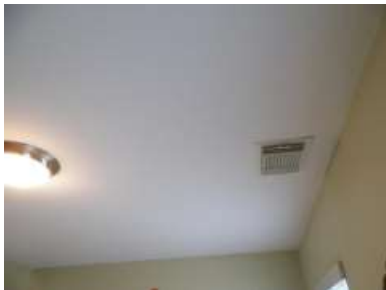
Heat Source Noted:

There is a heat source to this room. There is no comment as to the amount of air or temperature coming from the supply vent. There is no return air vent located in this room. The door is undercut by 1/2" - 3/4 " to allow adequate ventilation in this room.

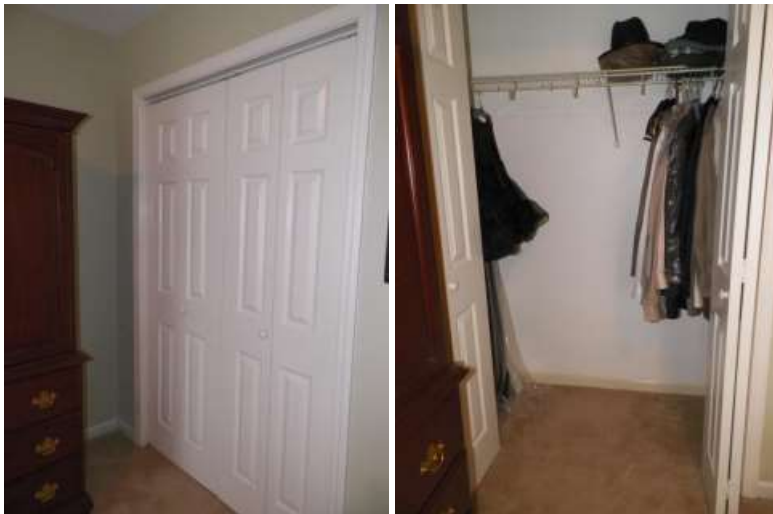
Walls:

The walls in the room appeared to be functional. There was some minor cracking in the sheetrock. Most likely this was due to slight settlement or shrinkage.

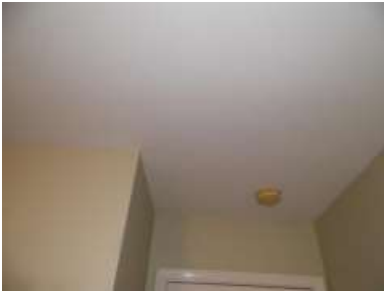
Carbon Monoxide Detector:

There is no carbon monoxide detector installed in this room. For safety considerations, you should consider installation of a battery operated or hardwired carbon monoxide detector.

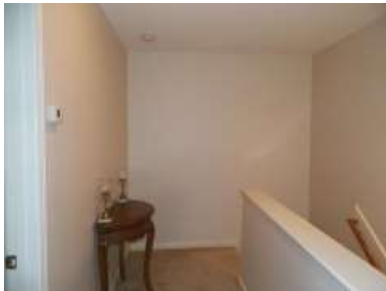
Carbon Monoxide Detector:

There is no carbon monoxide detector installed in this room. For safety considerations, you should consider installation of a battery operated or hardwired carbon monoxide detector.

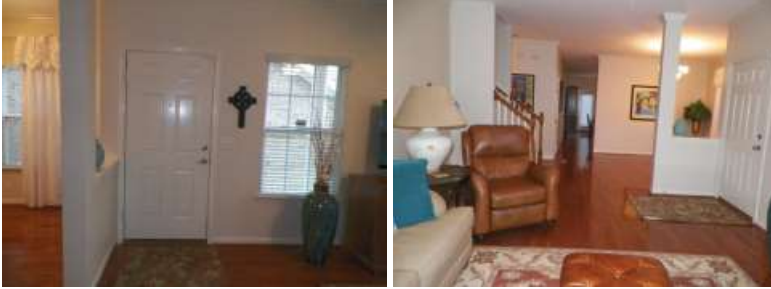
Walls:

The walls in the room appeared to be functional. There was some minor cracking in the sheetrock. Most likely this was due to slight settlement or shrinkage.

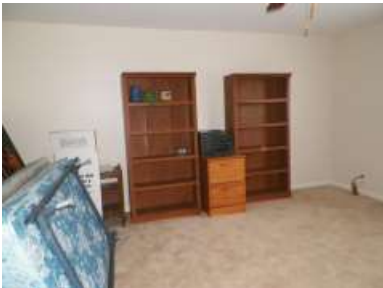
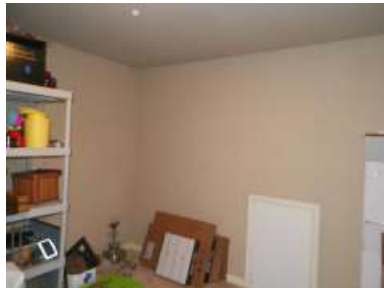
Walls:

The walls in the room appeared to be functional. There was some minor cracking in the sheetrock. Most likely this was due to slight settlement or shrinkage.

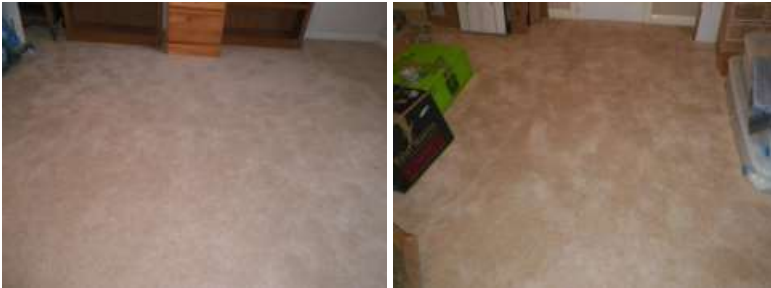
The floors were in functional condition. The floor covering material is carpet. Limited Visibility - due to the carpet or covering.

The windows and associated hardware in this room were all functional at the time of the inspection.

Attention Needed - The screen for this window needs repair.

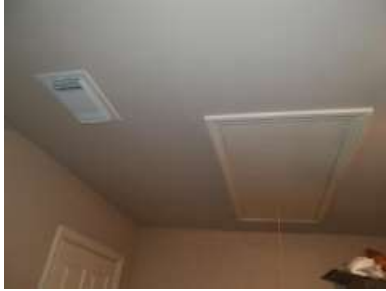
There is a heat source to this room. There is no comment as to the amount of air or temperature coming from the supply vent.

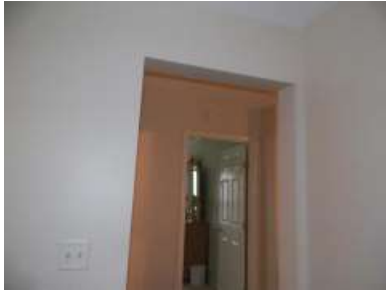
Not in this room. One was located in the upper hallway. There is no smoke detector installed in this room. For safety considerations, you should consider installation of a battery operated or hardwired smoke detector.

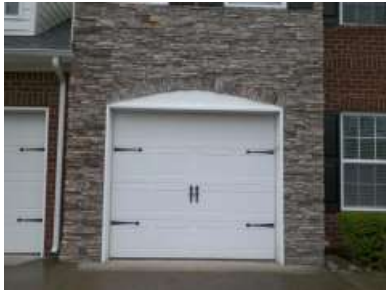
Built-In Under at the basement level.

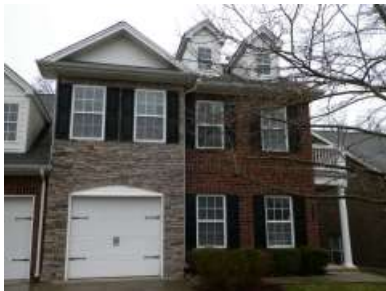
One car garage.

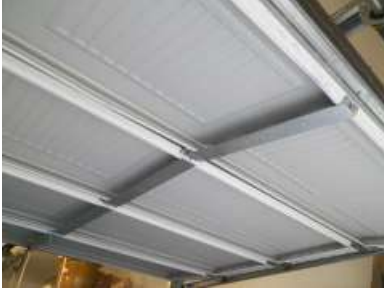
There is a single overhead door.

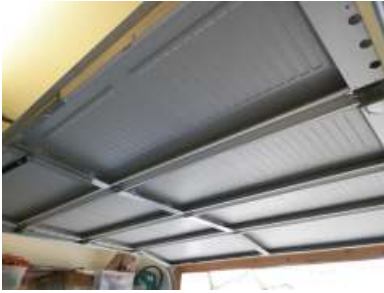
The overhead door is in satisfactory condition, and it is functional.

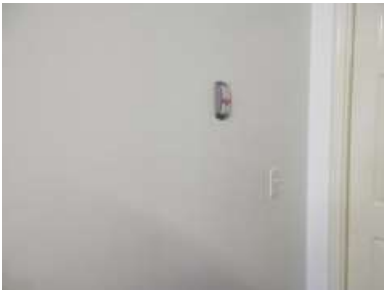
The overhead door opener appears to function appropriately. Testing the remote control for the automatic opener is not included as a part of this inspection.

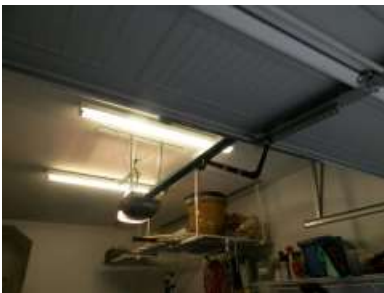
Yes - The door opener is equipped with an automatic reverse safety switch.

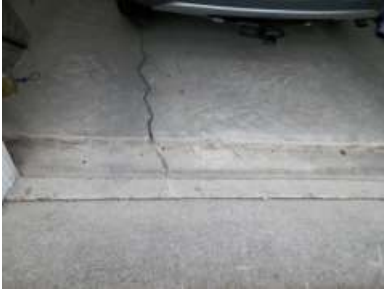
The garage floor is functional and has a satisfactory appearance. This crack had been sealed. It did not appear to be of structural concern at this time. Due to stored items on the garage floor, I was unable to determine the condition of the portions of the floor that are not visible.

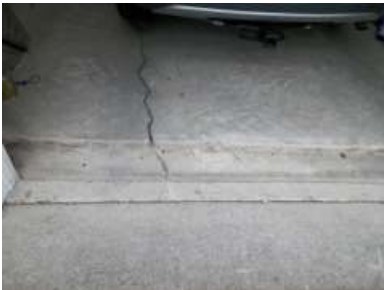
No - There is no floor drain installed. A Step down was present to prevent water from running into the garage and to help drain water from the garage floor.

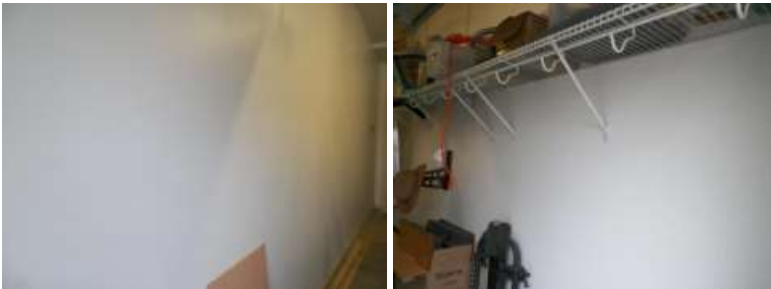
I was unable to determine if the installed sheetrock is fire rated.
The wall covering and framing appears to be without significant issues.

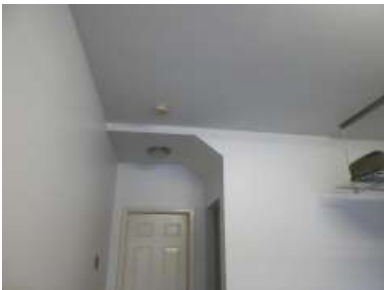
I was unable to determine if the installed sheetrock is fire rated.

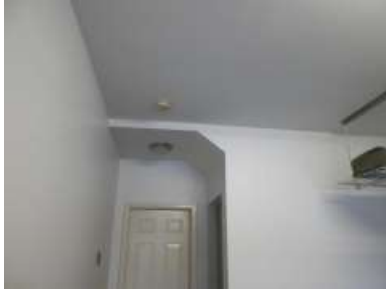
Yes - There is a fire rated door separating the garage from the living areas of the house.

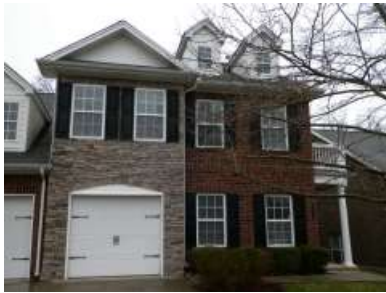
The detached garage roof covering materials are similar to that on the main structure, and they are in a similar condition.

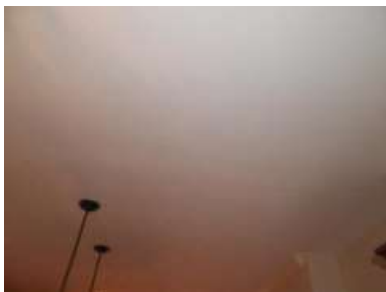
General condition appears serviceable.

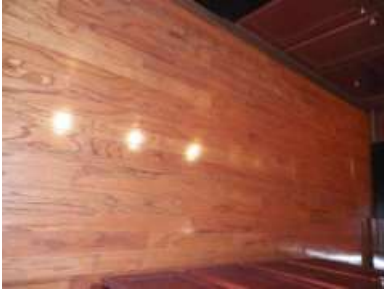
General condition appears serviceable, The floor covering material is hardwood.

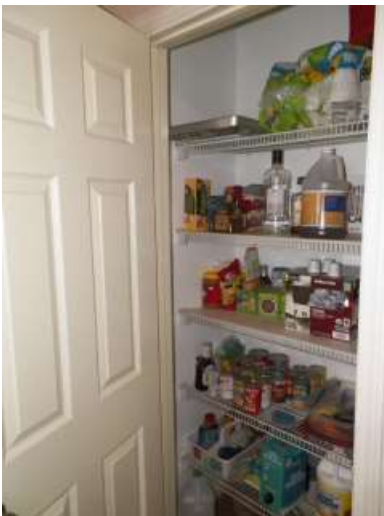
Pantry.

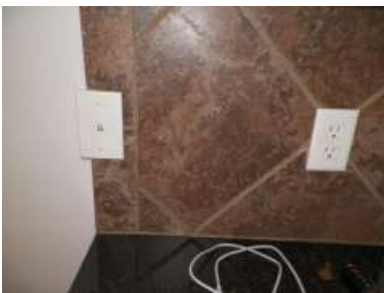
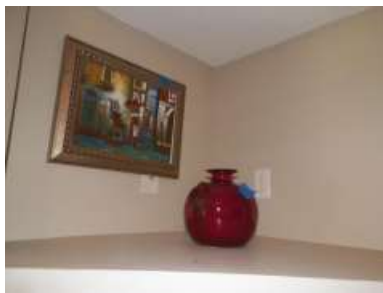
There is a telephone jack installed in this room. It may or may not be functional.

Cable connection over fireplace.
