Complete Tennessee Inspections, LLC
3554 Mahlon Moore Road
Spring Hill TN 37174
615-943-0051
Jeffrey.Bonner.JB@gmail.com

Inspection reference: 2021016 David Gilliam

Confidential Inspection Report
832 Barrington Place
Brentwood, TN 37027

March 16, 2021

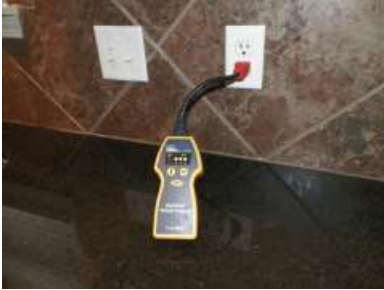
The outlets tested in the kitchen are correctly wired and grounded. As a whole, outlets throughout the room are in serviceable condition. There is a Ground Fault Circuit Interrupt outlet installed and functional above the kitchen countertop. It is in the area within a 6 foot reach of the sink.
